HUMAN CASUALTY AND DAMAGE DISTRIBUTION IN RELATION TO SEISMIC INTENSITY IN THE 2006 CENTRAL JAVA EARTHQUAKE IN INDONESIA

H. Murakami¹, D. Pramitasari², and R. Ohno³

ABSTRACT :

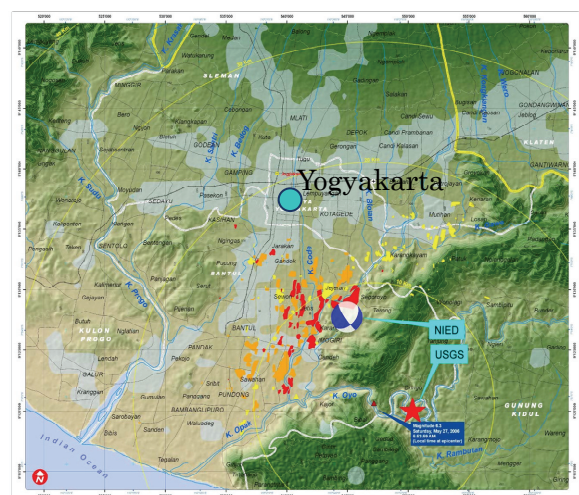
Figure 2.1 shows damage distribution obtained by UNOSAT and epicenters. Figure 2.2 shows dwelling damage and fatality distribution using sub-district-wise statistics. Pleret, Jetis, and Pundong sub-districts of Bantul district are in concentrated high damage zone over 60% of collapse ratio extending from NNE to SSW for approximately 20km. Gantiwarno and Wedi sub-districts located in the southern parts of Klaten district depict 30-60% total collapse ratio, which agrees with our field observation. Damage distribution agrees well with UNOSAT (2006) early estimation on their web-site after the earthquake (Fig. 2.1). The earthquake source locations estimated using Real-time-JISNET data by Nakano et al. (2006) agree with the severe damage zone in Fig. 2.2. High damage zone extends to north to Sleman district, in the east of Jogjakarta (Yogyakarta) city. Human loss distribution in Figure 2.2 indicates similar pattern as the dwelling collapse ratio. Human loss ratio in Pleret, Jetis, and

Figure 2.1 Damage distribution obtained by UNOSAT[1] and the location of the epicenter by USGS[2] and the mechanism of the moment centroid by NIED[3] (after Kawase, et al., 2006)

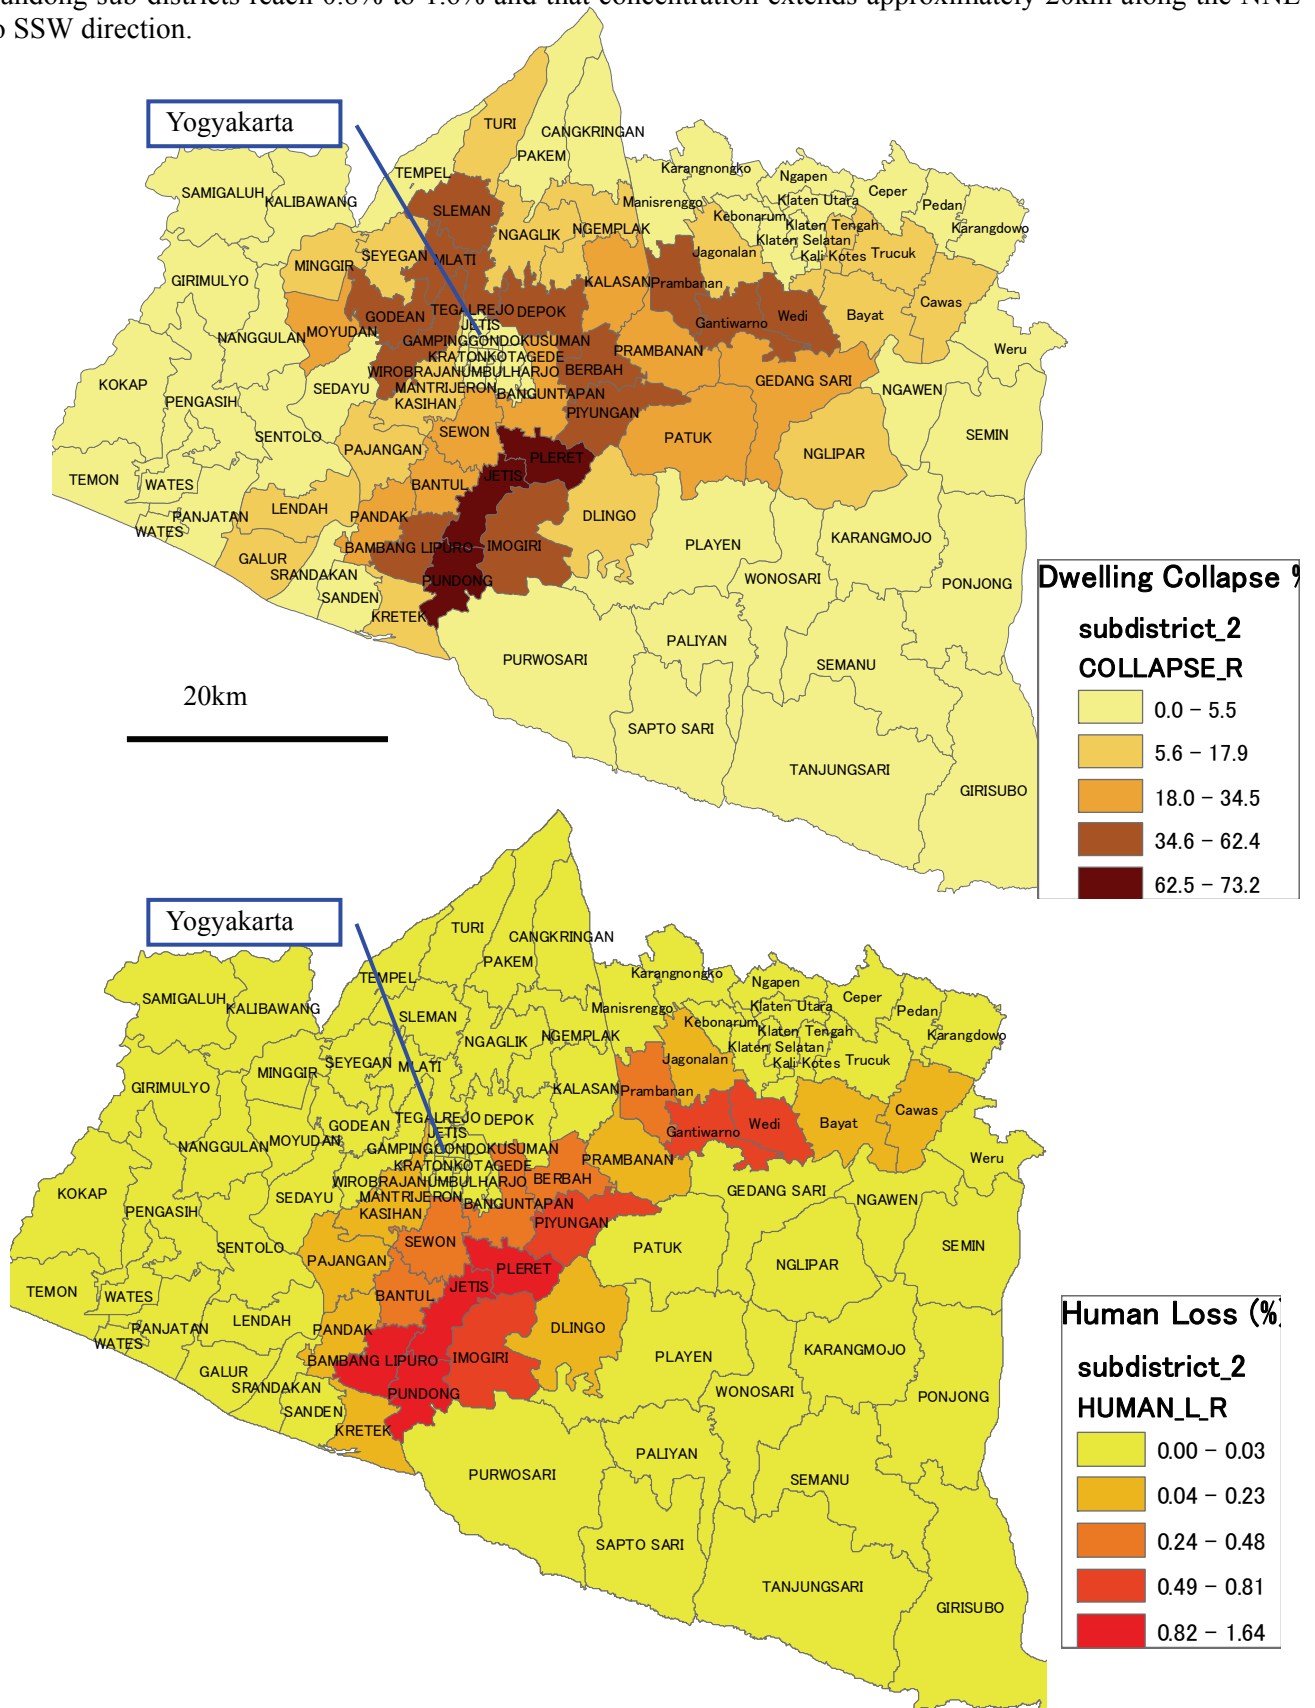
Pundong sub-districts reach 0.8% to 1.6% and that concentration extends approximately 20km along the NNE to SSW direction.

Figure 2.2 GIS distribution of dwelling collapse rate (%) above and human loss rate (%) below using sub-district damage statistics data.

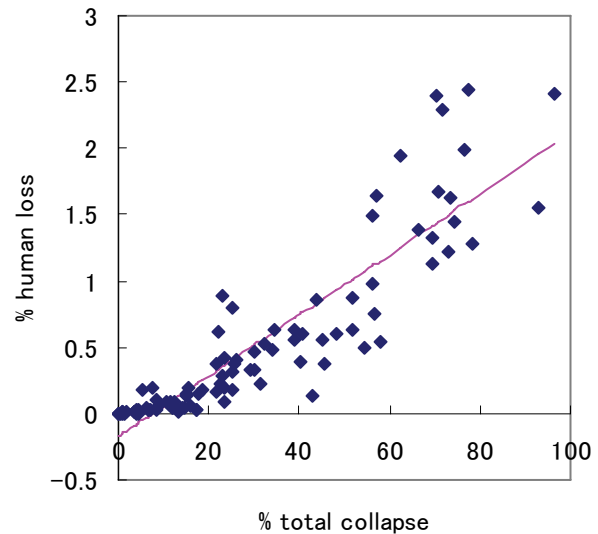
Figure 2.3 shows the relation between rate of dwellings totally collapsed and rate of human loss for village statistics in Bantul District. Normal correlation is obvious with correlation coefficient $R=0.896$ and human loss rate further increases while total collapse rate exceeds 60%. Linear regression equation is obtained as follows.

$$FR = 0.023 CR - 0.17 \quad (2.1)$$

Figure 2.3 Relation of total collapse % and human loss % in the Java earthquake

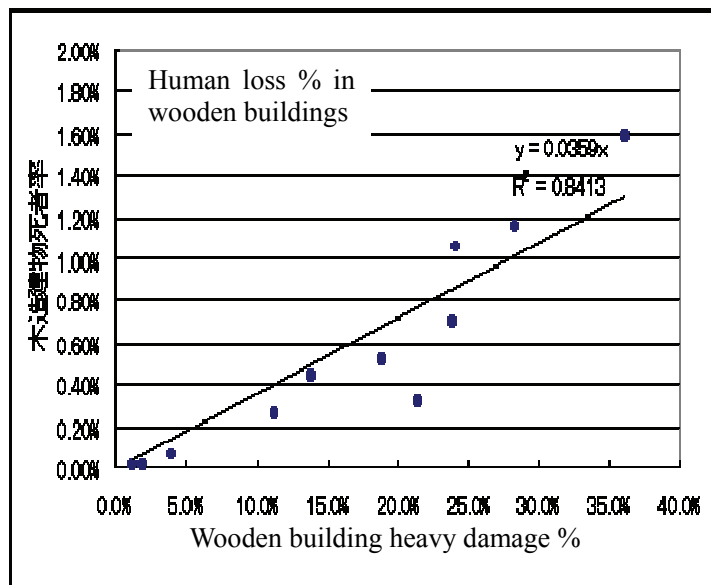
Based on the damage report of the 1995 Kobe earthquake by Fire Research Institute of Japan, the following relation between dwelling heavy damage rate and human loss rate is given for earthquake damage estimation manual (Fig. 2.4).

For the same levels of dwelling damages, fatality ratio in Java is approximately half of that in the Kobe earthquake, probably because single story dwellings are majority in Java, while two story dwellings were common in Kobe. In Central Java, more two story dwellings have been constructed along urban sprawl and economic development of the area. It is very important to provide education and training of dwelling earthquake safety (seismic resistance) for local residents (home owners) and carpenters, otherwise we are afraid that human casualty could be doubled in future earthquakes.

Figure 2.4 Relation of dwelling heavy damage rate (%) and human loss rate (%) for the 1995 Kobe earthquake (Disaster Mitigation Division of Cabinet Office, Japan).

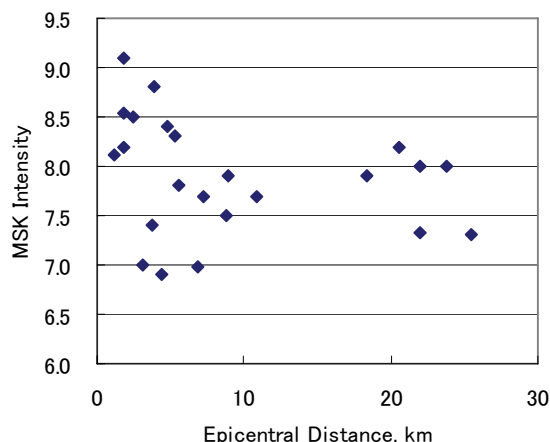
MSK intensity vs. epicentral distance is plotted in Fig. 3.1. Intensities attenuate from the epicenter to 10km distance, though they are largely scattered, probably due to the effects of source and local soil conditions. Villages at around 20km epicentral distance are located in Klaten district and they show high intensities.

Figure 3.1 MSK intensity vs. epicentral distance.

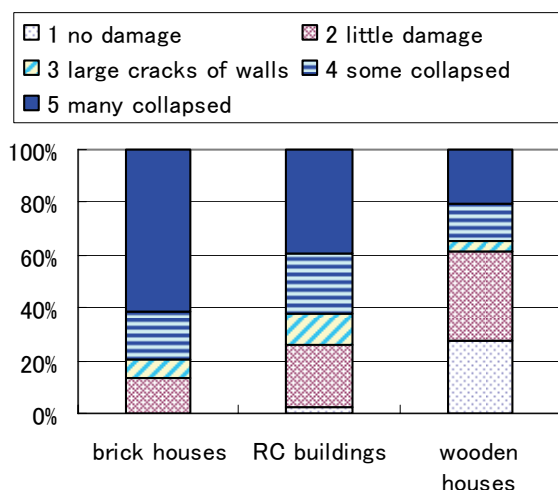
Figure 3.2 Comparison of damage levels of dwellings in your neighborhood among brick houses (Q18), wooden houses (Q19), and RC buildings

Figure 3.2 shows comparison of the damage levels of different types of dwellings or buildings in the neighbourhood (Q18, Q19, and Q20). Damage categories in Fig. 3.1 may correspond to official damage statistics as follows; 2. little damage corresponds to slightly or moderately damaged, 3. large cracks of walls and 4. some collapsed correspond to heavily damaged, and 5. many collapsed corresponds to completely destroyed. It clearly indicates that brick masonry suffered heaviest level of damage with most collapsed, followed by RC dwellings and by wooden dwellings. In case of wooden dwellings, responses of large cracks

of walls count few, suggesting there were either no damage or serious damage. If wooden dwellings mean traditional type of timber frame with woven bamboo wall panels, they are not likely to suffer many cracks. We may need more information regarding damage patterns of traditional timber frame dwellings, however, it is very important that traditional timber frame dwellings with bamboo net wall panels and light tile roofing are lighter in weight than masonry dwellings and are reasonable to be more seismic resistant and are less lethal to the occupants even when heavily damaged. Construction method and damage characteristics of traditional timber dwellings are described by Ohno et al. (2006).

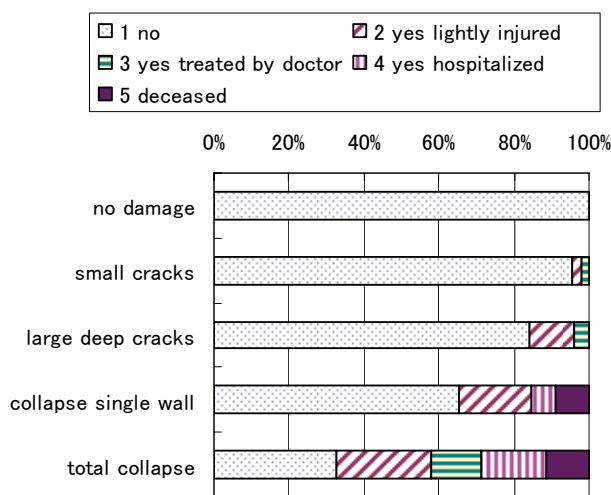
Figure 3.3 shows relations of human casualty of family members against the damage levels of dwellings. Entrapment probability significantly increases while damage level reaches to large cracks and partial wall collapse and it reaches to 60% in case of total collapse of a dwelling. In the same manner, human casualty increases as wall damage deteriorates and human loss occurred in approximately 12% of households, when a single wall collapsed or two or more walls totally collapsed.

Figure 3.3 Casualty of family members in relation to the damage levels of dwellings according to the questionnaire data.

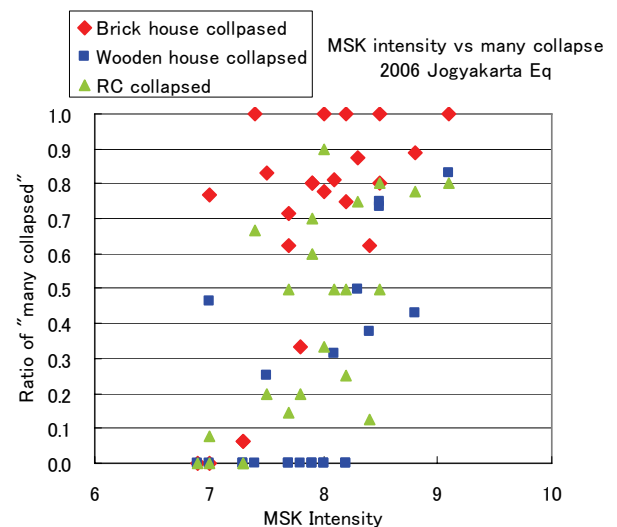
Using the intensity questionnaire data, rate of “many collapsed” response for brick, wooden, and RC dwellings are plotted vs. MSK intensity of the locations (Fig. 3.4). It is clearly observed that brick houses suffered highest rate of collapse, while RC buildings and wooden dwellings follow with lower rates of collapse. Data plotted in Fig. 3.3 are divided into MSK levels and average ratio of people who observed many of houses or buildings of each type collapsed are indicated in Table 3.3.

Figure 3.4 MSK intensity vs. rate of “many collapsed” response to neighborhood dwellings.
