Grain Boundary Precipitate Embrittlement in Alloy 617 due to Partial Solution Annealing

Rupesh Kumar, I. Kalpana Nayak, Sumita Santra, Y. Balaji Rao, S. V. Ramana Rao, K. S. Subramanian, S. Sairam, K. Kapoor, D. Srivastava
Nuclear Fuel Complex, ECIL, Hyderabad

Failure Analysis

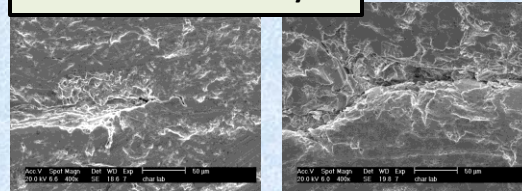
Fine crack like features observed on OD and ID surface

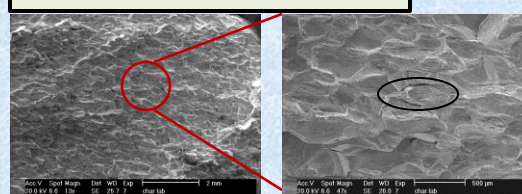
Crack propagation along Grain Boundary (GB)- Intergranular fracture

➤ The Fracture surface showed intergranular fracture suggesting embrittlement along grain boundaries. Microstructural characterisation showed enrichment (Mo, Cr, C) along the grain boundaries.

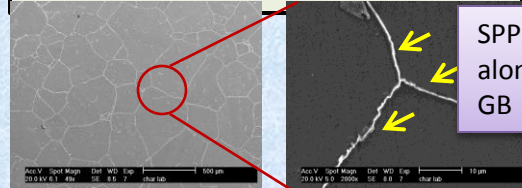
SPPs along GB

Enrichment free GB

As received

Reannealed

➤ It is confirmed that grain boundary enrichment resulted in embrittlement of grain boundary and subsequent cracking during cold working. Though proper solution annealing was imposed, slight delay in quenching resulted in formation of such precipitation and subsequent embrittlement.

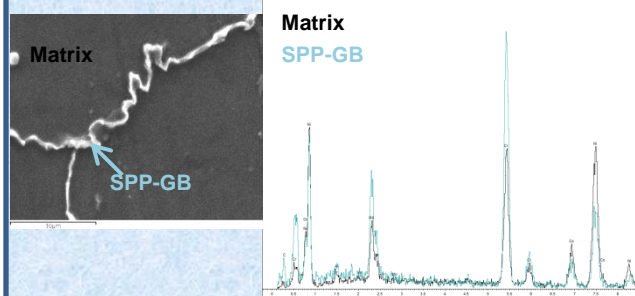
EDS Analysis of Second Phase particle(SPP)

% Composition	
	Matrix	SPP-GB
Ni	52.29	25.32
Cr	23.36	38.5
Co	11.74	5.8
Mo	11.79	15.5
Al	0.92	-
C	-	14.8

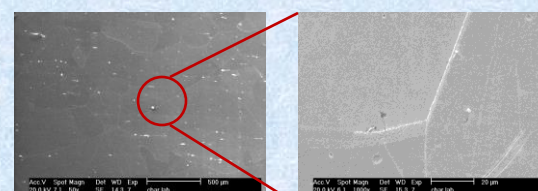
Microstructure of successfully pilgered tube : No GB enrichment
