## CONSIDERATION OF EARTH DAM BEHAVIOR DURING THE 1995 HYOGOKEN-NANBU EARTHQUAKE

S. TANI

NATIONAL RESEARCH INSTITUTE OF AGRICULTURAL ENGINEERING  
 TSUKUBA CITY, JAPAN

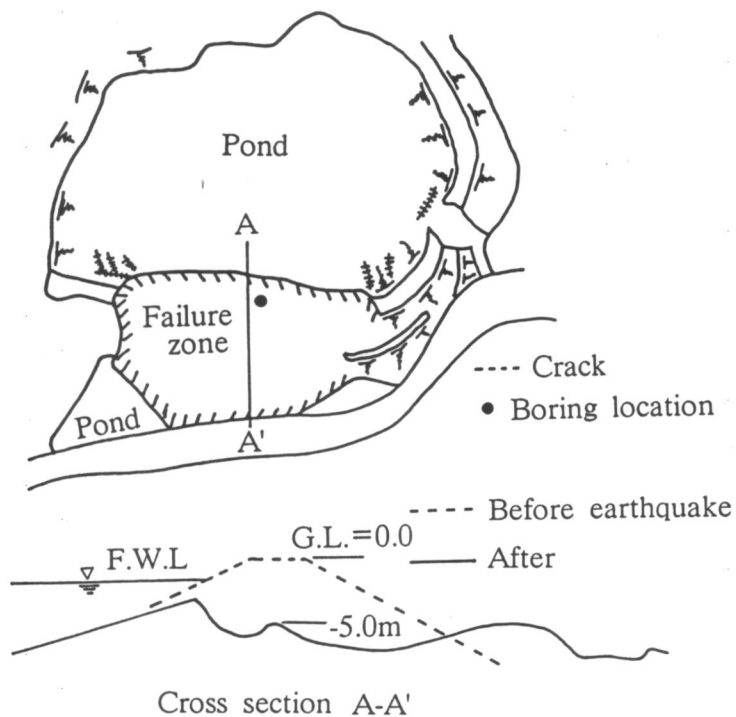
Fig. 9. outline the damage to Idenoshiri Dam, where the central part of the embankment failed. Sand boil due to liquefaction was observed within the water storage area. The grain size distribution indicates this to be fine sand. Soil profile obtained from a post-earthquake boring. The embankment section has an N-value of less than 5 and is composed of fine sand. The results of cyclic triaxial tests indicate that liquefaction strength was not very high. These results suggest that liquefaction caused damage to the embankments and foundations of this earth dam. Fig. 10. shows the locations of the three earth dams close to 'the Nojima Fault'. The example of Mukumoto Dam illustrates complete failure of dam facilities. Fig. 11 shows the failure to the spillway on the left side of the crest. Almost no damage was seen in the embankment section itself. The embankment consists of a mixture of silt and fine sand with an N-value of  $\approx 5$ . Near this dam are two other earth dams (Izuminaka and Izumi), where the Nojima Fault runs parallel to the longitudinal axis of these dams for several meters.

Fig. 9. General condition of the Idenoshiri Dam after earthquake

- (3) Boring surveys were conducted at Idenoshiri Dam to provide a case study for Level I damage. The results of these surveys indicated that liquefaction in the embankment and foundation may have caused them to fail.

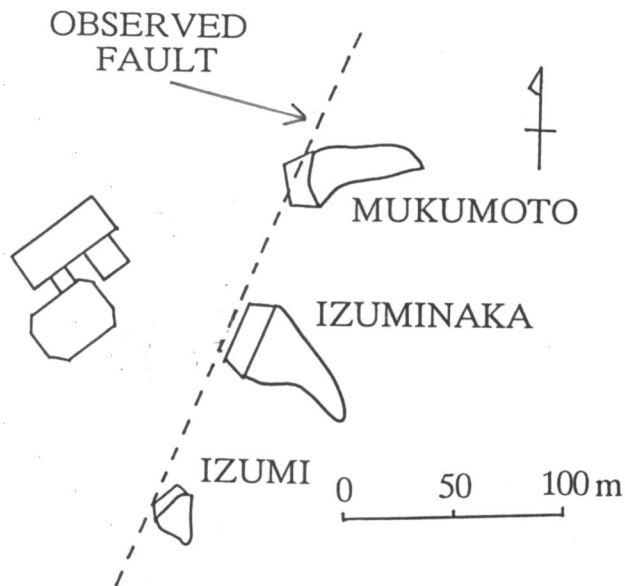
Fig. 10. Location of the earth dams close to the Nojima Fault

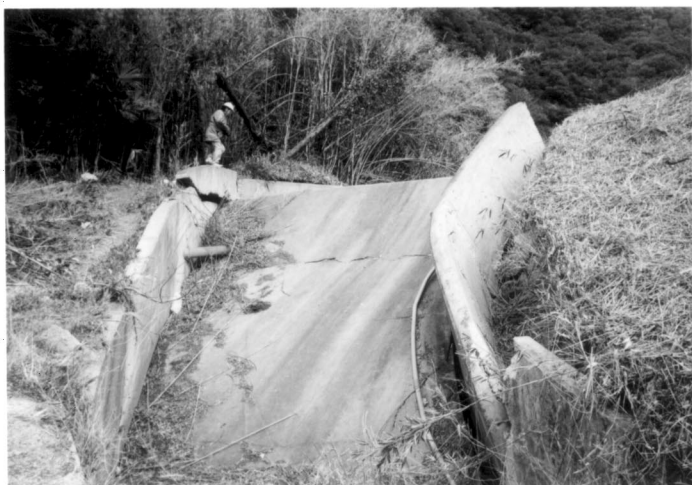
Fig. 11. Damage to the spillway on Mukumoto Dam close to Nojima Fault

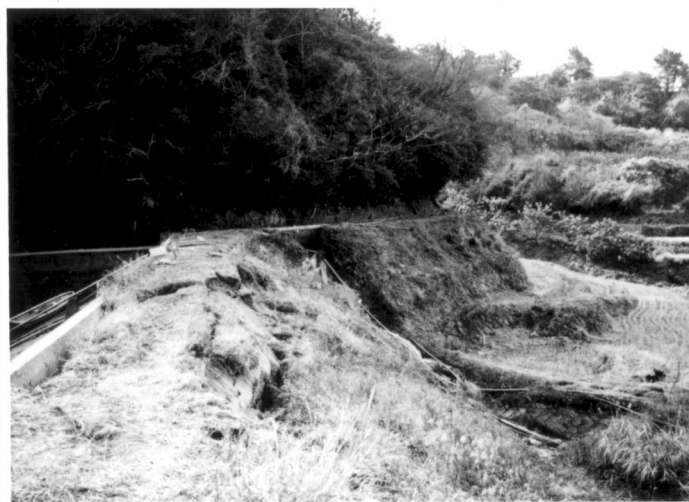
Fig. 11. shows the extent of damage sustained at Izuminaka Dam immediately after the earthquake. Sliding was detected on the down stream slope of the dam and leakage was found on the downstream slope of the dam. The results from a boring made after the earthquake are shows that the N-values and soil types were similar to those of Mukumoto Dam, Izuminaka Dam suffered extensive damage. Only a few minor cracks developed on the upstream slope of Izumi Dam. Even though the Nojima Fault is in the immediate vicinity, the embankment suffered only minor damage. No boring surveys were conducted at this dam. Despite having with stood severe shocks from the earthquake, the embankment suffered only minor damage. The reason for this could be because the Nojima Fault runs parallel to the embankment, although detailed analytical investigations will have to be conducted to determine the exact causes.

Fig. 12. Damage to Izuminaka Dam close to Nojima Fault
