LIQUEFACTION, LATERAL SPREADING, SLOPE AND EMBANKMENT FAILURES DURING THE MARCH 13 EARTHQUAKE OF ERZINCAN, TURKEY

ABSTRACT

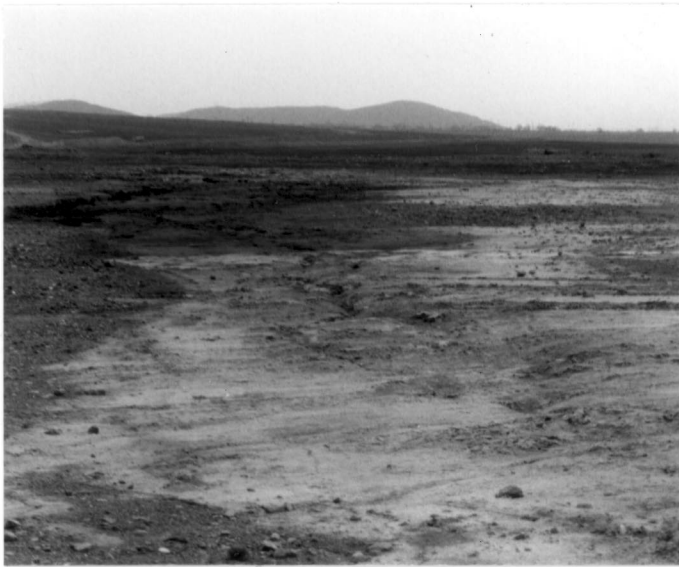
Severe liquefaction and liquefaction induced lateral spreading of ground were observed at Ekşisu, Karasu, Mertekli and Altınbaşak. (Photos 1-4). These localities are the old marshlands which were dried through an extensive network of drainage canals in the basin. Figs. 5 and 6 show particle size distribution curves of liquified ground at various locations and their porosities vs. unit weights. The samples were collected from sand volcanoes. In-situ explorations at Ekşisu showed that the top 4 m soil layer was silty sand or sandy silt with an SPT value ranging between 2-7 and with shear velocity V_s of 80-156 m/s. The ground water level is 0.5-2m below the ground surface which makes the ground to be susceptible to liquefaction (Erken et al. 1995).

Photo 1 Liquefaction at Ekşisu

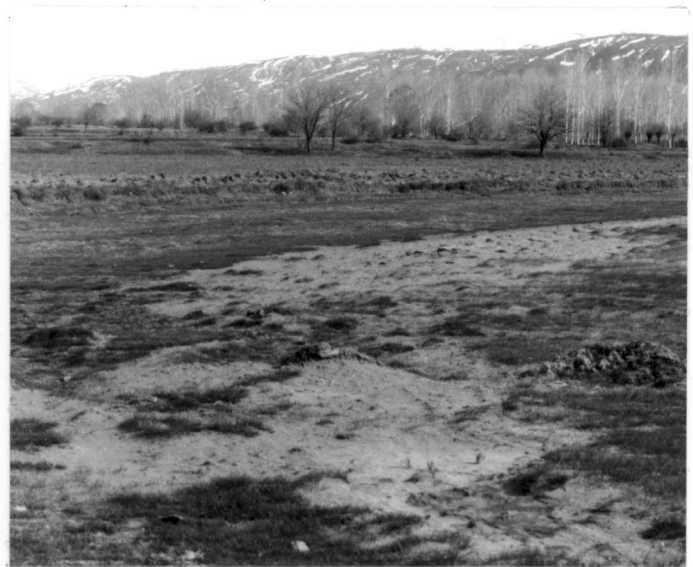
Photo 2 Liquefaction at Karasu

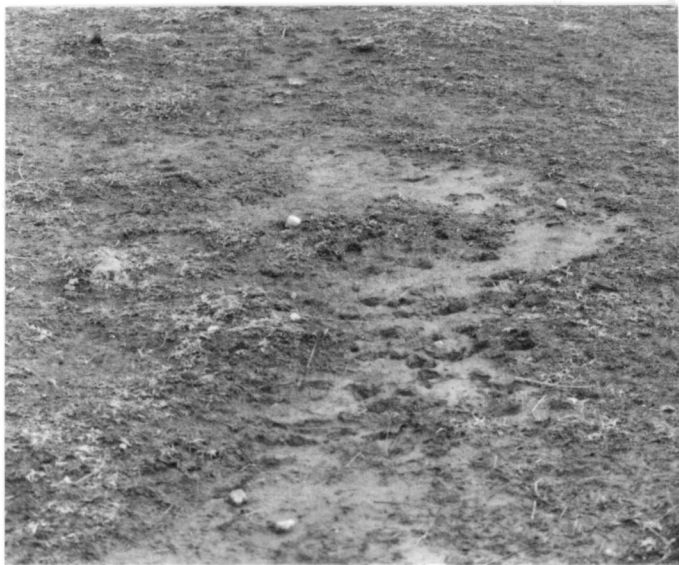
Photo 3 Liquefaction at Altınbaşak

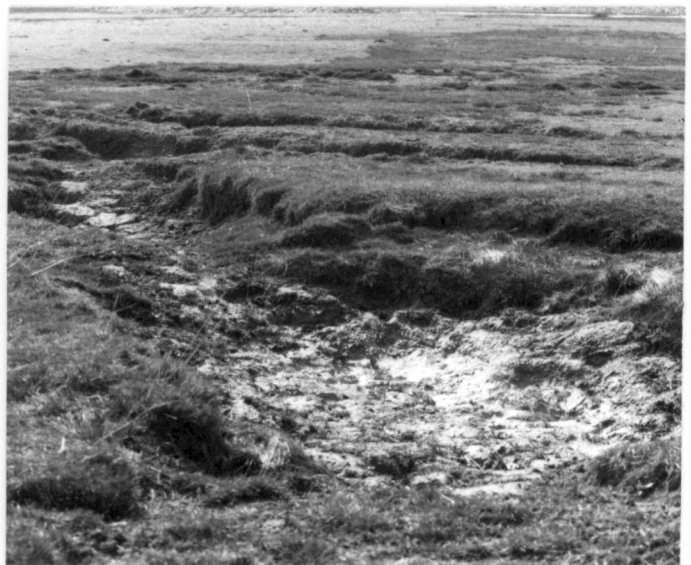
The liquefaction induced lateral spreading of ground were observed at all localities (Aydan & Hamada 1992). Photo 4 shows a liquefaction induced lateral spreading of ground at a locality called Karasu (Aydan 1995). The ground was relatively flat (1-2%) and the site was an old bed of Fırat (Euphrates) River. Fortunately, there was no structure of importance in these sites except the regulator at Mertekli.

Photo 4 Lateral spreading at Karasu

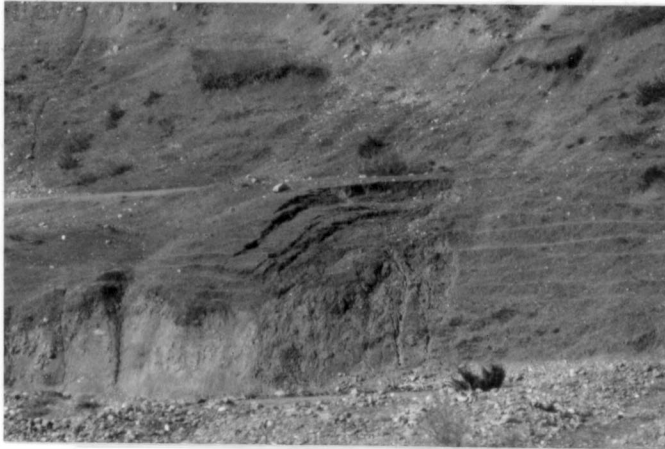
There were some natural soil slope failures on the banks of Fırat River (Photos 5-6). The soil is a residual type resulting from the weathering of ultra-mafic rocks. Soil slope failures were observed on the south-east looking northern bank of the river. On the opposite bank no soil slope failure was observed. The failure surface of the soil slope failures seems to be curved and shallow seated. The slope failure probably occurred on the interface between the top residual soil and rock formation beneath.

Photo 5 Soil slope failure near Tanyeri

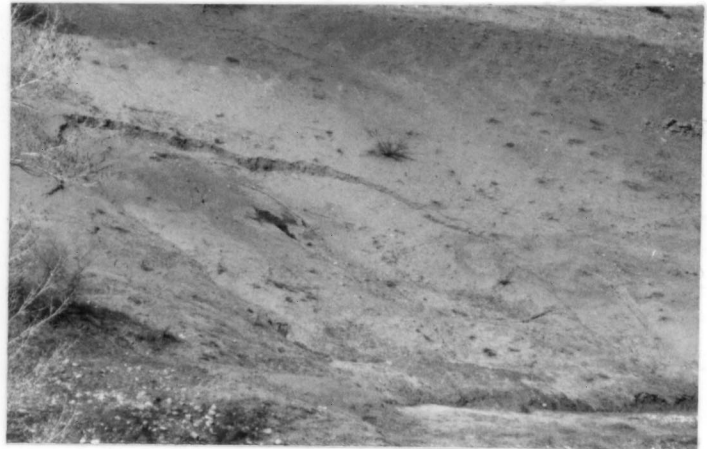
Photo 6 Soil slope failure near Tanyeri

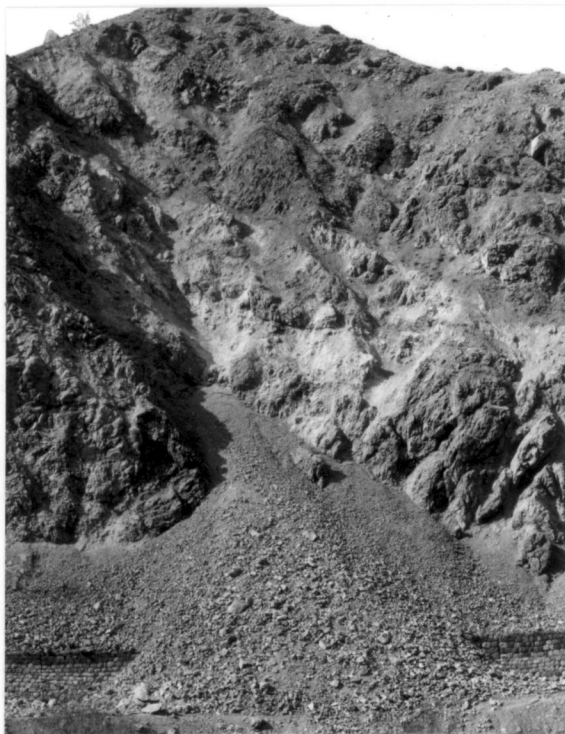
At several locations on the south-east looking northern slope of the narrow valley near Tanyeri, where the rock mass shows up and is highly fractured, there were also some rock slope failures (Photo 7). In addition to these, there were some rock falls weighting about 2-3 tonf at maximum (Photo 8). Some rock falls were also observed at rock cuts of roadways (Hamada and Aydan 1992, Çetinkaya 1993).

Photo 7 Rock slope failure near Tanyeri

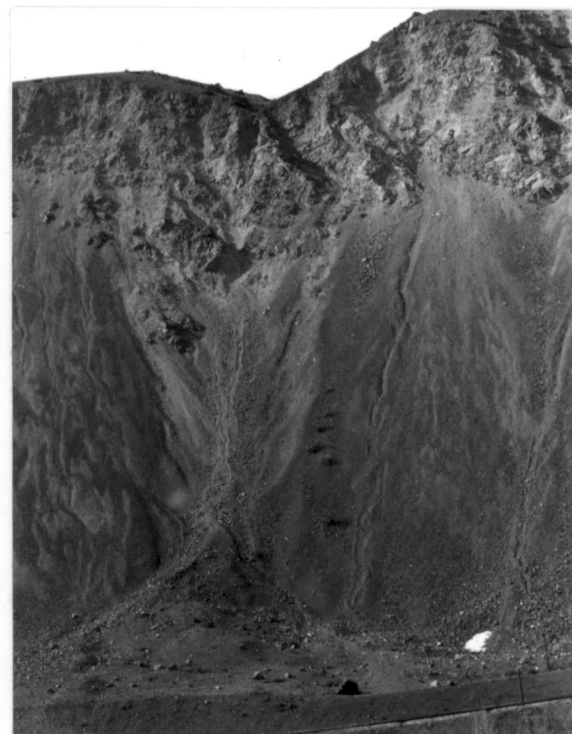
Photo 8 Rock block falls near Tanyeri

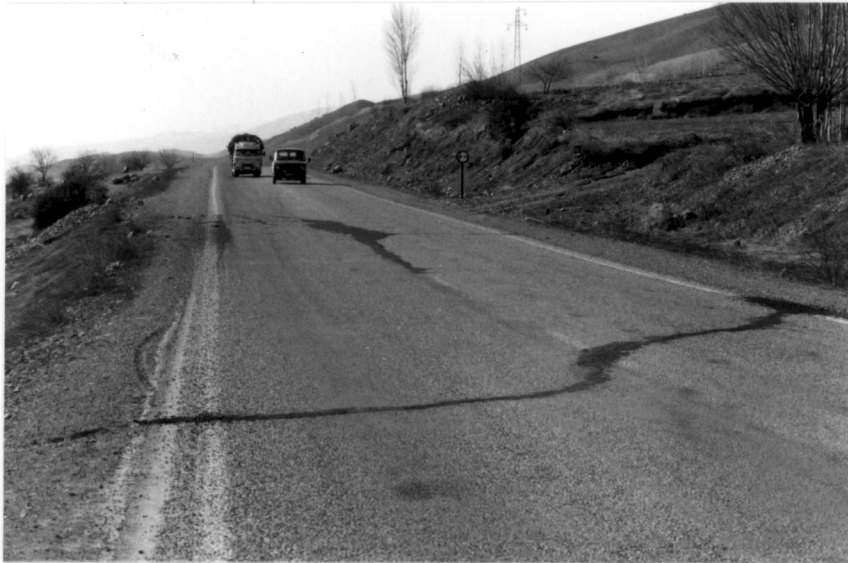
The most severe damage to the Erzincan - Erzurum Highway was observed at a locality called *Karasu*. There were lateral and longitudinal cracks on roadways, which generally run parallel to the northern side of the basin (see Fig. 1 for location). The highway was displaced by 200 mm towards the Fırat river (Euphrates) and settled by approximately 100 mm (Photo 9). This place is thought to be close to the junction point of NAF and Ovacık fault (OF) (Koçyiğit 1992, Barka and Gülen (1987)). There were also liquefaction induced lateral spreading of ground in this locality as discussed in the previous section. This type of embankment failures were also common at other highways which run parallel to the northern side of the basin.

Photo 9 Displaced highway near Karasu

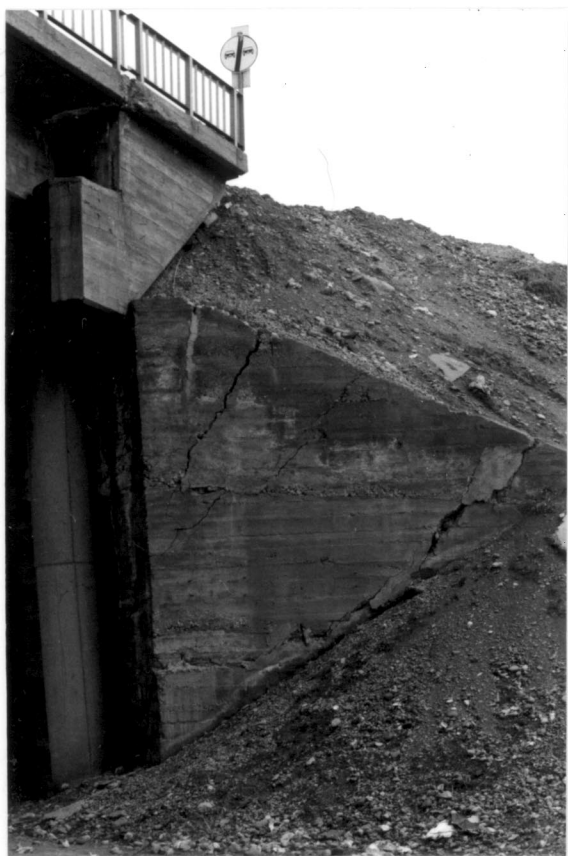
The most severe damage to bridges and their embankments was observed at a bridge which is a cross-over bridge on the Erzincan - Kemah Highway over the railway line. The walls of the eastern embankment of the bridge was ruptured and moved westwardly and struck the adjacent piers (Photo 10). As a result, the piers cracked at the top by bending. Piers in the middle of the bridge were also fractured by bending.

Photo 10 Fractured embankment walls of a cross-over bridge

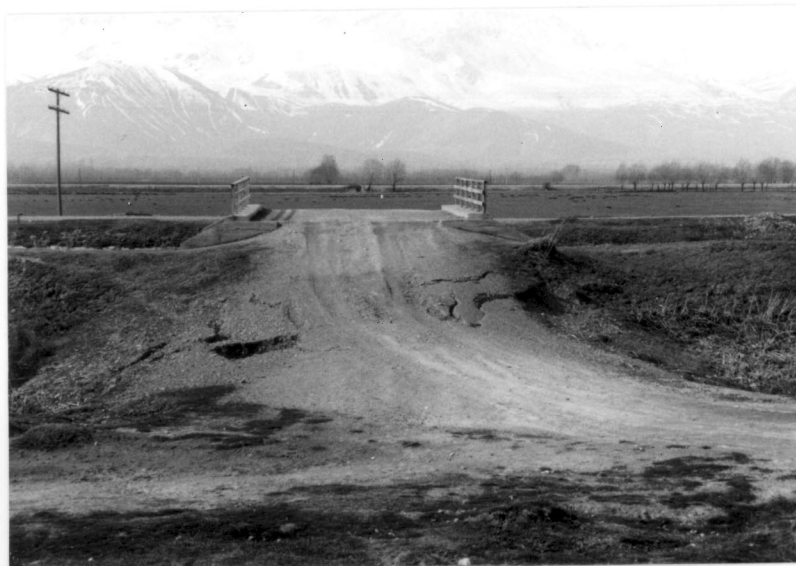
Photo 11 shows the failure of an embankment of a bridge over an irrigation canal. The direction of the bridge is North-South and the embankment failed by horizontal translation in the direction of East-West. Near the same bridge, a concrete conduit (1 m in diameter) under the bridge embankment was also translated in EW direction for about 10 cm which resulted in the washing-out of the soil above and the opening of a hole in the embankment (Photo 11).

Photo 11 Embankment failure of a small bridge

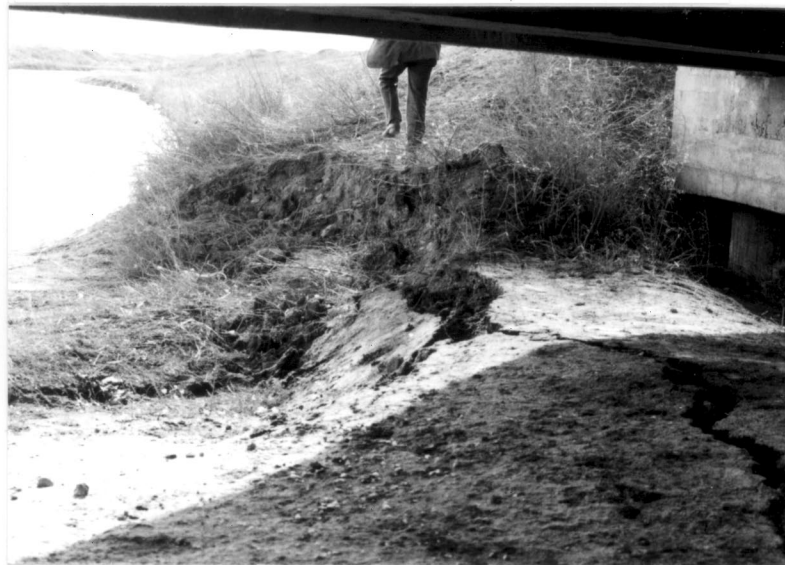
Photo 12 shows the failure of the western embankment of a creek called *Karasu Çayı* under a bridge on the Erzincan - Erzurum Highway. It was also interesting that the western embankment failed by slumping while there was no indication of any failure on its eastern embankment.

Some settlement of the piers was observed at a bridge over *Karasu Çayı* mentioned in the previous sub-section (Photo 12). The piers were slightly inclined towards the south by approximately 3° and there was slight spalling at the connections between beams and girders.

Photo 12 Embankment failure of a bridge over *Karasu Çayı*
