EARTHQUAKE RESISTANCE CONSIDERATIONS FOR DEGRADING SYSTEMS

Andrew B. King & Bruce L. Deam

Building Research Association of New Zealand (BRANZ)
Private Bag 50908, Porirua, New Zealand.
(Ph +644 235 7600 Fax +644 235 6070)

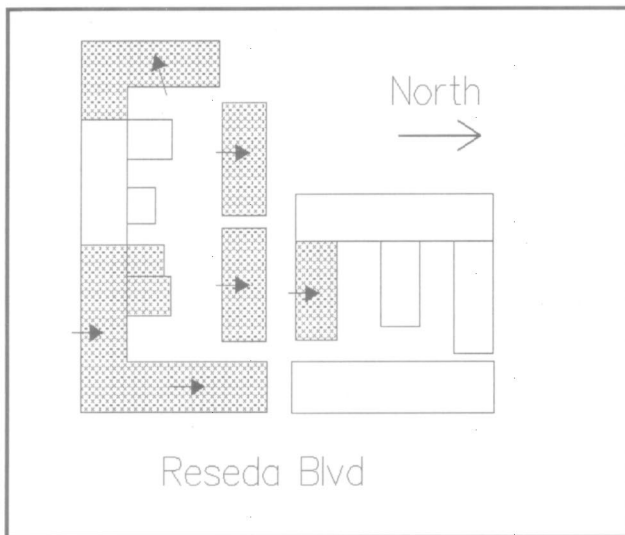
Figure 1 & Figure 2) where 7 of the 13 three storey timber framed blocks within the complex collapsed in a similar manner. The remaining 6 blocks were severely damaged and on the verge of collapse.

Figure 1. Meadows Apartment: General plan layout Shaded blocks collapsed in direction of arrows

Figure 1 and Figure 2 show the plan layout and the collapse directions (mainly northerly) observed during the site inspection. Even blocks which survived were noted to have experienced very large lateral drift (600 mm) within the ground floor storey height. No seismic separation provisions were observed between blocks and the collapse of some attached transverse blocks was attributed to them being dragged down by adjacent units. The characteristics of the bracing panel collapse was that of nail-head pull-through primarily along either the top or bottom framing member (plate) causing a complete loss of shear resistance. Large interstorey drifts followed, in some cases resulting in P- Δ shake-down collapse (refer Figure 3). . Cut-in timber diagonal braces failed even within the surviving blocks (refer Figure 4).

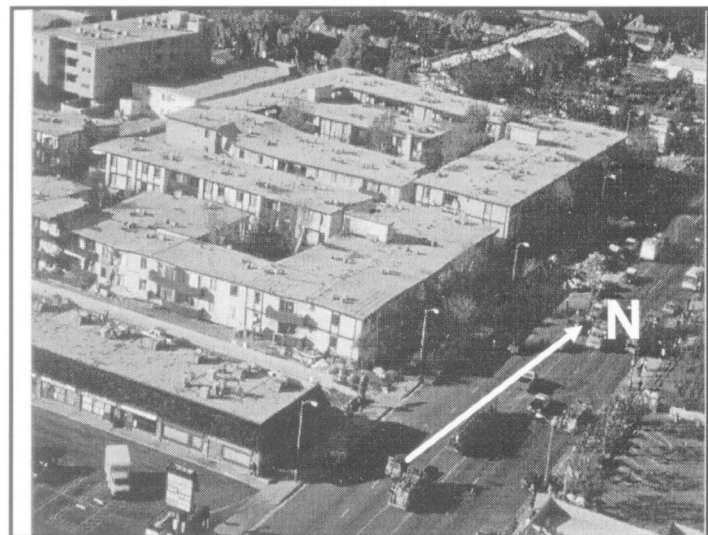
Figure 2. Meadows Apartment: Aerial view of front blocks

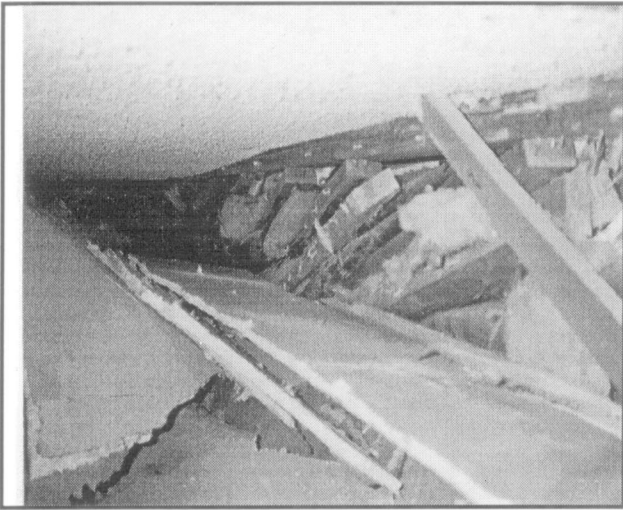
Figure 3. Within the 500 mm residual ground floor crawl space following collapse.

During the post collapse inspection of the Meadows Apartments at Northridge, the primary mechanism observed, and considered to be fundamental to the collapse of the building, was the loss of lateral load resisting capacity of the gypsum based wall bracing panels. The mechanism observed (see Figure 3) was the failure of the sheet lining fasteners along the top or bottom plate. Shear transfer was then only possible by flexure within the studs. The panels most obviously deficient in this regard were approximately 4.8 m long. The sheet linings were nailed to the framing timber with 8d nails at approx 6 inch centres. The lining sheets were installed horizontally, with paper reinforcing tape over the horizontal seam. The panels were assessed as supporting an axial load of not less than 500 kg/metre length.

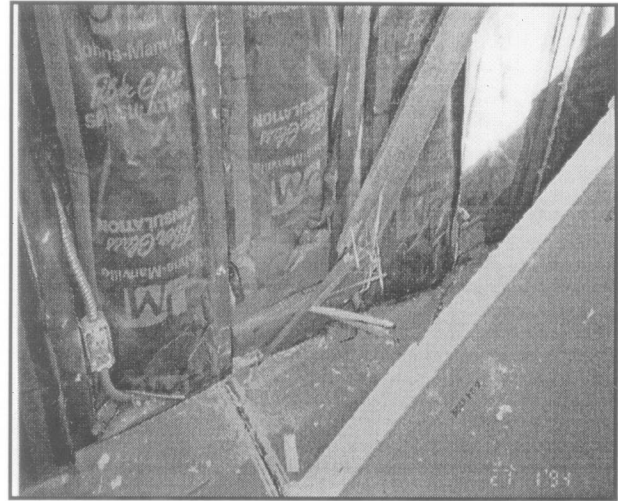
Figure 4 Compression brace failure and loss of sheet lining nearing collapse.
