## **DAMAGE OF R/C RESIDENTIAL BUILDINGS IN THE 1995 HYOGOKEN-NANBU EARTHQUAKE**

TAIZO MATSUMORI and SHUNSUKE OTANI

Department of Architecture, School of Engineering, the University of Tokyo,  
7-3-1 Hongo, Bunkyo-ku, Tokyo 113, Japan

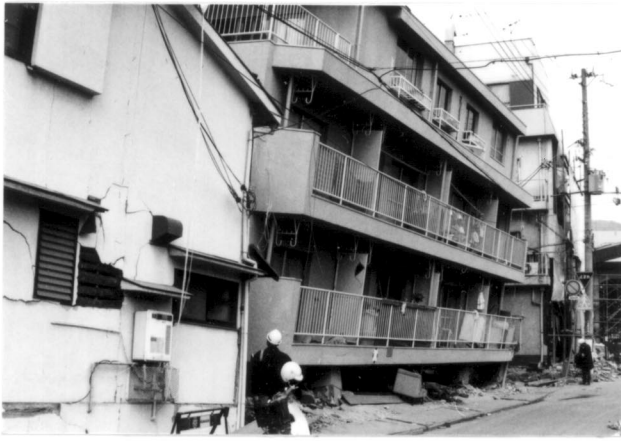
(a) 4-story building

The locations of the heavy damage in each building was classified as (1) damage of foundation leading to tilting of the building, (2) collapse or heavy damage of the first story (Fig. 2), (3) collapse of an intermediate story, or (4) distributed damage, as shown in Fig. 3.

Fig. 2. Collapse of the first story

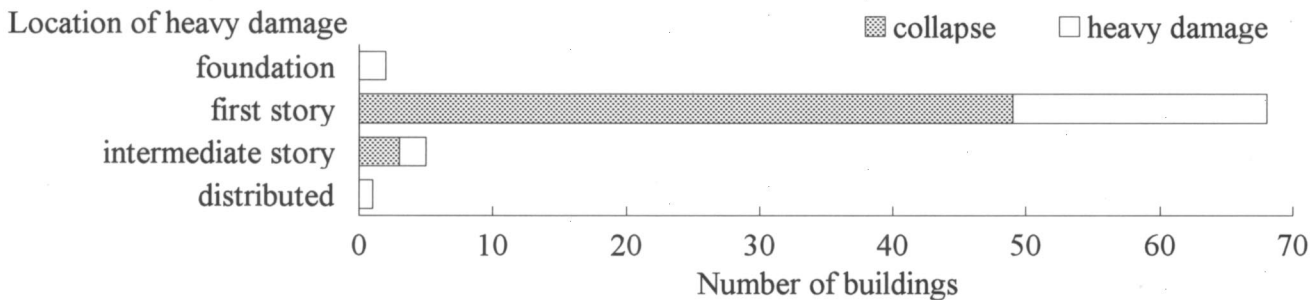
Fig. 3. Locations of heavy damage in the collapsed or heavily damaged buildings

In 68 buildings (89 % of the 76 investigated buildings), heavy damage and collapse were observed in the first story. Relatively few buildings exhibited a mid-height failure. The use of heavily damaged first story was studied for the 68 buildings (Fig. 3); in 63 buildings (93 % of the 68 buildings), the first story was used not for residence, but for parking of automobiles, shops, offices, or warehouses. In residential stories, residential units were separated by structural walls. However, the structural walls were removed in the first story for use for shop, garage or storage. Therefore, structural walls can be considered to be less in the first story than in the upper residential stories. In some collapsed buildings, structural walls were provided only in one of the principal direction, and the collapse occurred in the other direction.

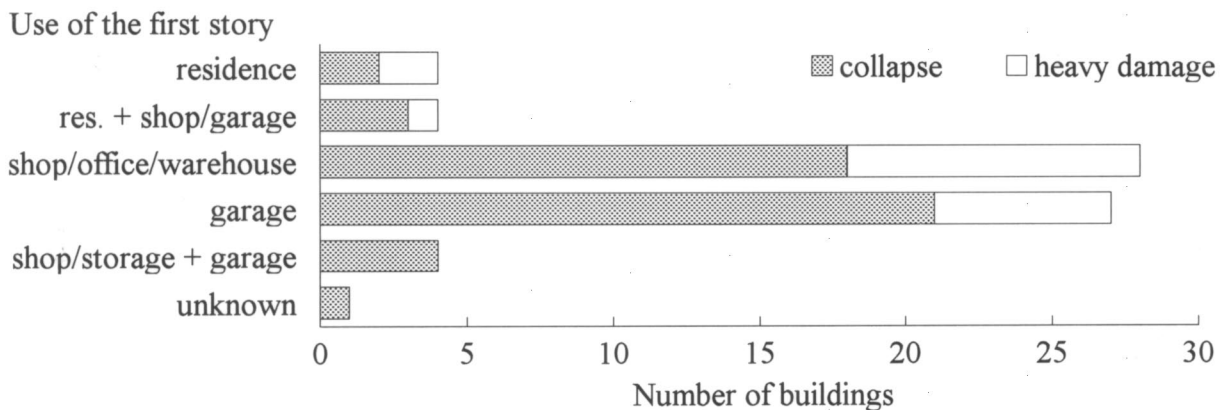
Fig. 4. Use or occupancy of the heavily damaged first-story

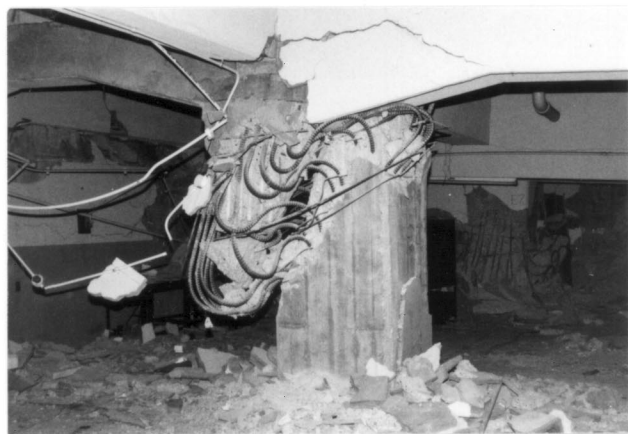
Most of the heavy damage and collapse were caused by shear failure of the first-story columns (Fig. 5). Therefore, the amount and arrangement of lateral reinforcement were studied. Generally, closely spaced lateral reinforcement is expected to restrain shear cracks from opening and confine the concrete if the lateral reinforcement is well anchored at both ends. The survey revealed that the bend at the ends of the lateral reinforcement opened after the spalling of cover concrete, and that the columns failed in shear without yielding of the lateral reinforcement.

(a) shear failure of the first-story columns

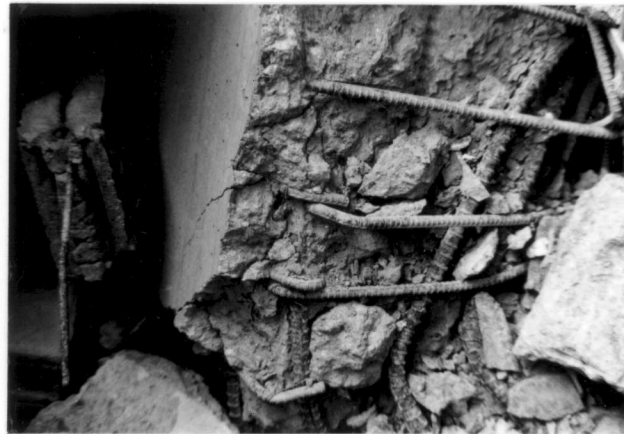
(b) 90-degree and 135-degree hooks at the two ends

Of the 63 heavily damaged or collapsed buildings where the ends of the lateral reinforcement in the columns could be observed, 135-degree hooks were found at both ends in one building; welded closed-shape reinforcement was used in one building; the lateral reinforcement was anchored with either both 90-degree hooks or 90-degree and 135-degree hooks at the two ends (Fig. 5(b)) in the other 61 buildings (97 %). Although R/C Standard has recommended the use of 135-degree hooks since 1933, the difficulty in construction did not permit such detailing in construction practice until special devices were developed for the 135-degree bending. The existing buildings are susceptible to the earthquake disaster due to the same inadequate lateral reinforcement workmanship. The importance of reinforcement detailing was reconfirmed.

In the building in which welded closed-shape reinforcement was used, the perimeter hoops were found not sufficient to confine the concrete after shear cracking; supplementary cross ties should be used in a region where large plastic deformation is expected. There was, however, one building in which the first-story columns failed in shear although both perimeter hoops and supplementary cross ties were used and well anchored by 135-deg hooks. Further research is needed to study the cause of the damage and to review the required story shear capacity of the soft first story.

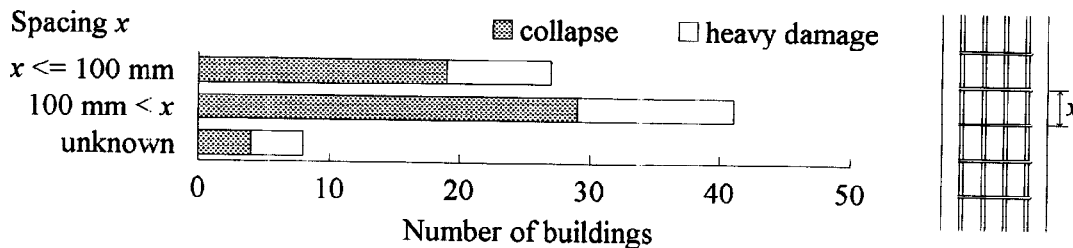
Fig. 6. Vertical spacing of lateral reinforcement

Of the 68 heavily damaged or collapsed buildings where the spacing of lateral reinforcement could be observed, the vertical spacing of lateral reinforcement exceeded 100 mm in 41 buildings (60 %); the vertical spacing of lateral reinforcement was 100 mm or less in 27 buildings (40 %). Statistics show that the quantitative requirement of lateral reinforcement was not sufficient to avoid shear failure of columns.

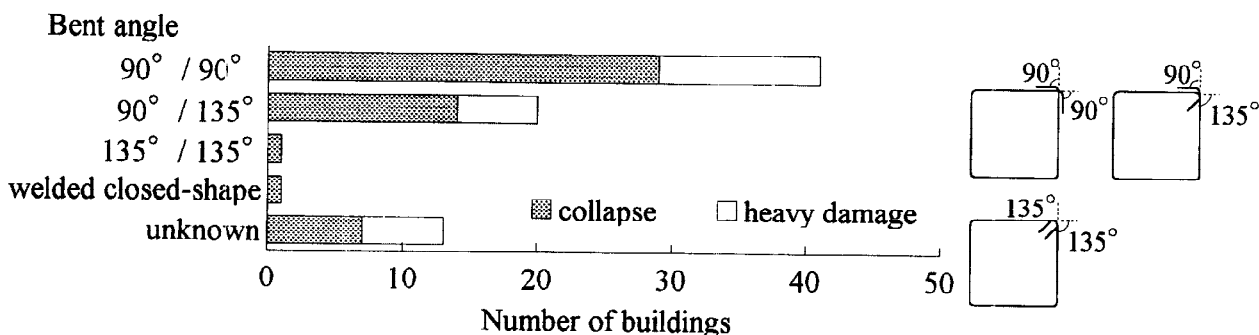
Fig. 7. Bent angle at ends of lateral reinforcement
