POST-EARTHQUAKE ASSESSMENT OF BRIDGE COLLAPSE AND DESIGN PARAMETERS

K. Y. LOU and F. Y. CHENG

*Department of Civil Engineering, University of
Missouri-Rolla, Rolla, MO 65409, U.S.A.*

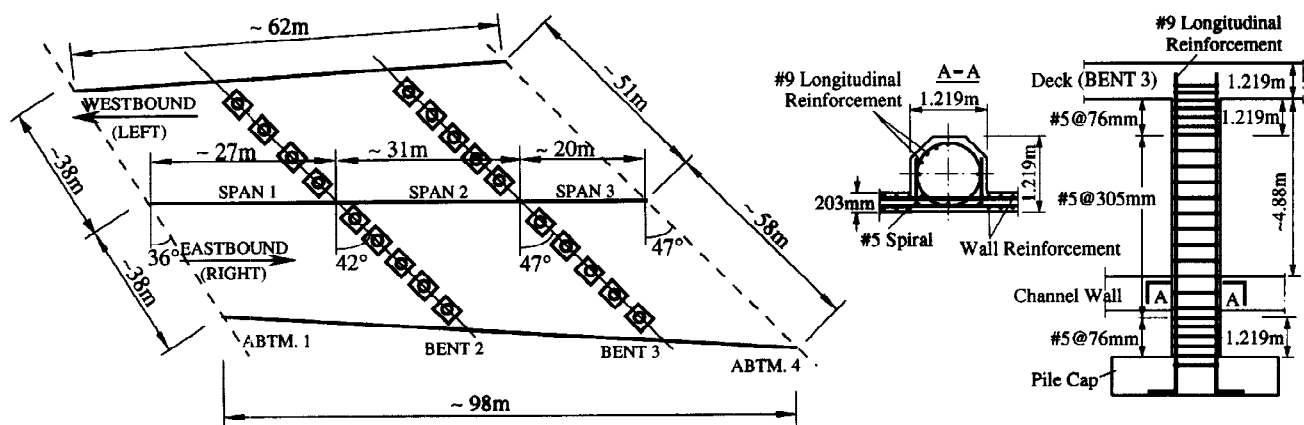
Fig. 1. Bull Creek Canyon Channel bridge and details of column reinforcement

Field observation after the earthquake indicates that the bridge suffered severe damage during the earthquake. Two southernmost columns of the right structure at bent 2 showed a rupture of spiral and buckling of longitudinal reinforcement just in the transitional area of spiral spacing. Column failure led the superstructure to drop. Columns at bent 3 for both structures failed above the channel wall. At this failure area, spiral spacing was 305 mm. Approximately 381 mm offset of approach pavement on the southeast side

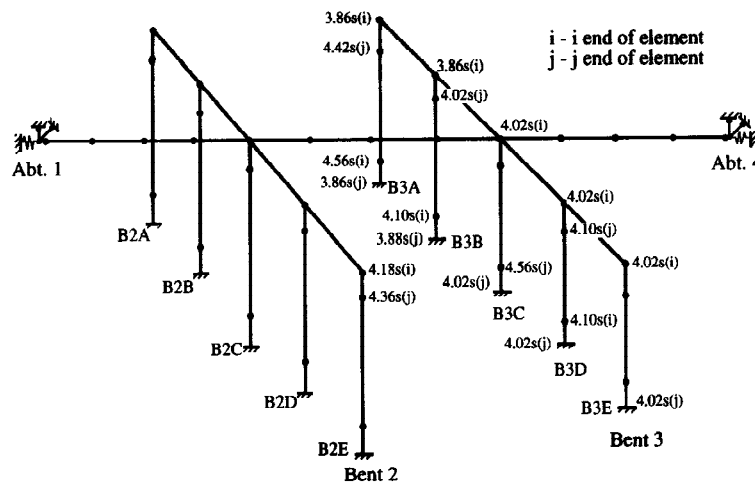
Nonlinear time-history analysis of the right bridge structure is performed by IAI-NEABS on Sun Sparc station. Yield pattern of the right Bull Creek Channel bridge is presented in Fig. 2. Column B3A first yields at both ends (3.86 s). Yielding first appears at the top of column B3B (3.86 s) and then at the bottom (3.88 s). After 0.16 s, the remaining columns of bent 3 yield. Most of the columns at bent 3 begin to yield at the top and bottom simultaneously. Column B2E finally yields at the top only.

Fig. 2. Yielding pattern of Bull Creek Canyon Channel bridge's right structure

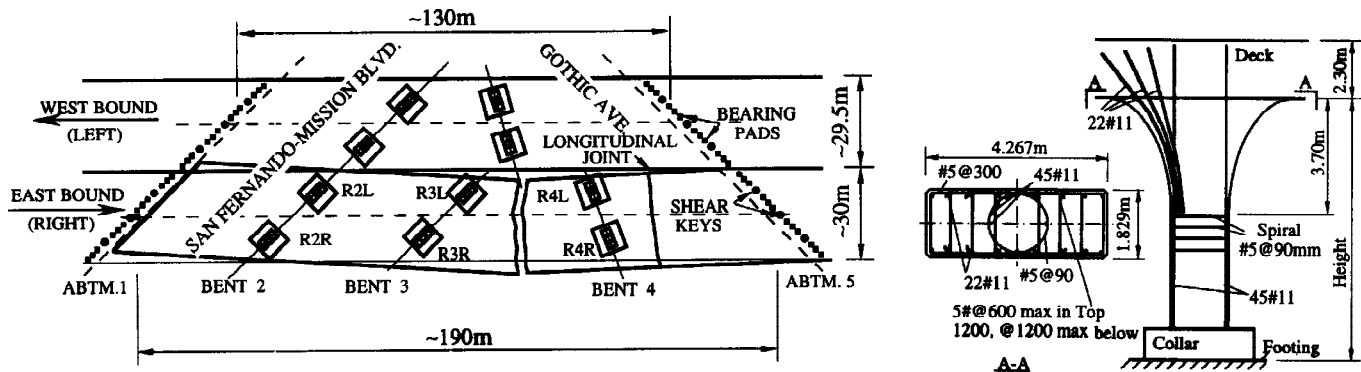
Fig. 3. Mission-Gothic Undercrossing and column reinforcement details

Three square shear keys at each bridge end are embedded in the abutment seat, and the superstructure can move 152 mm in the bridge's longitudinal direction. Reinforcement details of each flared column are the same and are shown in Fig. 3. Note that there is no stirrup to enclose flare reinforcement along the lower part 1.22 m of flare. Detailed descriptions are reported by Cheng and Lou (1996, 1995).

The right bridge structure collapsed completely between span 3 and 4. Severe damage to span 1 and 2 was observed. Abutment 1 remained seated, showing little longitudinal movement, but transverse movement was about 330 mm. At bent 2, the right column failed and slid on the footing due to damage in the reinforced concrete collar, while the left column collapsed, dropping the flare to one side of column. Columns at both bent 3 and 4 failed at the lower part of flare. Since flares were not completely damaged, the bent was able to rest on them. The end of the diaphragm at abutment 5 was unseated. The left bridge structure did not collapse, but it suffered extensive damage. Most columns failed in the region of flare. Abutment 1 moved approximately 76 mm in the longitudinal direction and 51 mm in the transverse direction. Transverse movement of 254 mm was observed at abutment 5. Diaphragms at both ends remained seated.

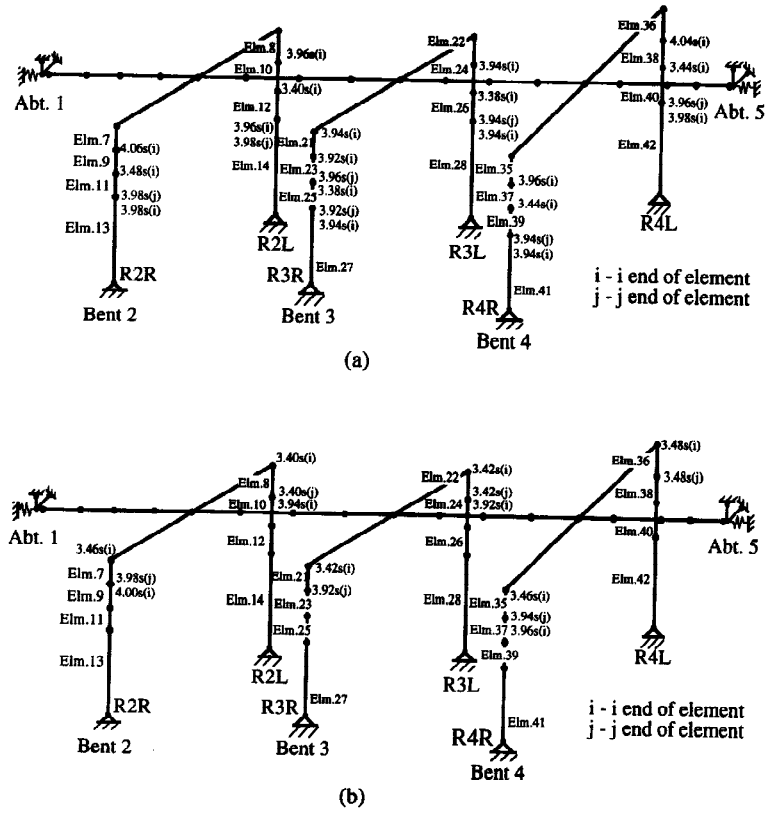
Figure 4 displays the yielding pattern of the right bridge structure under three-dimensional ground motion. The structure yields from column R3L and R3R in the lower part of the flare at 3.38 s. After 0.06 s, column R4L and R4R yield. Column R2L and R2R reach yielding at 3.40 s and 3.48 s, respectively. All the columns yield within 0.7 s after 3.38 s, which suggests the bridge collapsed in a sudden manner. Shear keys at both abutments are expected to fail at 3.3 s. Failure mechanism of Mission-Gothic Undercrossing conforms to that observed after the earthquake (Priestly et al., 1994). Consideration of three-dimensional ground motion may give a more accurate description of collapse behavior and reveal unfavorable column's internal forces (Cheng and Lou, 1995).

(identical with the former except that there are no flares in the upper part of columns) is used for analysis. Yielding pattern of the right bridge structure without flares is presented in Fig. 4. Yielding begins at the top of columns. All the columns enter yielding stages from the top, and yielding extends toward the middle. The yielding pattern here is totally different from that with flare in the upper part of columns. Thus the effect of flare cannot be neglected in prediction of bridge failure mechanism even though flare was originally considered as architectural aesthetics and not purposely designed to strengthen column capacity.

Fig. 4. Yielding patterns: (a) column with flare; (b) column without flare
