## SEISMIC RETROFITTING OF MASONRY BUILDINGS DAMAGED IN THE SEPTEMBER 1993 EARTHQUAKE IN INDIA

S.S. MOMIN<sup>1</sup>, S. NIKOLIC-BRZEZ<sup>2</sup> and K.M. BAJORIA<sup>3</sup>

### ABSTRACT

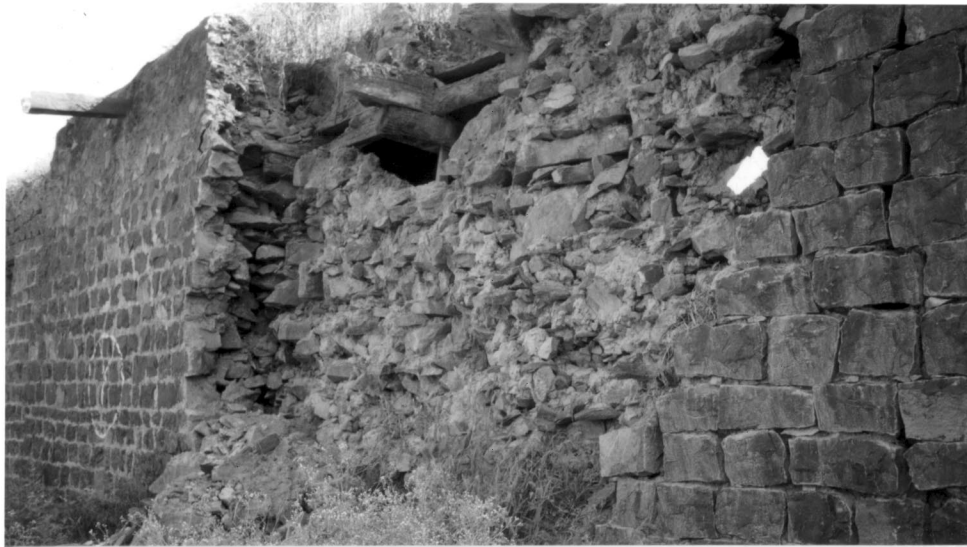
- Separation of adjoining walls at the corners and junctions as a result of out-of-plane action of seismic forces;
- Separation (delamination) of the wall wythes, due to the absence of through-stones (Fig. 2);
- Out-of-plane wall failure as a result of inadequate flexural resistance;
- Instability of timber frames due to excessive lateral drifts at the roof level, and
- Partial/total collapse of roofs induced by the failure of load-bearing walls.

Fig. 2. Delamination and failure of a multi-wythe stone masonry wall in Marathwada.

Due to above outlined constraints, it was not possible to use majority of known technologies for upgrading mechanical strength of stone masonry walls. Introduction of through-stones (i.e. transverse wall ties) was recommended in order to prevent lateral instability of multi-wythe stone masonry walls (Arya, 1994). This is a simplified alternative to the commonly used wall anchors. Installation of through-stones consists of the following steps: i) one stone at each of the exterior wall wythes is removed manually using a small crowbar; ii) rubble filling in-between the wythes is removed and wedge-shaped hole of approximately 75 mm diameter is made in the wall; iii) one hooked steel bar 8 mm diameter is then placed in the hole, and iv) the hole is finally filled with concrete to match the original condition. Nominal spacing of through-stones at about 100 cm apart with 50 cm horizontal stagger has been recommended. An illustrative example related to field application of through-stones is presented in Fig. 4.

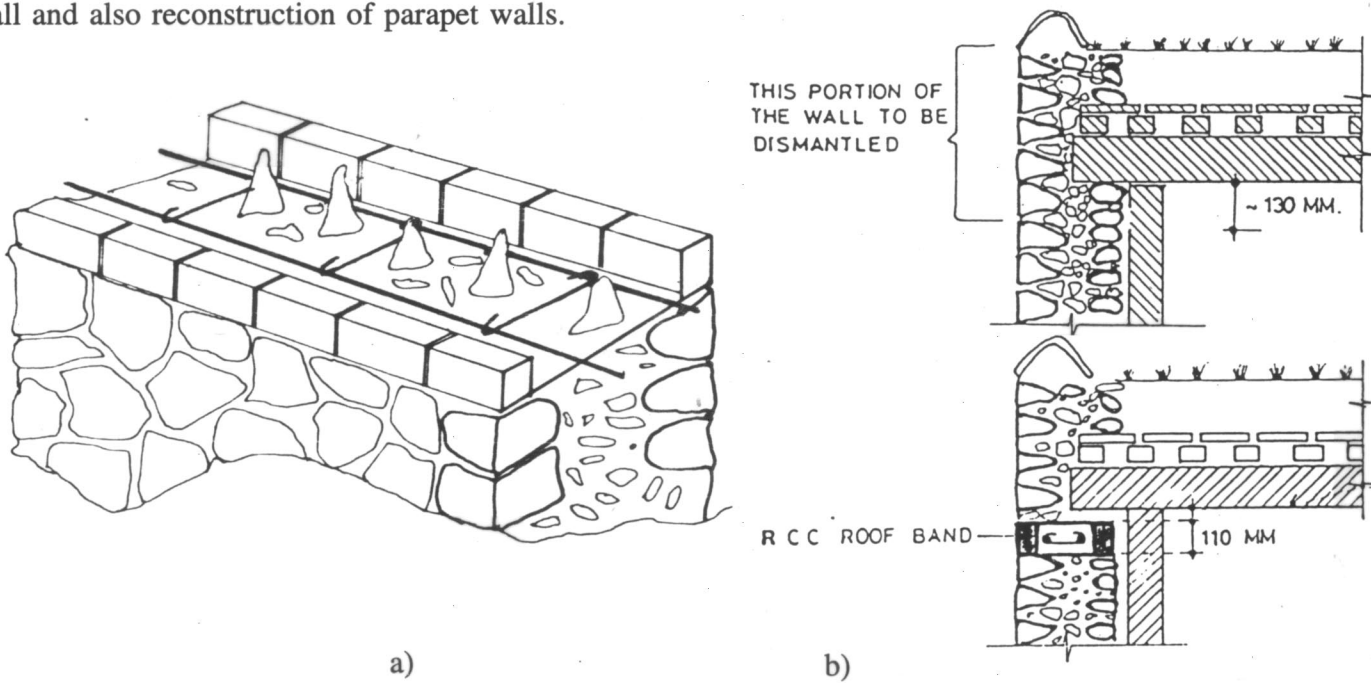
Fig. 3. Installation of reinforced concrete ring beam at the eaves level: a) Layout of a band, and b) Vertical section of a top portion of an existing wall with a ring beam.

Reinforced concrete ring beams (bands) fall in the category of fundamental seismic strengthening provisions related to masonry building construction (IS:4326, 1993). Placed at the critical elevations in the structure, such as plinth, lintel and/or roof level, the bands are tying walls together and imparting the required flexural strength to them. In the case of existing stone masonry buildings, however, introduction of bands at an elevation below the roof level was not considered feasible. Moreover, having in mind vulnerability of existing stone walls, such an operation could even have a destructive effect. Consequently, introduction of a ring beam at the eaves level of a building just below the roof joists was recommended, as illustrated in Fig. 3. A ring beam is typically constructed in lean concrete (15 MPa compressive strength), reinforced with two longitudinal deformed steel bars 8 mm diameter and steel links 6 mm diameter spaced at 300 mm on centre. Note that burnt clay bricks were used here as a substitute for formwork, as illustrated in Figs. 3 and 4.

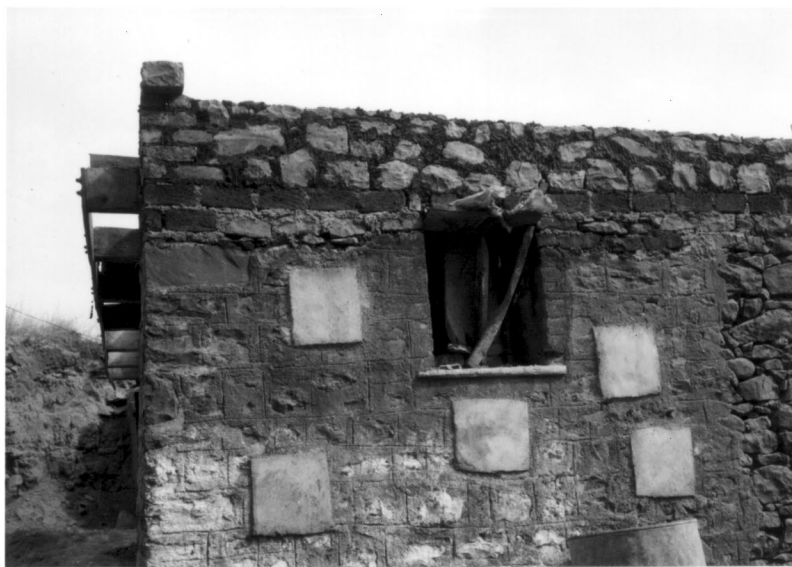
Fig. 4. A field application of retrofitting methodology showing ring beam installed at the eaves level including reconstruction of parapet walls, and through-stones installed in a stone wall (Kharosa village, Marathwada).

In order to introduce a ring beam at the eaves level of an existing structure, parapet wall had to be dismantled. Evidence from the previous earthquakes reveals that parapet walls frequently get crumpled and fail in the earthquakes. This pattern of damage was particularly pronounced in case of loosely binded stone masonry walls in mud mortar typical for the Marathwada region. Therefore, reconstruction of parapet walls in an improved manner was recommended as an additional seismic upgrade, as illustrated in Fig. 4. Also

shown in Fig. 4 are other seismic retrofitting provisions, such as through-stones installed in an existing stone wall and also reconstruction of parapet walls.

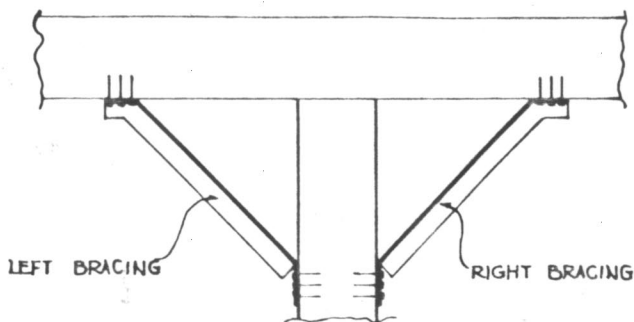
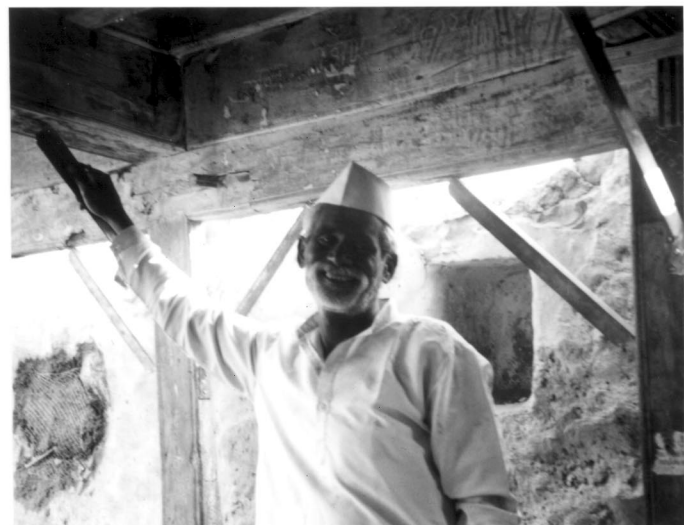
Fig. 5. Knee-bracing of a timber frame: a) Detail of a rolled steel angle bracing, and b) Field application in a rural house, Marathwada.

By and large, performance of timber frame structures (khans) in the September 30, 1993 earthquake was found satisfactory. Moreover, confinement action of khan structures prevented an inward failure of stone masonry walls and saved many human lives. However, considering the absence of provisions for restricting earthquake-induced lateral movements of timber frames, knee-bracing of frames has been recommended as one of the seismic upgrade provisions (GOI, 1993). Several simple and cost-effective alternatives of steel/timber knee-bracing have been worked out. Field experience revealed that installation of knee-bracing was found feasible for a practical application in majority of the affected rural dwellings. Details of a knee-bracing along with an example of field application are illustrated in Fig. 5.
