## **STRUCTURAL PROJECT OF THE REINFORCEMENT OF TWO BUILDINGS WITHOUT SEISMIC DAMAGES**

**RAUL J. IZQUIERDO and HERIBERTO IZQUIERDO**

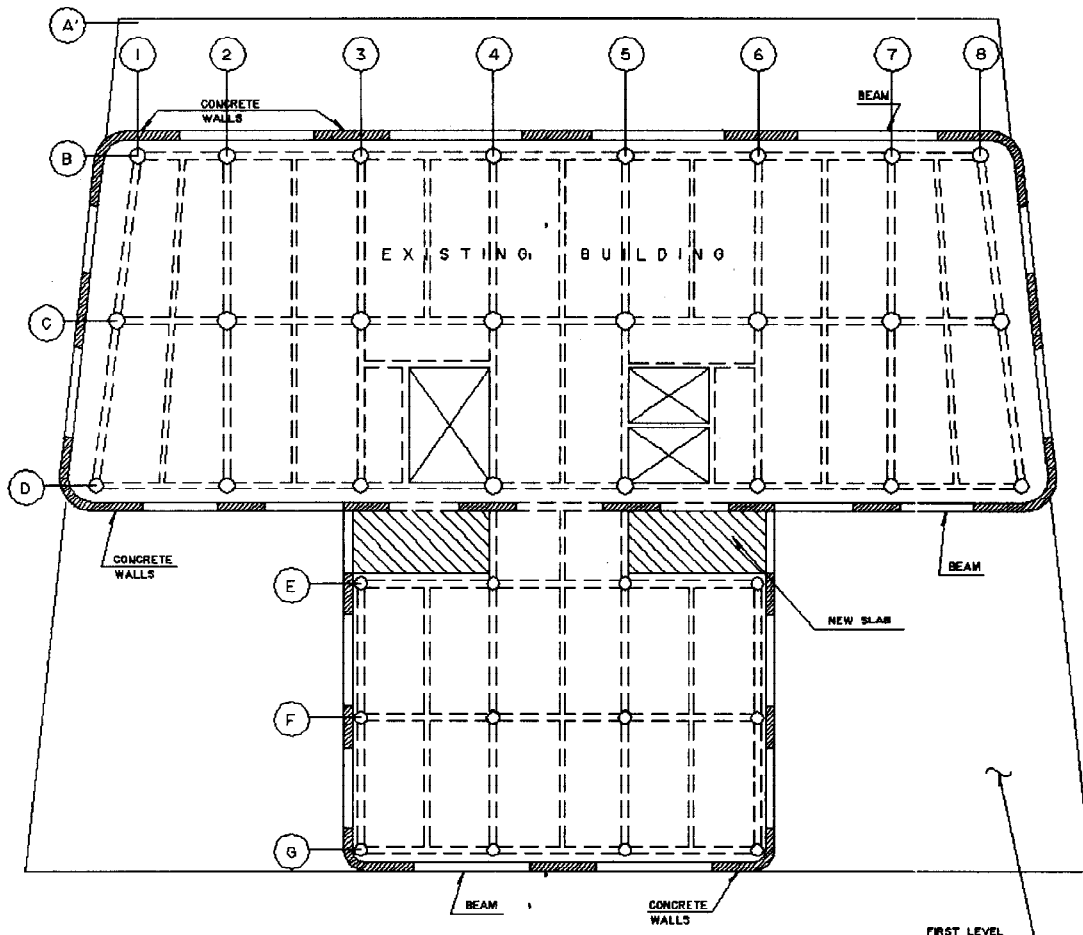
GENERAL PLAN  
 BUILDING A SCALE 1 : 202.6  
 FIG. 1

This structure (Fig.1) was projected for housing in 1950 and built in 1951-1953. It occupies the total of a trapezoidal shape lot, with maximum dimensions of 23.7 x 26.8m., having one underground level, one grade level, eleven floors plus the elevator machinery level. The structure consists formed of concrete frames, with columns, main and secondary beams and solid slabs. The original foundation is a partially compensated one, with a shallow concrete box of about 2m high below the underground level, having therefore a compensation of 5m in relation to the street level. As is normal for these type of buildings, the partition walls were of masonry.

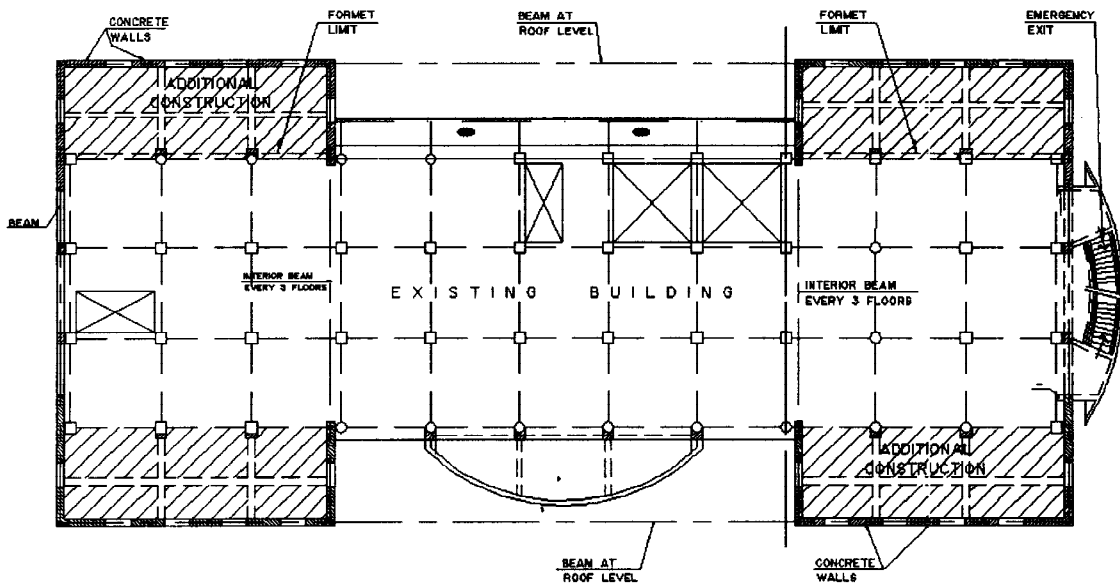
GENERAL PLAN  
 BUILDING B SCALE 1 : 416  
 FIG. 2

This is an office building that was projected and constructed in 1956 (Fig.3). It had a rectangular shape in plan, 16.2m wide and 59.4m long, with a total height of 50.7m . On one side it had a communication with a 6 story building and on other with a 20 story lateral construction, all these on the same lot. It has one underground level, the ground level, 11 type floors, one roof level and machinery level. The first floor is 4.6m high and the rest are 3.5m .

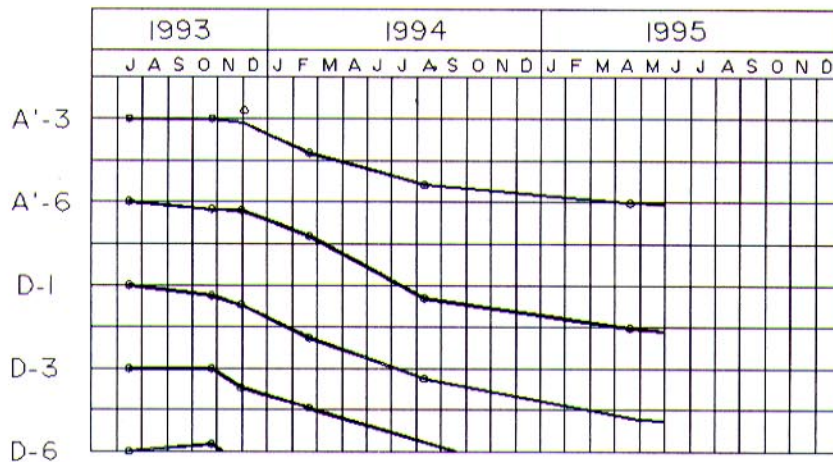
Fig.3 Vertical movements in some points

The reinforcing was finished in late 1994, matching the time and cost schedules. The vertical movement registers ( Fig.3 ) show that the performance of the structure has been according to the expectations and the aspect of the building is of a new one.
