INVESTIGATION OF SPREAD FOUNDATIONS ON LIQUEFIED RECLAIMED GROUND AFTER THE 1995 HYOGOKEN–NANBU EARTHQUAKE

Y. Hirai, M. Kakurai, M. Maruoka, K. Yamashita and M. Aoki
Research & Development Institute, Takenaka Corporation, Chiba, Japan.

Copyright © 1996 Elsevier Science Ltd
Paper No. 1689. (quote when citing this article)
Eleventh World Conference on Earthquake Engineering
ISBN: 0 08 042822 3

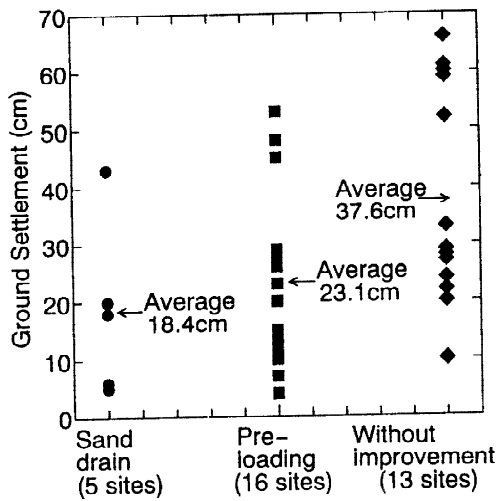
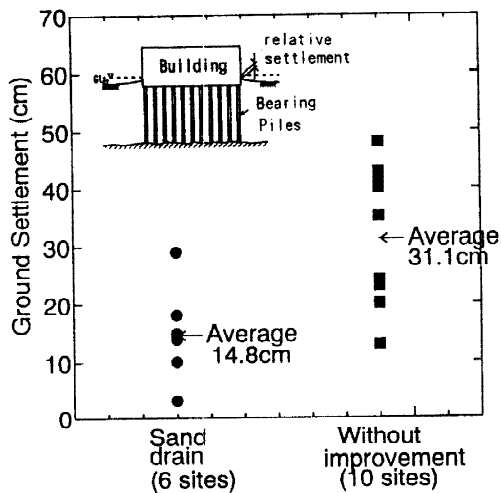
Fig.5. Effects of soil improvement on ground settlement in Port and Rokko Islands.

Figure 5 shows the relative ground settlement of the reclaimed layer as estimated from the vertical gaps between the ground surface and the base of the building founded on point bearing piles. The relative ground settlement near buildings varied from 5 to 70 cm in Port Island and from 3 to 50 cm in Rokko Island respectively. In measuring settlement, we tried to estimate the settlement caused by the earthquake and exclude continuing settlement due to consolidation of the clay layer. Areas where the reclaimed layer was improved by sand drain and pre-loading methods show smaller relative ground settlement than areas without any improvement.

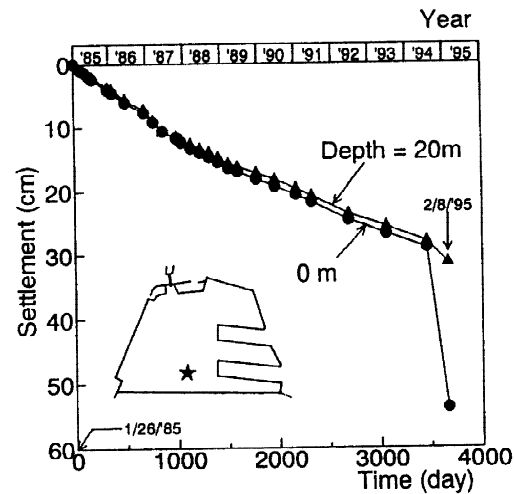
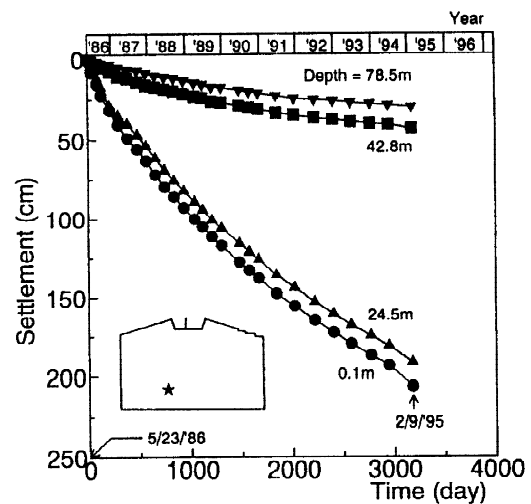
Fig.6. Time history of ground settlement measured with differential settlement gauges in Port and Rokko Islands.

Figure 6 (a) shows the time history of settlement in the last ten years at ground surface and bottom of the reclaimed layer (20 m below the ground surface) in Port Island. The measuring point is located on a road without any improvement. Assuming that the measuring point at 90 m below the ground surface did not settle, the reclaimed layer is seen to be compressed 22 cm by the earthquake. Figure 6 (b) shows the time history of settlement at various depths at a measuring site in Rokko Island on reclaimed layer which was not improved. Assuming that at this site there was no settlement at a depth of 110 m below the ground surface, the reclaimed layer is seen to be compressed 3 cm by the earthquake.

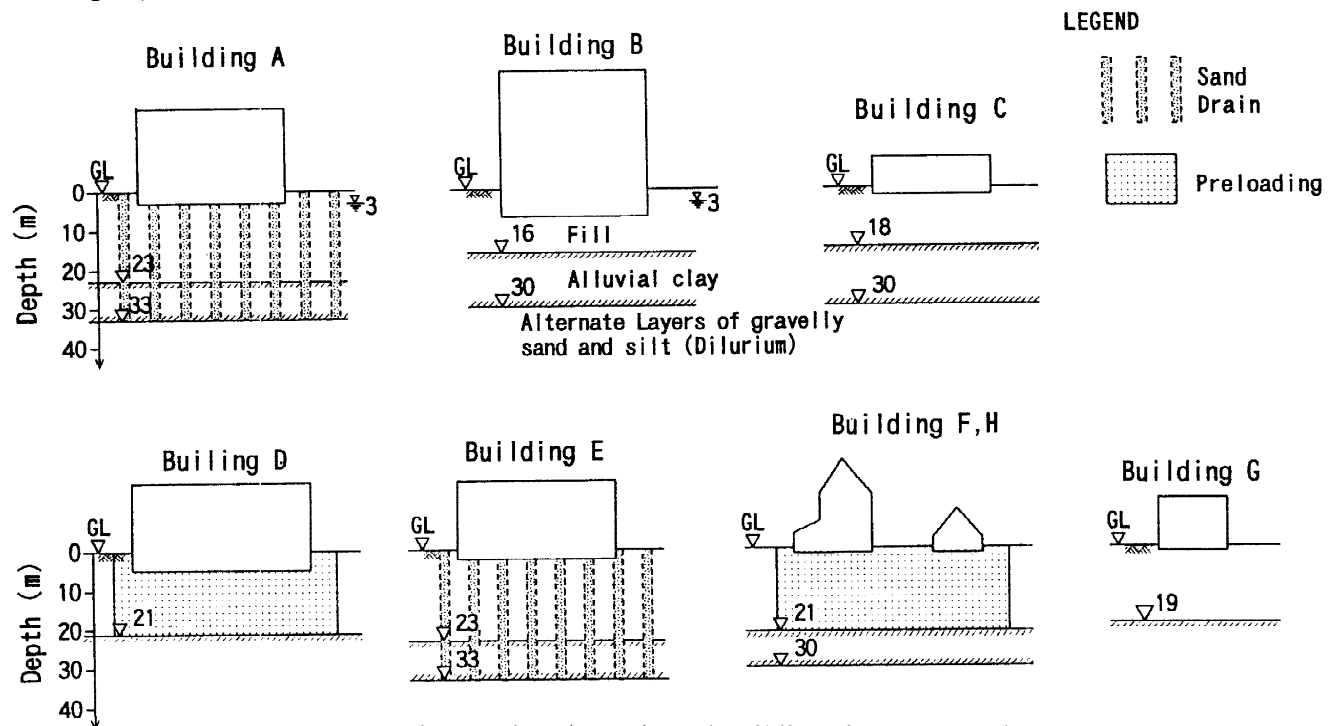
Fig.7. Outline of eight investigated buildings in Port Island.

horizontal sectional area of the building) vary from 0.23 to 0.65. The average relative settlement shown in Table 1 is the average difference in elevation at corner points obtained from the results of leveling. The average relative settlement (which does not include the uniform settlement component) ranges from several centimeters to tens of centimeters. The increase in tilting angle of the building is also shown in Table 1.

Although a maximum tilting angle of approximately 1/100 rad was observed in some buildings, little damage was seen in these buildings by visual inspection. All buildings remain in service up to now.

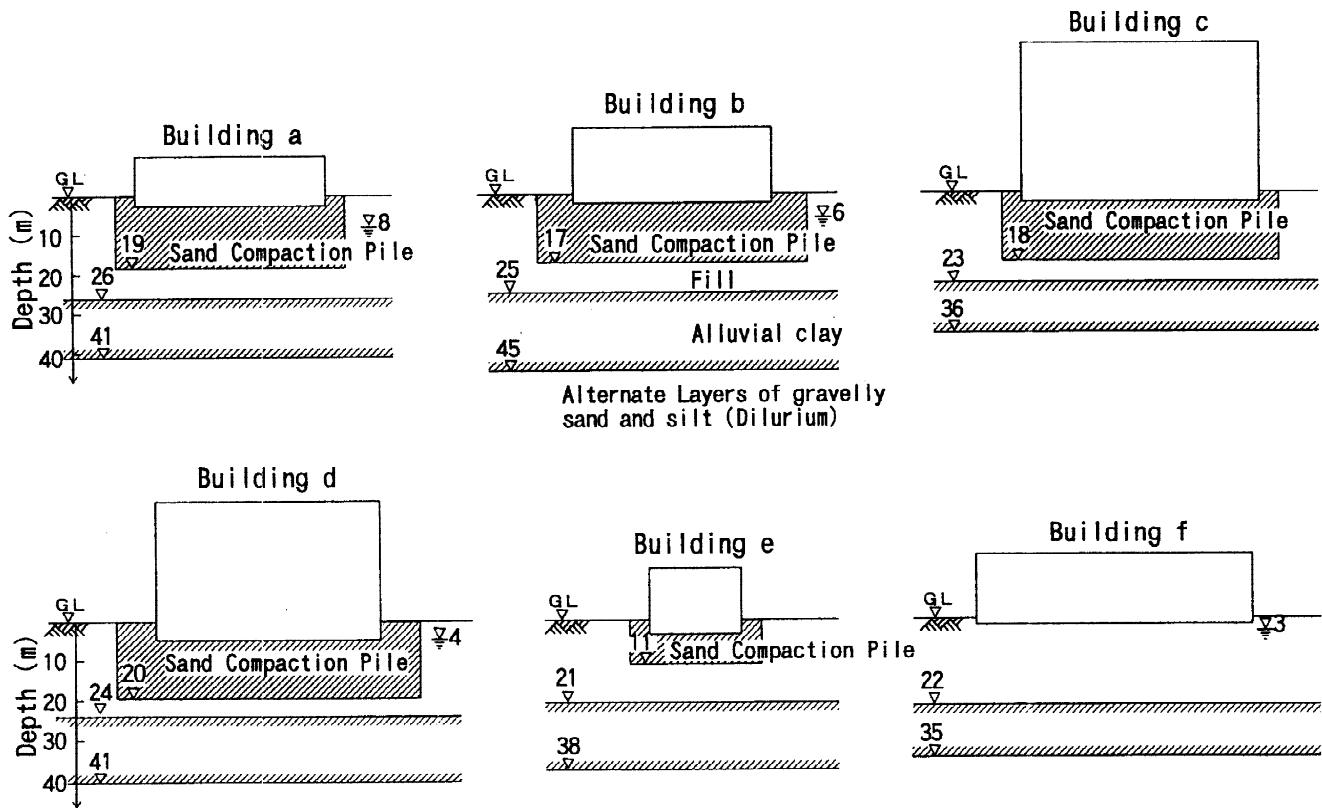
Fig.8. Outline of six investigated buildings in Rokko Island.

The outline of the six surveyed buildings in Rokko Island and the results of the investigation are shown in Fig. 8 and Table 2. The six buildings except Building f have mat foundation and the supporting reclaimed layer had been improved by the sand compaction pile method. The improved portion under the foundation is shown shaded in Fig. 8.

uniform settlement component ranges from 2 to 20 cm. The increase in tilting angle of the building is also shown in Table 2. The maximum angle increment of tilt is found to be smaller than 1/760 rad.

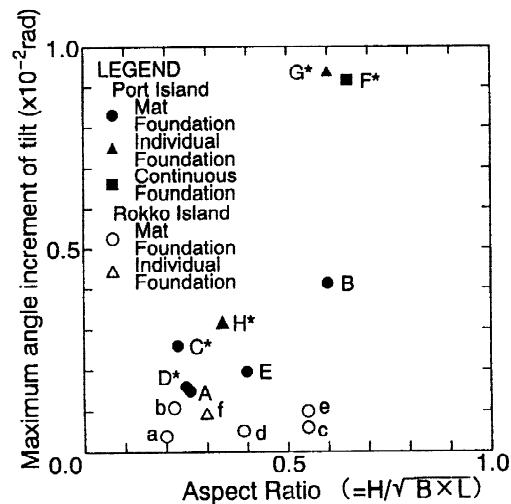
Fig.9. Effects of aspect ratio of buildings on angle increment of tilt.

Figure 9 shows the relationship between aspect ratio and maximum increase in tilting angle for buildings shown in Fig.7 and Fig.8. The increase in tilting angle is obtained as the difference of tilting angles before and after the earthquake. The symbol * in the figure indicates that the value is the maximum tilting angle measured after the earthquake because the tilting angle before the earthquake is not available.

When the relationship between maximum tilting angle and aspect ratio of buildings is examined, it is found that in Port Island spread foundation buildings with a larger aspect ratio have a greater

maximum angle increment of tilt. This tendency is more obvious when the building is supported on a continuous or individual foundation or the building has the marked non-uniformity of the load intensity. The results indicate that the aspect ratio of buildings greatly affects the angle increment of tilt. However, in Rokko Island, the maximum angle increment of tilt of the spread foundation buildings does not increase with aspect ratio and remains relatively small even at larger aspect ratios. The reasons for the small angle increment of tilt and the insensitivity of maximum angle increment of tilt to aspect ratio are considered to be the following:

1) Severe liquefaction did not occur in the central part of Rokko Island because of the difference on the fill materials between the two islands.

2) Some building sites in Rokko Island had been improved by the sand compaction pile method and all buildings except Building f have mat foundations as the countermeasures against long-term settlement.

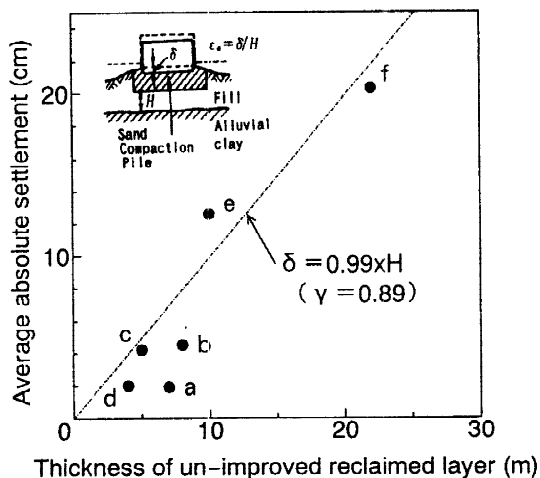
Fig.10. Relationship between thickness of un-improved reclaimed layer and average absolute settlement of buildings in Rokko Island.

Figure 10 shows the relationship between thickness of un-improved reclaimed layer under spread foundations and average absolute settlement of the buildings in Rokko Island. As the reclaimed layer is improved to deeper depths the un-improved layer becomes thinner and the average absolute settlement of buildings becomes smaller. Therefore, soil improvement is seen to be effective on reducing the average absolute settlement of the buildings.

Vertical axial strain defined as average absolute settlement divided by thickness of un-improved reclaimed layer is seen to range from 0.3 to 1.3%. The result of direct regression shown in the figure reveals a high correlation between average absolute settlement and thickness of un-improved reclaimed layer (with a correlation coefficient of 0.89).

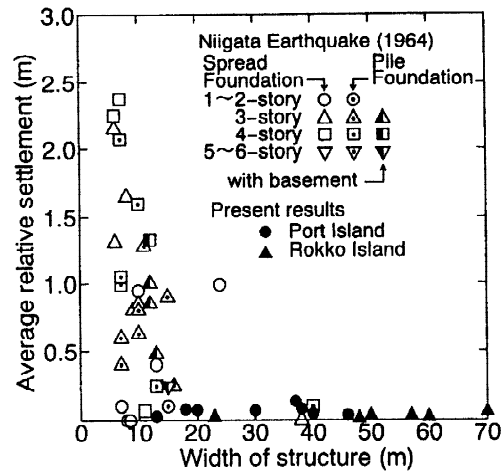
Fig.11. Relationship between average relative settlement and width of buildings (after Yoshimi and Tokimatsu, 1977).

relative settlement to ground surface and width of reinforced concrete buildings obtained from the survey results after the 1964 Niigata Earthquake. During the earthquake, the spread foundation buildings on loose and medium sand deposit of high groundwater level (about 1.0 m deep below the ground surface) suffered heavy damage in Niigata City and the maximum relative settlement of the buildings was 2.5 m. The relationship for spread foundation buildings obtained by our survey after the 1995 Hyogoken-Nanbu Earthquake is superimposed in this figure.

The relationship for the Niigata Earthquake shows a tendency of decreasing average relative settlement with increasing building width. However, in the Hyogoken-Nanbu Earthquake, the average relative settlement remained small irrespective of the building width in Port and Rokko Islands.

The reason for this is mainly considered to be the relatively deeper groundwater level in both islands from 3 m to 8 m deep below the ground surface. Therefore, the surface reclaimed layer near the buildings did not liquefy directly.
