SEISMIC RETROFITTING OF STONE HOUSES IN MARATHWARA AREA, INDIA

ANAND S. ARYA

Professor Emeritus, University of Roorkee
Roorkee, INDIA

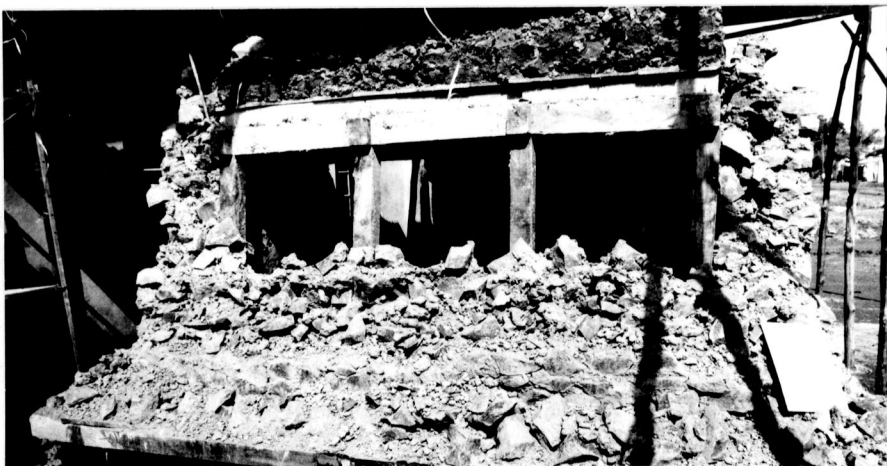
- 1) Large seismic force created in the building due to its closeness to the earthquake epicentre, very heavy roof mass and that of the walls themselves, caused excessive shaking of the walls along with the wooden frames. The strength of the clay mortar being low to nil, and due to the absence of 'through' or bond stones in the walls to provide connection between the outer and

Fig. 2. Delaminated wall (Arya 1995)

inner wythes of stones, the walls split or delaminated through the hearting and crumbled into heaps of rubble (See Fig. 2 which shows a damaged wall by delamination).

- 2) *Installing 'Through' or Bond Elements in Walls.* Such elements are to be constructed in-situ at vertical and horizontal spacing of about 1 to 1.2 m. Through hole has to be made in the wall by gently removing one stone from outside, then the hearting material, finally the opposite stone from inside. The hole is to be filled with cement concrete with a reinforcing bar link of 8 mm dia (See Fig.3). These bonding elements of reinforced concrete will prevent the delamination of wythes in any future shaking.

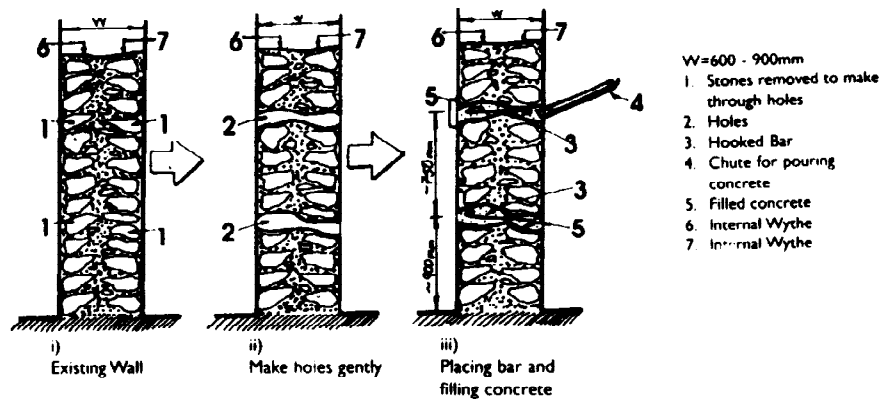
Fig. 3 Installing R.C.C. 'through' elements (Arya, 1994)

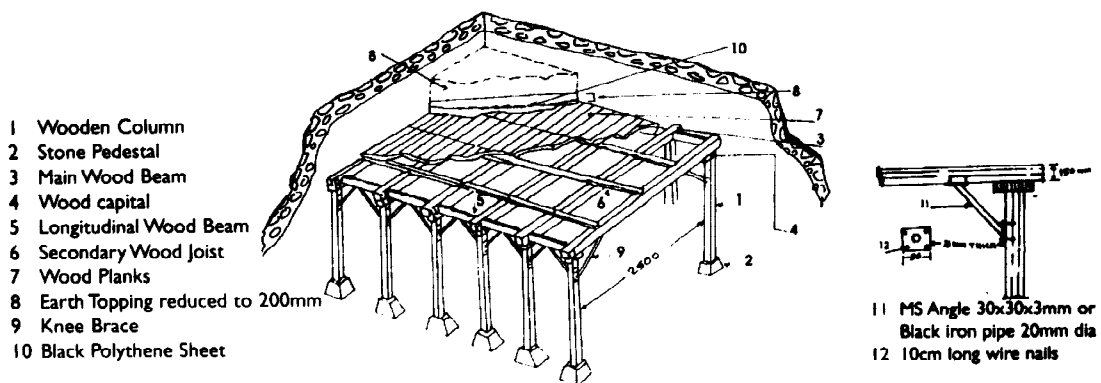
Fig. 4 Intalling knee-braces in wooden frames (Arya, 1994)

- 3) *Installing Knee Braces in Wooden Frames.* To fully utilize the wooden frame, they are to be made strong against lateral forces caused by the seismic inertia of the roof and the upper half of the walls. It was found by calculations that the desired strength will be achieved by installing knee braces in each frame along both axes of the rooms(Fig.4). The knee braces could be of standard length and sizes (750 mm inclined length, 30x30x5 mm MS angle iron or 20 mm internal dia)

black iron pipe, with welded end plates nailed to posts and beams by 100 mm long wire nails, 4 at each connection). Cross-bracings were also investigated but found to be unsuitable due to higher cost, requiring special site measurements and much higher skill for installation, difficult to get in the rural areas.

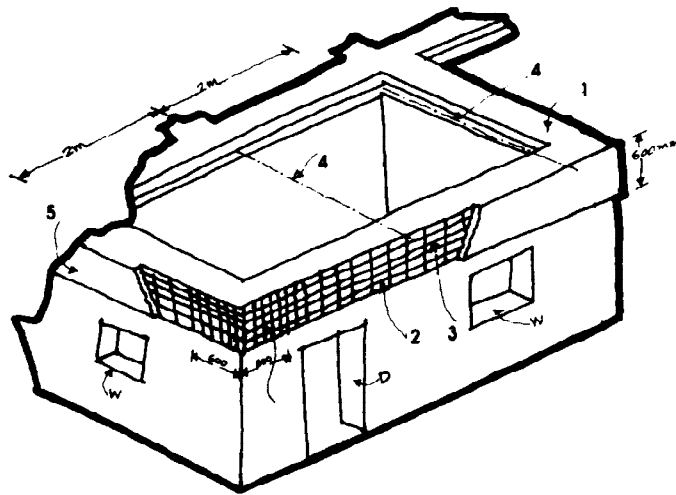
Fig. 5 Seismic belt and cross ties (Arya, 1994)

4) *Seismic Belt Around the Rooms.* In order to integrate the walls to ensure 'box action' under horizontal earthquake forces, a seismic belt of ferro-cement is to be provided just above the door lintel level upto the ceiling level all round each of the rooms. Where cross walls exist or in long rooms at about 4 m apart, cross-ties are to be installed connected to the seismic belt going round the whole house(Fig.5). For installation of the belt, the joints between the stones are to be raked out to a depth of 20 to 25 mm and the whole surface cleaned by wire-brush and all dust removed. Welded wire fabric is next nailed to the wall through 150 mm to 200 mm long nails to hold it in position. The mesh is then covered with 1:3 cement-coarse sand mortar in two coats of 15 to 20 mm each making a total thickness of 35 mm. The mortar bonds the weld-mesh to the stones and shear keys are formed by the mortar entering the raked joints.

- D Door
- W Window
- 1. Existing Stone Wall
- 2. Steel Welded Wire Mesh 25X25 mm gauge
- 3. Overlap in mesh, 600+600 mm
- 4. 12 mm dia TOR tie
- 5. Micro concrete 1:1.5:3 or Cement Plaster 1:3, about 30 mm thick

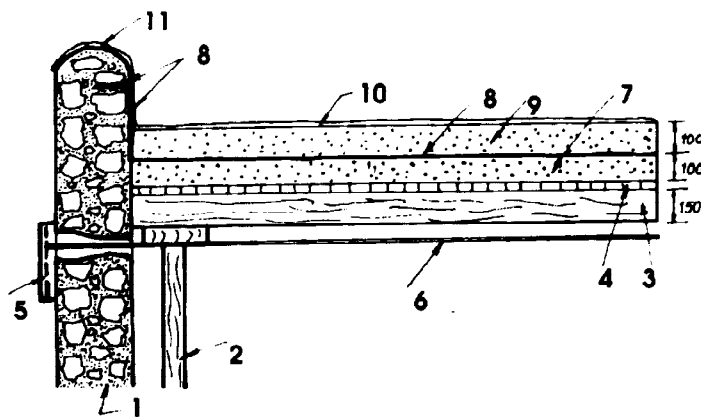
Fig. 6 Water proofing of roof and parapets (Arya, 1994)

5) *Water Proofing the Parapets.* In order to ensure safety of walls during monsoon rains, the parapets are to be covered with cement sand plaster of 1:6 mix embedding in it chicken wire mesh (Fig.6). It is not an essential requirement of seismic retrofitting, but very helpful in maintaining the dry strength of mud mortar in the walls (saturated strength could become as low as 15-20% of the dry strength) and preventing the disintegration of parapet masonry during earthquake shaking and falling away.

- 1 Stone wall
- 2 Wood post
- 3 Wood joist
- 4 Wood plank
- 5 Seismic belt
- 6 Cross tie
- 7 Soil Fill (Base layer)
- 8 Black polythene
- 9 Soil Fill (Top layer)
- 10 Water Proof Mud Plaster
- 11 Galvanised chicken-wire mesh with cement plaster 1:6 or Water proof mud plaster

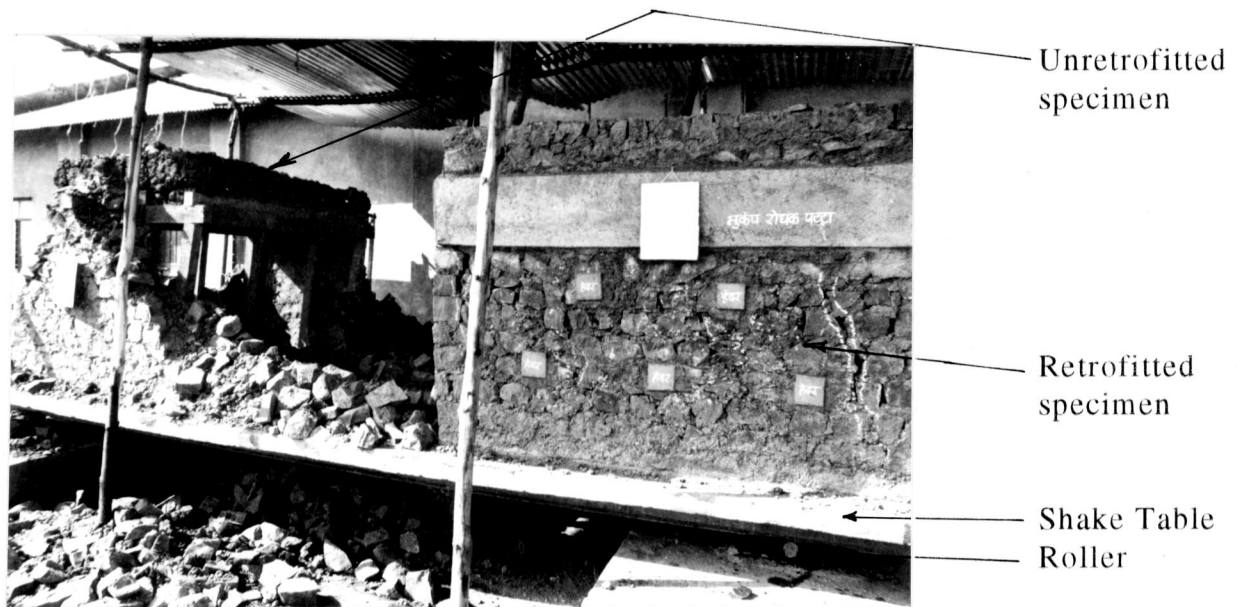
Fig.7 Half scale model rooms tested on shake table (Arya, 1995)

- ii) The unretrofitted specimen developed serious cracks and delamination of walls at 0.47g base acceleration, falling of masonry and tilting of wooden frame continued in subsequent shocks. The pattern of damage resembled exactly what happened in the real earthquake.
- iii) The retrofitted specimen developed only minor cracks at 0.47 g base acceleration and remained intact with increasing extent of cracks which did not become wide, even upto 1.6g base acceleration.

This showed that the retrofitting was fully effective in preventing (a) delamination of walls, (b) separation of walls at corners, and tilting of the wooden frame. In fact complete collapse was still not in-sight. The tests on walls and the half-size specimens clearly demonstrated the effectiveness of the retrofitting measures. About 80 persons including the bureaucrats, high and low level engineers and public men witnessed the testing. The press reporting later on has created the necessary confidence in the retrofitting program.
