EFFECTS OF THE HANSHIN-AWAJI GREAT QUAKE DISASTER ON THE AKASHI KAIKYO BRIDGE

SHOICHI SAEKI, Executive Director, HSBA
KAZUO TADA, Director-General of Second Operation Bureau, HSBA
MAKOTO KITAGAWA, Manager of First Design Division, HSBA
ATSUSHI NITTA, Manager of Third Design Division, HSBA
TOSHIHIRO KURIHARA, Deputy Manager of Third Design Division, HSBA

Honshu-Shikoku Bridge Authority (HSBA)
Toranomom 45 Mori Bldg., 5-1-5 Toranomom, Minato-ku, Tokyo 105, Japan

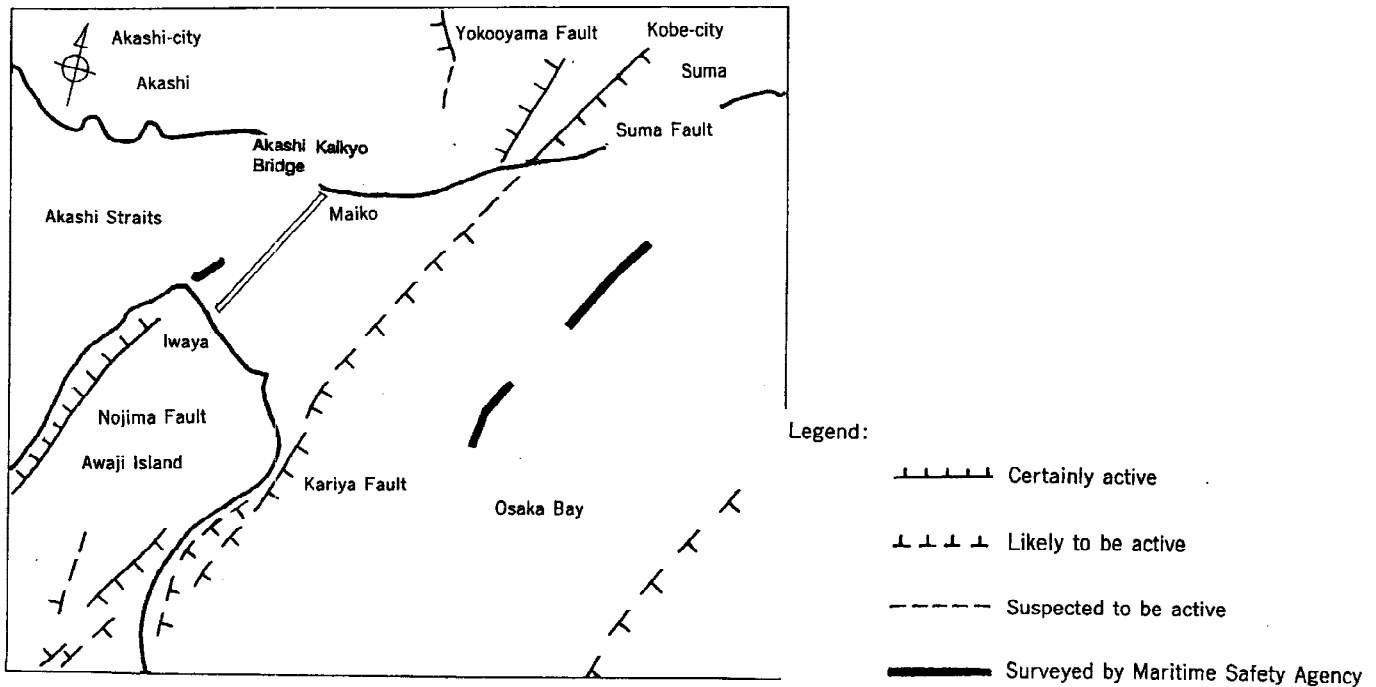
Fig. 3. Faults near the Akashi Kaikyo Bridge

The east-west faults, including F1 — which as noted do not enter the Quaternary layers, were very seen in sonic prospecting around the center of the straits. However, they were less clear in the east and west extensions. In choosing locations for the bridge foundations, the positional relations between the extension of F5, one of the south-north faults, and 3P, and those between the extension of F11 and 4A were surveyed by sonic prospecting and other methods. This work confirmed that neither fault extended into the area earmarked for the foundations. Thus, the foundations of the Akashi Kaikyo Bridge were placed so as to avoid the faults existing in the straits. The status of seabed faults after the Southern Hyogo Earthquake has been surveyed by the Maritime Safety Agency. The new faults located in this survey are shown in Fig. 3. There are apparently no new seabed faults in the vicinity of the bridge.

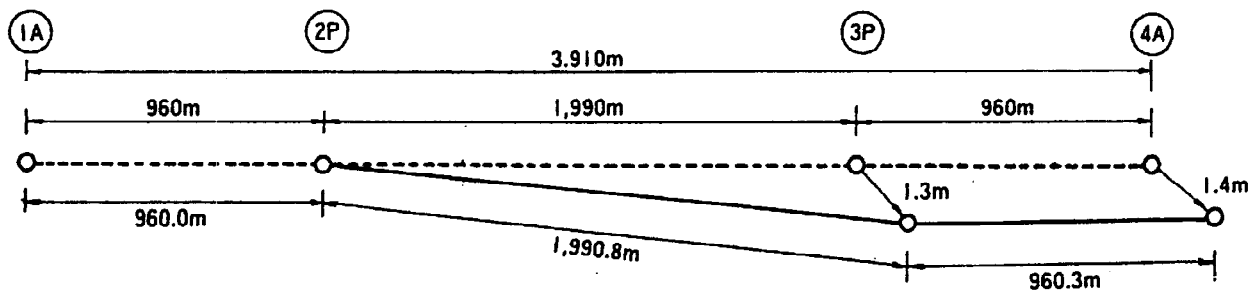
Fig. 6. Location of foundations following earthquake

[2] Surveys by GPS and geometric methods indicate that both the tower foundation (3P) and the anchorage (4A) on the Awaji island side moved relatively by about 1.3 m in an almost westerly direction.

As the result of these foundation movements, the 1,990 m center span has widened to about 1990.8 m while the 960 m side span on the Awaji island side is now about 960.3 m. Fig. 6 shows these changes in the horizontal layout of the foundations.

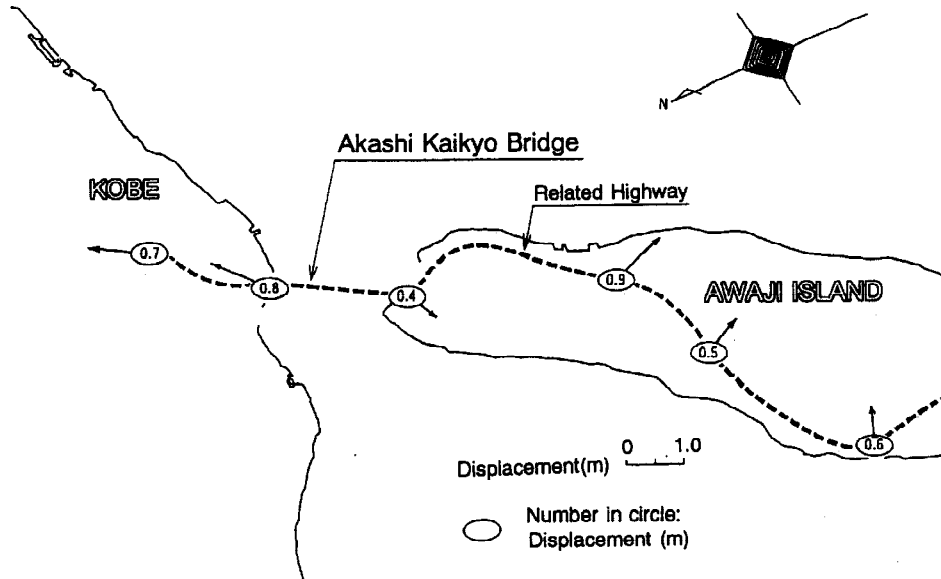
Fig. 7. Absolute displacement of control pPoints

Fig. 7 shows the absolute displacement of control points near the Akashi Straits as prepared from the results of surveys by the HSBA and the Geographical Survey Institute. As this figure makes clear, survey points on opposite sides of the Akashi Straits moved by 50 to 100 cm in the direction indicated by the arrows. It can be concluded from these results that the relative movement of the bridge foundations occurred because the ground on which they were constructed moved.

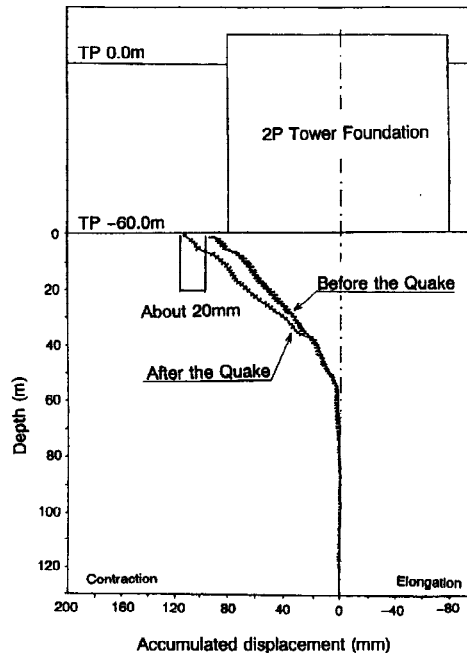
Fig. 8. Results of measurements on 2P with a sliding micrometer before and after the earthquake

[4] Regarding the tower foundations (2P and 3P), displacement of the bearing ground due to subsidence was measured with a sliding micrometer. The results are shown in Fig. 8. The 2P tower foundation subsided by about 20 mm (strain: 4×10^{-4}) as a result of the earthquake, probably because the bearing Akashi strata was compacted.

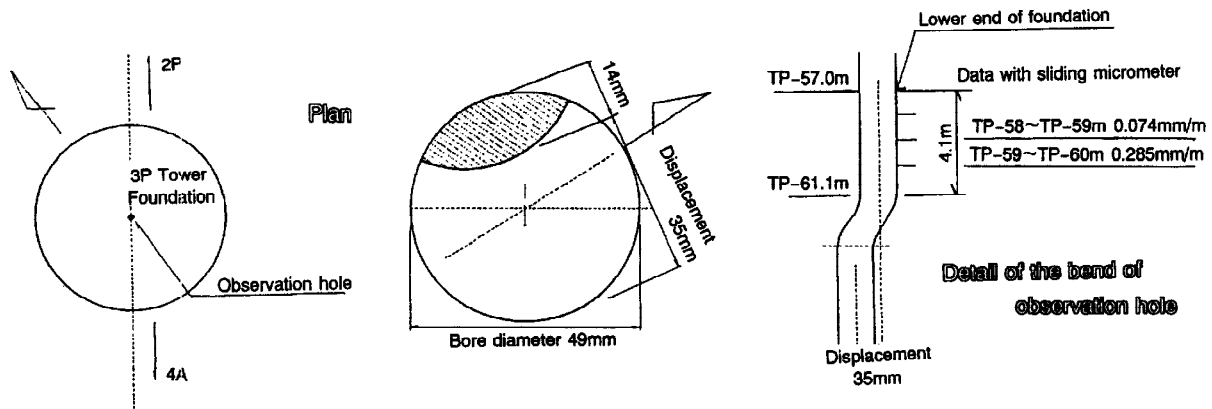
Fig. 9. Position of observation hole

In the 3P foundation, the measurement hole located 4 m below the seabed foundation was choked, making measurements impossible. The choked section was checked with a borehole camera, and a bend of about 35 mm was observed, as shown in Fig. 9. There was no curvature in deeper sections. This appears to be a result of partial sliding of a mud layer within the bearing Kobe strata.

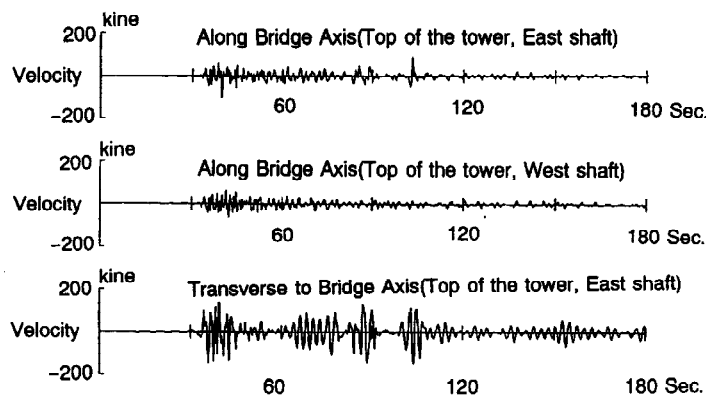
Fig. 10. Velocity record at the top of tower 2P

A number of seismographs were in operation at the bridge site, including some in the tower. However, these were not strong-motion seismographs, so they were unable to properly record the large vibrations caused by this earthquake. The only usable records obtained at the site are from seismographs at the top and mid-points of the tower shafts. A typical record is shown in Fig. 10. The vibration of the tower last more than a minute, which is much longer than the ground vibration. In the transverse component, the maximum velocity was reached more than one minute after the motion began.

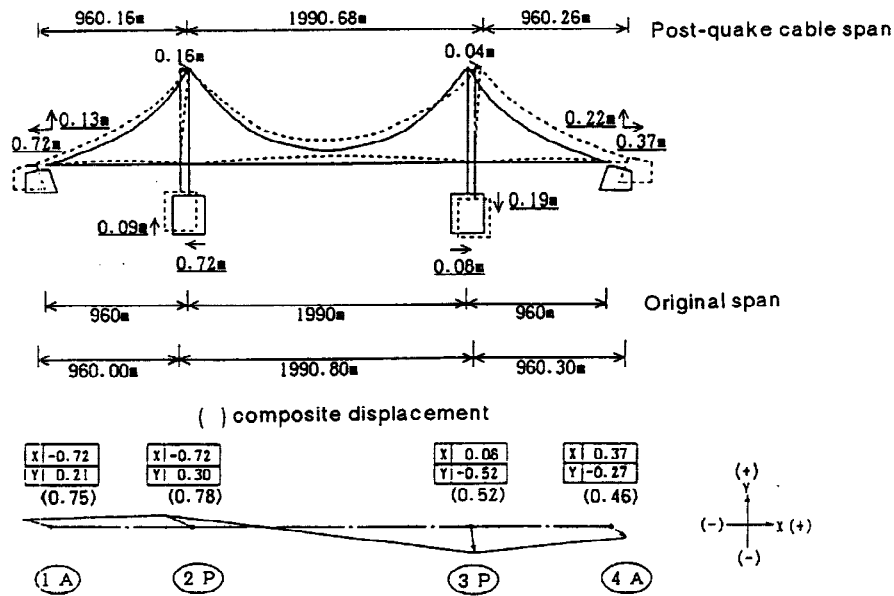
Fig. 11. Effect on the structural skeleton of the Akashi Kaikyo Bridge

The effect of the earthquake displacement on the skeleton structure of the bridge is shown in Fig. 11.

Issue	Effects of earthquake and countermeasures
Strength	An analysis in which the earthquake-induced foundation displacement is added to the completed structure indicates that no stress-related problems will arise as regards towers, cables, the stiffening girder, etc.
Alignment	Although some of vertical alignment exceeded 3 due to reduced cable sag in the center and the side spans, this presents no problems as regards the highway structure ordinance. Further, the horizontal alignment is now off by about 0.03 degree at the towers, but this is not expected to present problems as far as vehicular traffic is concerned.
Span	The increased 2P-3P and 3P-4A spans will be coped with by adjusting the length of the stiffening girder now being fabricated.
