A CASE STUDY FROM THE NORTHRIDGE EARTHQUAKE

M. ALA SAADEGHVAZIRI

Dept. of Civil Engineering, New Jersey Institute of Technology
Newark, NJ 07102-1982, USA

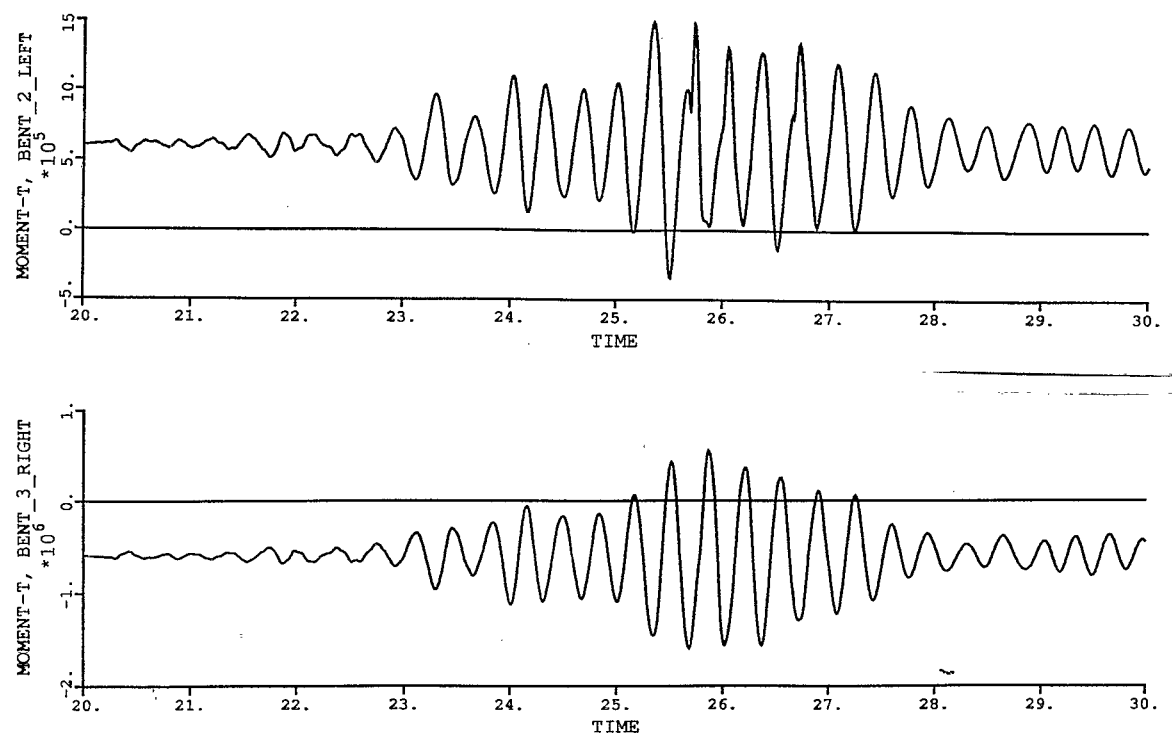
FIG. 5. Time Histories of Moments at the Right End of Left Span and Left End of Right Span

Time histories of the moments in the superstructure at the right end of left span and the left end of right span are shown in Figure 5. Note the difference in the frequency content of the time histories for these two sections. This is due to directionality of the mode shapes as discussed before, which has an effect on the response of the left span. However, it does not significantly affect the response of the right span. The maximum moments at critical sections are given in Table 1. For comparison these values corresponding to dead load are also given.
