SEISMIC PERFORMANCE AND REPAIR OF MAJOR STEEL BRIDGES ON THE HANSHIN EXPRESSWAY, JAPAN

HIROYUKI NAKAJIMA

Design Section, Engineering Division, Hanshin Expressway Public Corporation
Osaka, Chuo-ku, Kyutaromachi, Japan

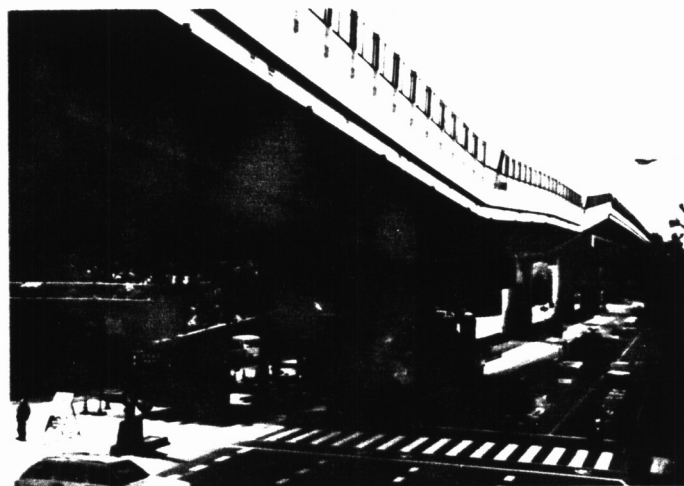
Photo 3 Collapsed steel pier

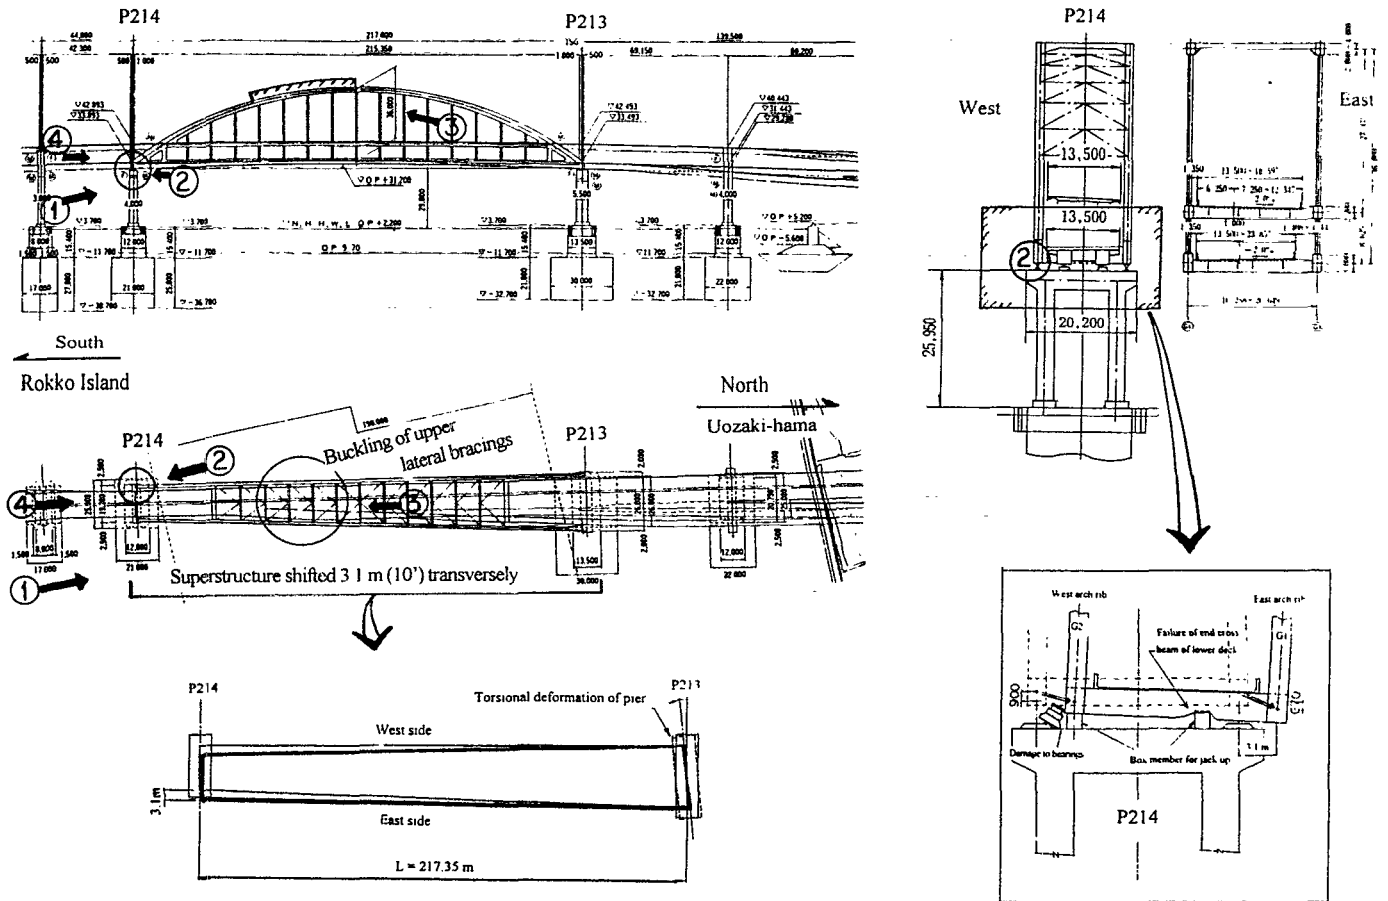
Fig. 2 Rokko Island Bridge

This is a Lohse double-deck arch bridge with a span of 252 m as shown in Fig. 2. This arch bridge shifted transversely to the east by 3.1 m on the south end pier (P214) in response to the earthquake and fell off its pivot bearing, damaging the end cross beams. Lateral bracing members, which connect two arches near the top of the arches, also buckled. The following is the repair procedure for the bridge.

- a) Temporary removal of the approach spans (P214–P215).
- b) Installation of temporary supports for the main span.
- c) Lifting up the main span (9,170 tons) with two floating cranes (capacities 3,500 and 4,100 tons).
- d) Shifting the main span back to its original position, but 6" higher for the exchange of bearings.
- e) Repair of end cross beams, top lateral bracings, the box member to allow the main span to be jacked up and the pier cap.
- f) Installation of new bearings and jacking the main span back down.
- g) Re-erection of the approach spans.

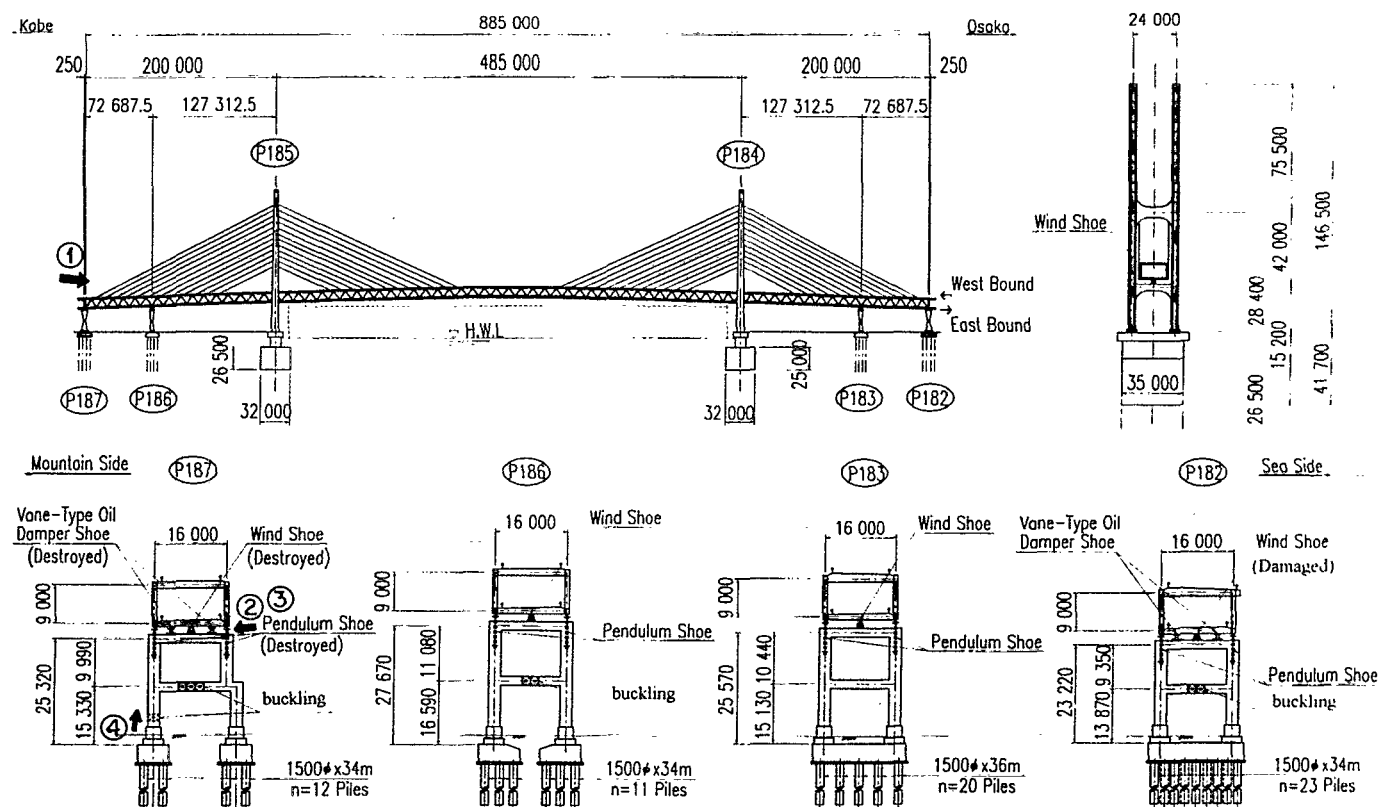
Fig. 3 Higashi-Kobe Bridge

This is a double-decked three-span continuous cable-stayed bridge with a center span of 485 m and side spans of 200 m as shown in Fig. 3. The stiffening truss girder of this bridge is suspended only by stay cables and this system makes the period of vibration longer in the longitudinal direction. This reduces the response acceleration of the bridge in that direction. But in the transverse direction the girder is restrained by wind shoes which are installed on the lower beams of the towers and the cap beams of the end piers. The transverse restrainers at the west end pier broke during the quake and could not hold the girder in place. Also installed at the end pier were two inverse pendulum type shoes to resist the lifting-up force of the girder and vane-type oil dampers against excessive longitudinal displacement under normal traffic conditions.

These devices were badly damaged by the large longitudinal and unexpected transverse displacement of the girder, with the girder springing up some 50 cm at the end piers. Two-story frame-type steel piers suffered serious local buckling in the lower column and diagonal wrinkles due to the shear in the cap beam.

When retrofitting these damaged devices and members the earthquake waves recorded at the site were used. Wind shoes were redesigned and manufactured especially for larger transverse forces. Inverse pendulum shoes were partly replaced and the oil dampers were completely replaced. Buckled beams and columns were partially replaced or reinforced by adding new cover plates or stiffeners after heating the deformed plates back into plane.
