SEISMIC REHABILITATION OF A LARGE MANUFACTURING PLANT

STEVEN P. SHEKERLIAN, AND ERIC C. WICKSTROM

EQE International, Inc.
18101 Von Karman Avenue, Suite 400
Irvine, California 92715-1032
USA

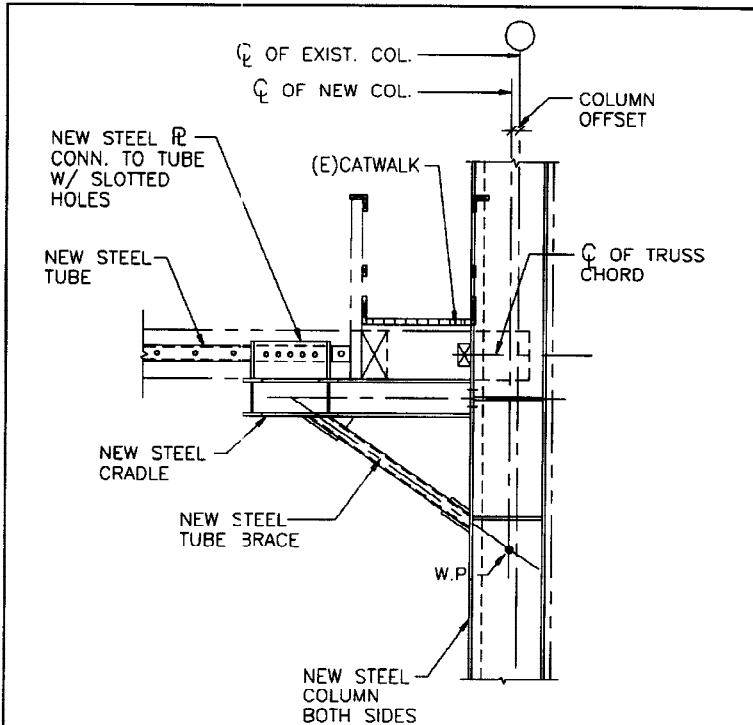
Figure 2 - Column to Truss Connection

Typical Column Retrofit The major deficiencies discovered in the transverse trusses were that the columns were extremely overstressed due mainly to bending forces induced by lateral loads (Load Cases #2 and #3). The philosophy behind the seismic strengthening was to stiffen interior columns, thus dragging more load from the exterior columns, reduce deflections to an acceptable level, and strengthen any interior truss members/connections such that capacities exceeded induced loads.

Stiffening interior columns (along lines E and F) was accomplished by installing two steel wide flange columns, one on either side of each of the existing 14x22 wood columns. Loads were transferred from the existing trusses into new columns via steel tube/steel plate bolted and welded connections as shown in

Figure 2. As these were the only main connections to the columns, no significant vertical load (aside from the new steel column self weight) was supported by the new columns. Lateral loads would travel the length of the new columns to the bottom where they will be taken out through shear at the base.

Connection Retrofit The bulk of the connection overstresses as previously listed occurred at chord-to-column and chord-to-strut connections. To transfer loads effectively into the new steel columns, new connections between the chords and the columns were developed. As shown in Figure 2, the new column-to-truss connection transfers lateral loads from the existing chords directly into the new steel columns, thus bypassing the original chord-to-wood column connection. This portion of the retrofit eliminated the overstress problem at the chord-to-column connection. Chord-to-web member connections which were overstressed were typically strengthened by the addition of steel plates designed to transfer member loads to the new tube steel chord members (see Figure 5).

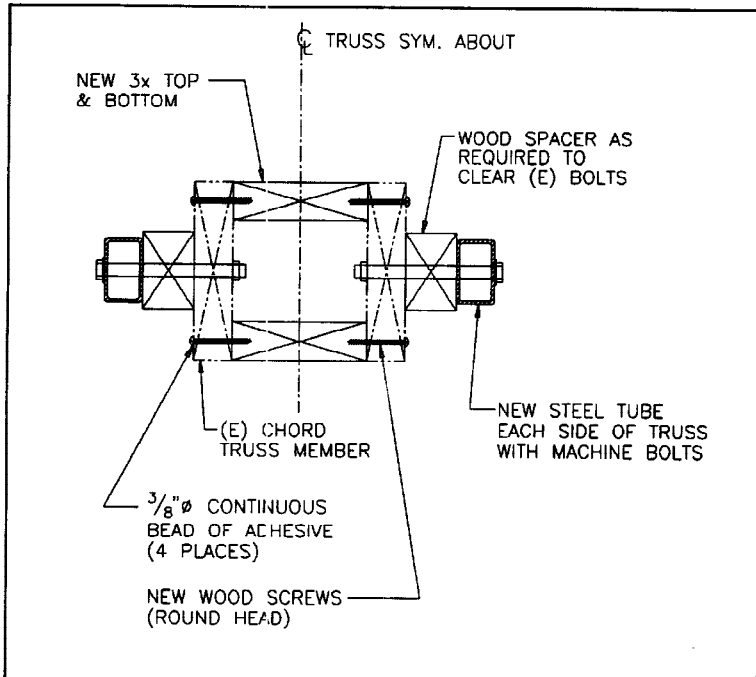
Figure 4- Member Strengthening Detail

Interior Truss Member Retrofit Interior truss members that required strengthening were typically limited to the vertical or diagonal truss members. The strengthening of these members was typically accomplished by installing additional wood members between existing members to increase stiffness and cross-sectional area

Retrofit Induced Overstresses and Strengthening Procedures In any structure, loads tend to flow toward and be resisted by the stiffest elements assuming there is an acceptable path for the loads to take. For this building, with the addition of the steel columns, interior column lines E and F became the stiffest elements of each truss. As such, forces tended to flow toward these interior columns by dragging loads along members that were likely not designed to resist forces of such magnitudes. In effect, forcing loads along

of the member as shown in Figure 4. As these members are predominantly subjected to axial loads only, an increase in cross-sectional area, with adequate connections, typically solved any tensile or compressive overstress problems.

under-designed members resulted in an overstress in some members. Retrofit of the newly created drag lines required a combination of the typical member strengthening with the installation of additional wood members and steel tubes to increase member stiffness and cross-sectional area (see Figure 4).

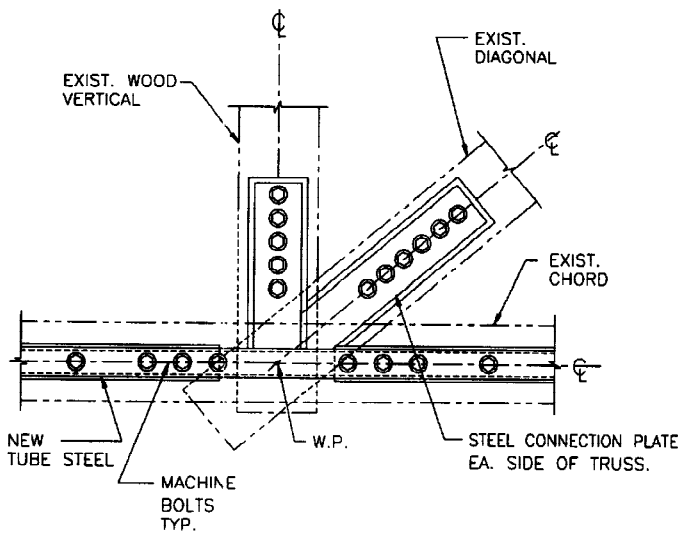
Figure 5- Connection Strengthening Detail

In addition, member forces were transferred into connections to determine if allowable capacities were sufficient. Load Case #2 was used to determine the connection overstresses for the transverse truss. One bottom chord-to-diagonal connection was found to be 15% overstressed. Three chord-to-column connections were overstressed as much as 122% and two chord-to-column connections exhibited overstresses as high as 55%.
