DAMAGE TO CONCRETE MASONRY GARDEN WALLS CAUSED BY 1994 NORTHRIDGE EARTHQUAKE IN USA AND 1995 HYOGOKEN-NANBU EARTHQUAKE IN JAPAN

K. KIKUCHI^{*1}, K. YOSHIMURA^{*1} and K. KAJIMURA^{*2}

*1 Department of Architectural Engineering, Oita University,
 700, Dan-no-haru, Oita, 870-11, JAPAN

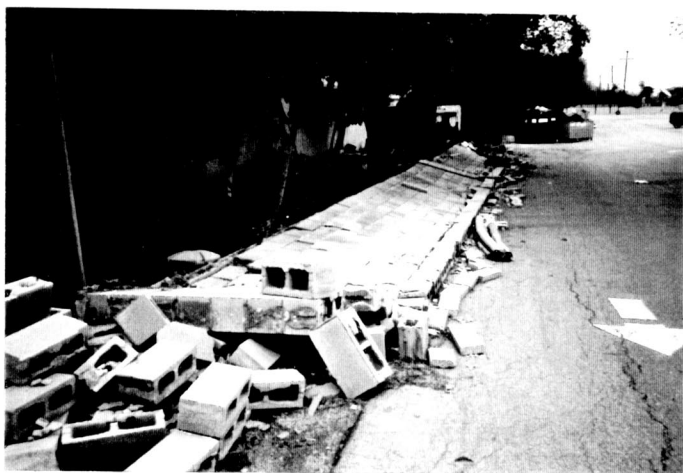
- (1). Most of the damaged masonry garden walls were composed of hollow concrete-block units as shown in Fig. 2, and dimensions of the masonry units, $(t) \times (h) \times (l)$, were $(9 \text{ to } 13 \text{ cm}) \times (20 \text{ cm}) \times (40 \text{ to } 55 \text{ cm})$, where (t) , (h) and (l) represent the thickness, height and length of the masonry units, respectively.

Fig. 2. Damaged wall and masonry units.

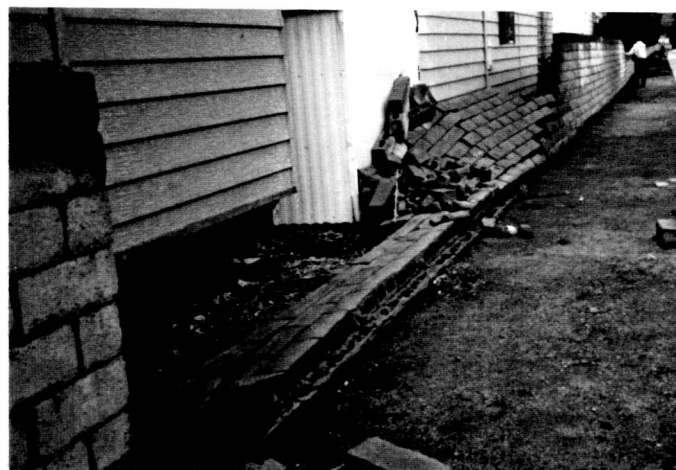
- (3). Most of the damaged garden walls did not have any effective foundations such as R/C foundations, but bottom of the walls were buried into ground as shown in Fig. 3.

Fig. 3. Masonry wall without foundation.

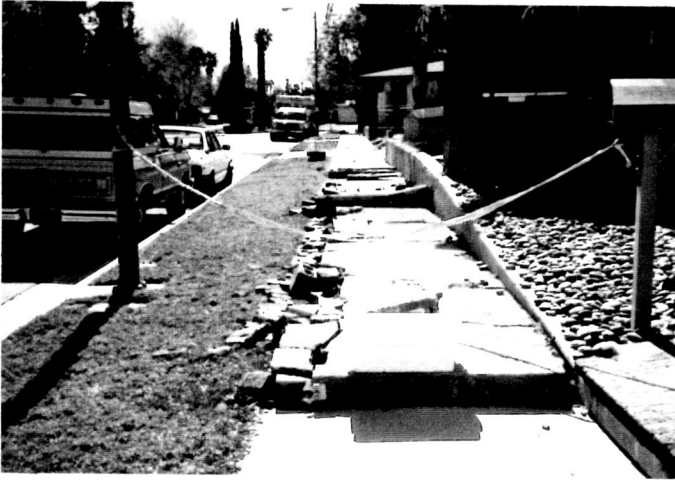
- (4). Masonry wall in Fig. 4 had insufficient anchorage lengths in vertical Re-bars, where bottom ends of the vertical Re-bars were pulled out from the R/C buttress wall (or foundation).

Fig. 4. Inadequate anchorage for vertical Re-bars.

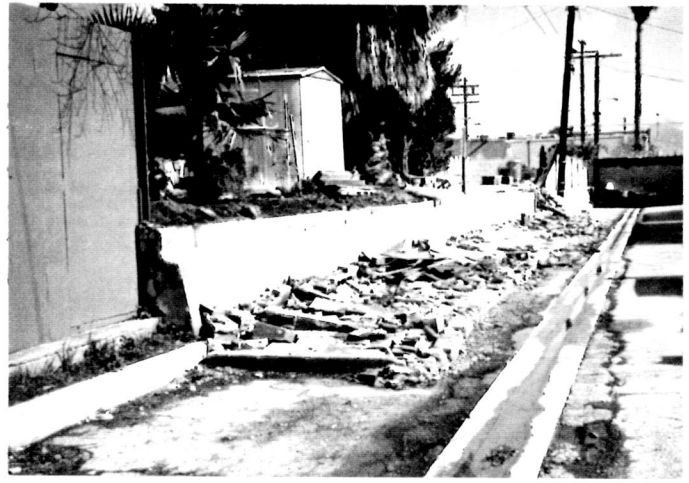
- (5). All the damaged masonry walls which were subjected to horizontal earth-pressure turned over toward the road-side (see Fig. 5).
- (6). There were no effective buttress or pilasters observed in damaged masonry garden walls. Fig. 6 shows one of the partially survived walls due to the presence of effective pilasters composed of double H-shape masonry units with wide thickness.

Fig. 5. Damage due to earth pressure.

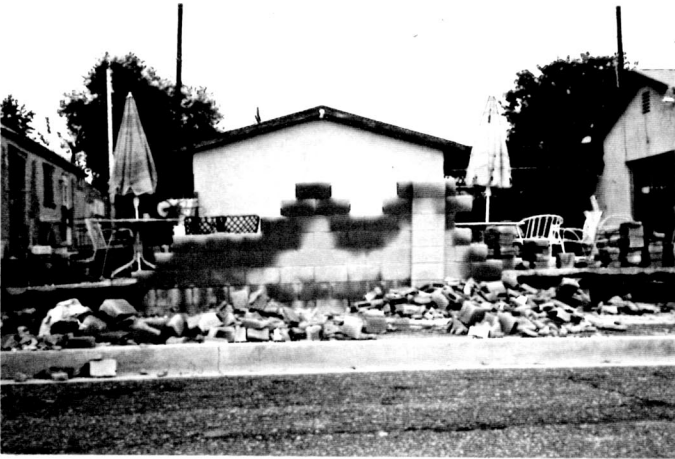
Fig. 6. Locally survived wall due to pilasters.

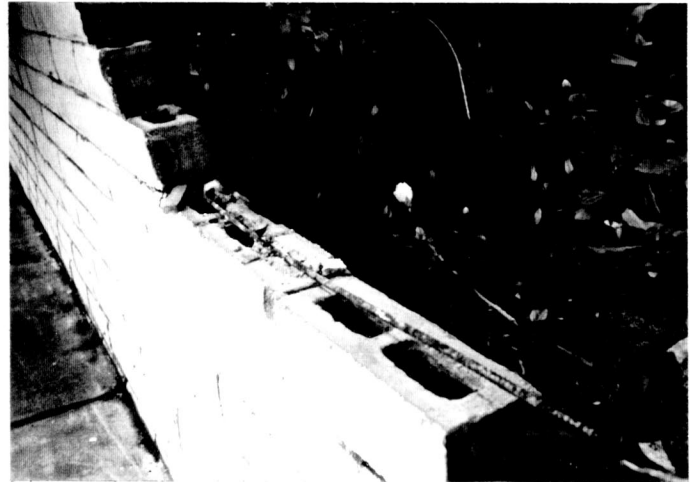
- (7). Most of the structurally damaged masonry walls were completely un-reinforced or not reinforced by the effective reinforcement such as vertical and horizontal Re-bars with sufficient anchorages. In case when the effective masonry units for horizontal Re-bars are not available as shown in Fig. 7, it is difficult to construct the seismic masonry walls which are monolithically reinforced by wall Re-bars. If the masonry walls without any monolithic reinforcement are subjected to strong earthquake, masonry units are expected to be scatted as shown in Figs. 2 and 5.

Fig. 7. Masonry units not for horizontal Re-bars.

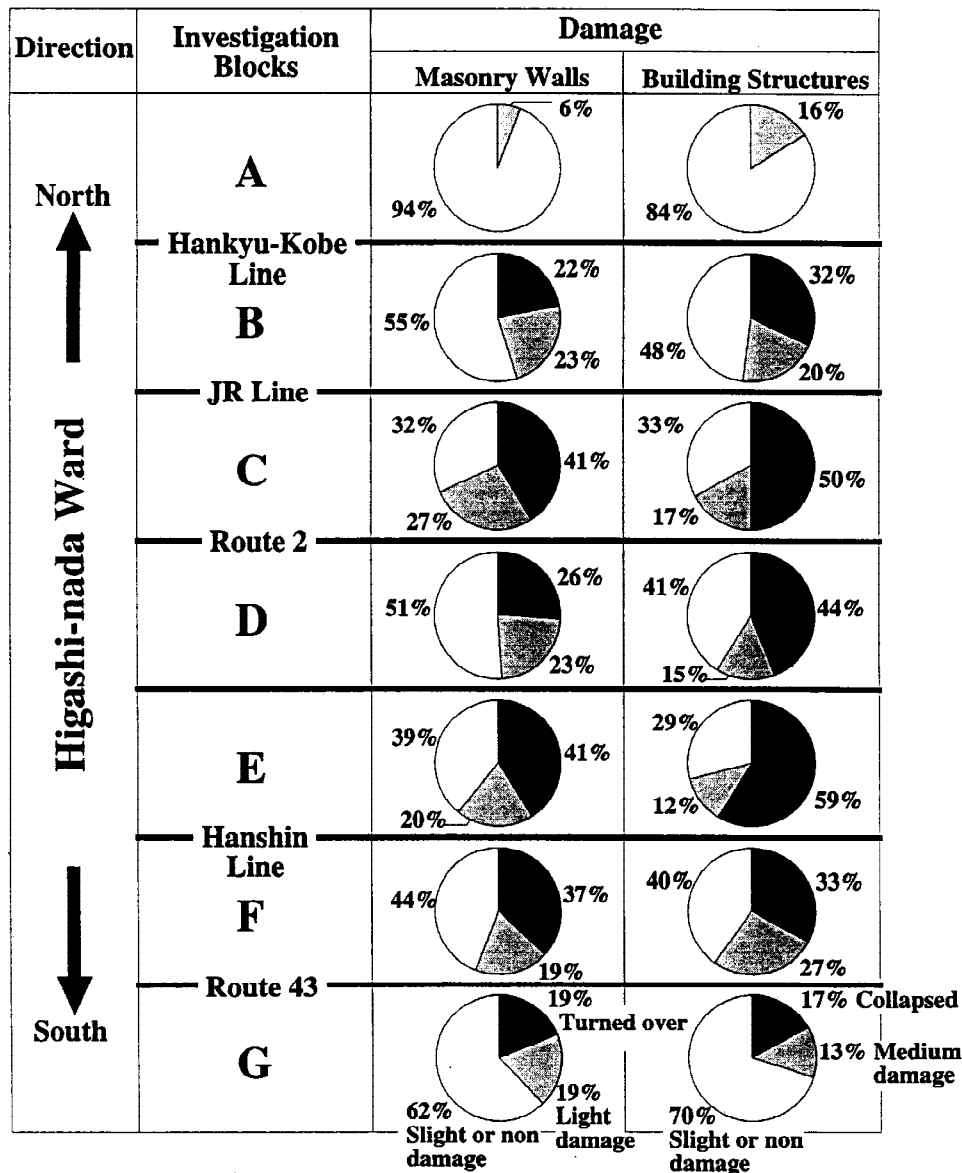
Investigation results are shown in Fig. 8, where damage to the masonry garden walls were classified into three

Fig. 8. Field investigation results in Kobe City.

grades, "turned-over", "light-damage" and "slight- or non-damage", and damage to the buildings were classified into "collapse", "medium-damage" and "slight- or non-damage". Among the building structures investigated, timber buildings were 76 percent, reinforced concrete (R/C) and steel buildings were 14 and 7 percent respectively, and others were 3 percent. In the figure, circle diagrams in left column show the damage statistics in masonry garden walls and right ones are for building structures. It can be seen from Fig. 8 that damage statistics in masonry garden walls is well corresponding to that of the building structures. In this area, however, damage to the building structures was more significant than that of the masonry garden walls. In masonry garden walls, total of completely collapsed (or turned over) walls was approximately 25 percent, but in the worst Investigation Blocks (C and E) in Fig. 8, completely collapsed masonry walls were more than 40 percent. On the contrary, damage to the building structures was 33 percent in total, but in Block (E) in Fig. 8, about 60 percent buildings were completely collapsed.

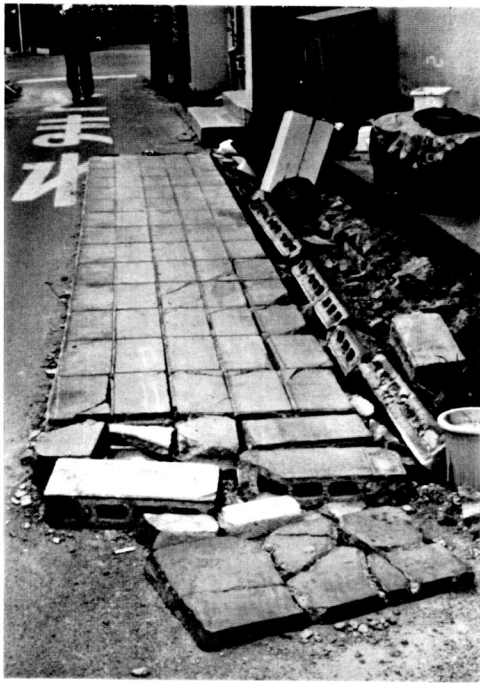
Fig. 9. Masonry wall without foundation.

- (1). No foundations to give an effective anchorage for vertical Re-bars (Fig. 9):
- (2). Shallow depth for embedment in foundations (Fig. 10):
- (3). No or small amount of vertical wall Re-bars (Figs. 11 and 12):
- (4). Insufficient anchorage for bottom of vertical Re-bars (Fig. 13):
- (5). Poor reinforcement details:
- (6). Inadequate reinforcement for buttress and/or wall-to buttress joint (Fig. 14):

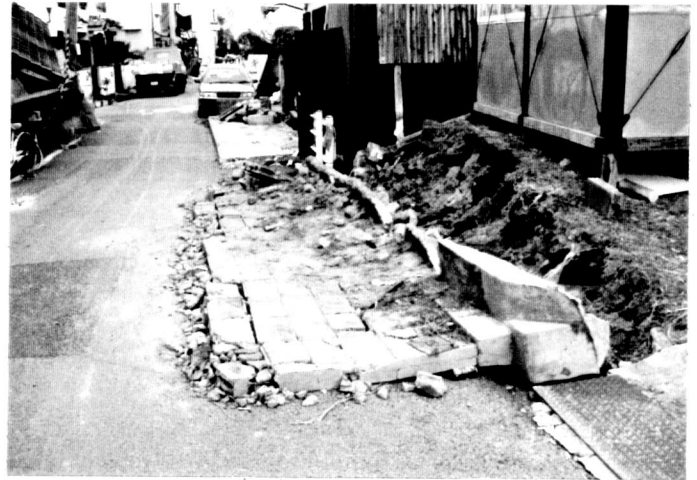
Fig. 10. Shallow depth for embedment in foundation.

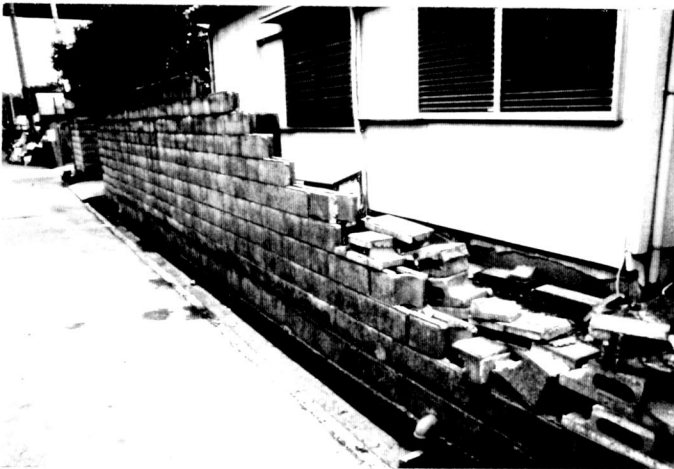
Fig. 11. Masonry wall without wall Re-bars.

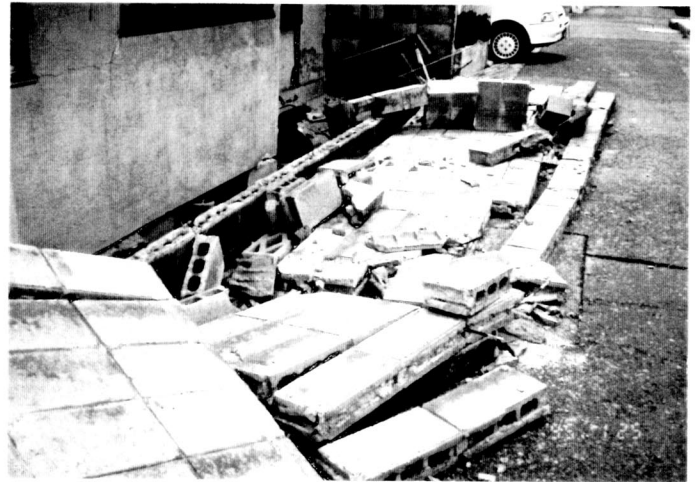
Fig. 12. Insufficient wall reinforcement.

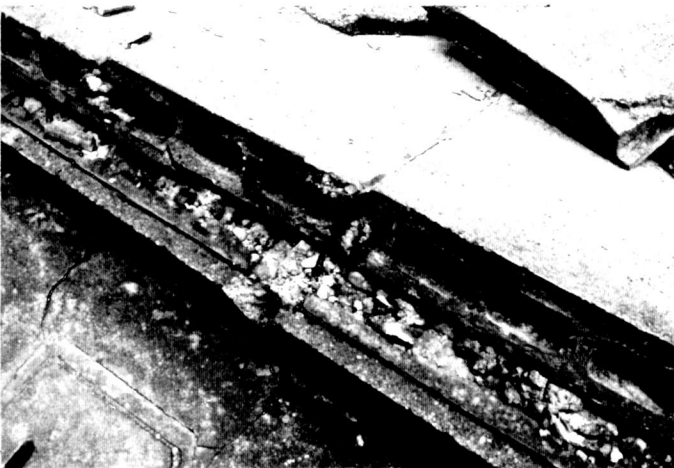
Fig. 13. Insufficient anchorage for vertical Re-bars.

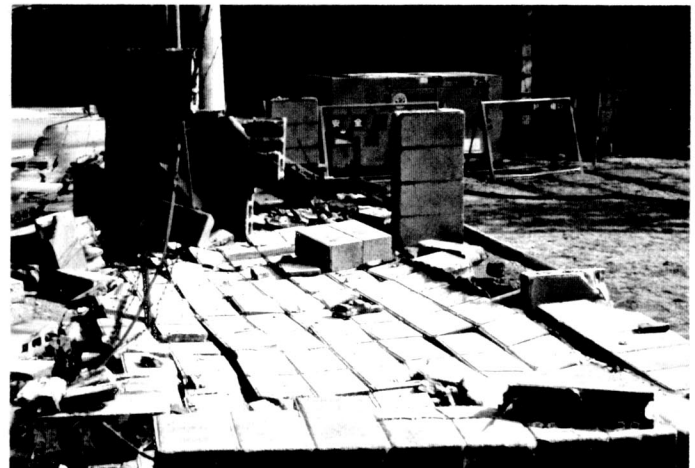
Fig. 14. Inadequate joint between wall and buttress.
