SEISMIC EVALUATION OF BELEN CHURCH IN MERIDA, VENEZUELA

A. I. UZCATEGUI and P. J. MONTILLA

Departamento de Estructuras, Facultad de Ingeniería, Universidad de Los Andes,
Av. Tulio Febres Cordero, Mérida, Venezuela.

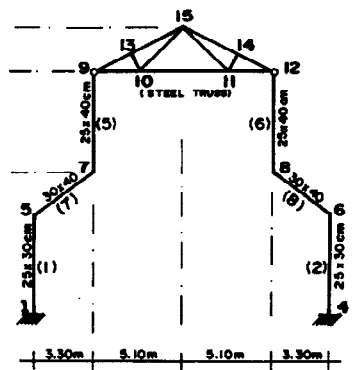
(b) Frame B. Without central columns continued to ground level.

For vertical loads the safety factors are high in both transverse frames. For 10% of g it can be seen that in frame B members 5 and 6 are close to failure with factors very close to the critical condition ($Mr/Mac \cong 1$). This shows that under moderate earthquakes the building will have problems in those frames whose central

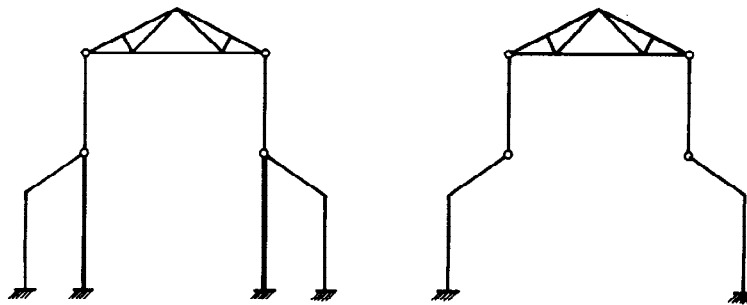
(a). Collapse for Frame A. (b). Collapse for Frame B.
Fig. 4. Collapse mechanism for transverse frames.

columns do not reach the ground. In Fig. 4 the collapse mechanisms are shown for transverse frames under the selected earthquakes. For both earthquakes failure is produced by the formation of a lateral mechanism at the top level. In Frame A collapse is produced under the El Centro scaled at 30.3% of g at time $t = 1.0$ sec, and under the Monay scaled at 31.1% of g at time $t = 5.1$ sec. In Frame B collapse is produced for El Centro scaled at 11.5 of g and $t = 1.6$ sec, and for Monay scaled at 16.2% of g and $t = 3.9$ sec. It can be seen that the most probable failure mechanism occurs in Frame B, with non continuous columns, which indicates that this frame is the most vulnerable of the structure; the church will have behavioral problems in these frames for moderate levels of seismic actions and in general, El Centro earthquake is more destructive than Monay. This is due to the fact that although both earthquakes were registered on hard soil, their frequencies content is different. Table 2 shows the interstorey drift obtained in Frame B for both scaled earthquakes. According to the Venezuelan Seismic Code (Norma Venezolana, 1982), for severe earthquake the allowable drift is 0.015, and it is considered in this study that for moderate earthquakes with an assumed ductility of 2 for the structure, the lateral drift is of 0.0075. Comparing these values with those obtained in cases 2 and 3 of the Table 2, it is concluded that they are not surpassed; therefore the lateral drift is not a determinant factor in the seismic behavior of the frame. The values of lateral drift for Frame A are smaller than those of Frame B.

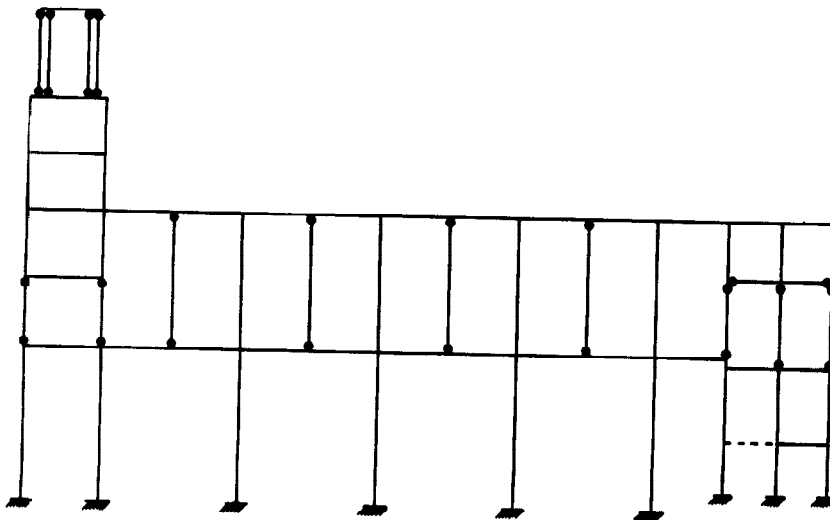
Fig. 5. Partial collapse mechanism in longitudinal frames.

Longitudinal Frames. The collapse of the last level of the Tower occurs under the action of El Centro scaled to 10% of g. The most severe damages in these frames occur for the same earthquake without scaling, at time $t = 1.2$ sec, represented in Fig. 5, characterized by the collapse of the last level of the Tower and severe damage at the top of the Chorus, the Central Nave and the Presbytery. It can be seen that the lateral stability of the structure is maintained by the contribution of the columns continuous to the ground of the Central Nave. For Monay scaled to 16.2 % of g, at time $t = 1.5$ sec, the collapse of the last level of the Tower was observed, with no more structural damages. Scaling this earthquake to 30% of g, the maximum ground acceleration expected at the site according to the Venezuelan Seismic Code, the previous behavior is maintained. It was found that for both earthquakes scaled to levels of accelerations above 30% of g, the acting shear surpassed the shear strength in the short column located in the Presbytery, failing it by shear (Fig. 5). The shear ratio history for El Centro earthquake is shown in Fig. 6. The shear strength was calculated using the equations obtained for R. C. short columns by Umehara (Umehara et al., 1984). In these frames, the values of lateral drift are less than the allowable values. In the 3D analysis done previously, it was observed that the arches of the Presbytery and of the Chorus, because they are not braced, contribute to create zones that are vulnerable and could cause the collapse of that part of the building. Also, the structure of the Chorus is very stiff (Photo 3), and attracts a great part of the inertial forces, localizing the damage in the surrounding zones (Fig. 5).

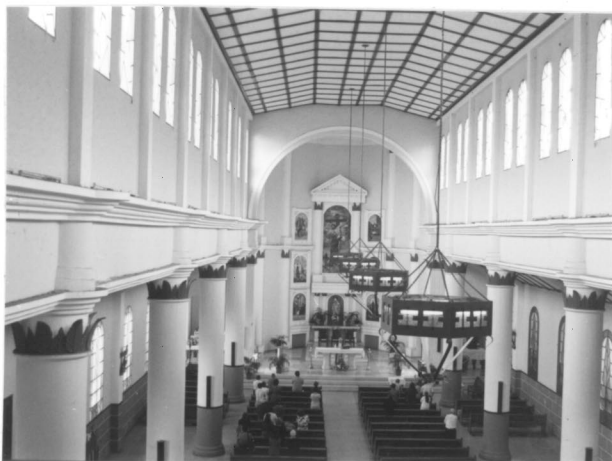
Photo 3. Interior view of the church toward the Presbytery

The false ceiling is made of laminated asbestos cement, is very heavy and simply supported from the roof trusses by flexible braces (Photo 3). These elements could deform considerably and cause the lamina to fall down representing a great hazard for the occupants. The metallic lamps of the Central Nave are heavy and are hanging from the roof trusses with chains welded to them (Photo 3); they are hexagonal in form and have sharp edges, that could represent a hazard to the occupants if they fell. The longitudinal beam of the Central Nave is decorated with a concrete covering of 0.06 m of thickness, with great outcrops at the top and bottom of the beam (Photo 4). The seismic experience obtained from other similar buildings (Montilla *et al.*, 1996), has shown that this type of decoration can fall down easily, being very dangerous for the users of the building. The religious images are simply placed on wooden pedestals without bracing and could overturn.
