TEST OF A MICRO-CONCRETE MODEL OF A BUILDING DAMAGED DURING THE 1985 CHILE EARTHQUAKE

R. TOBAR and P. BONELLI

Universidad Técnica Federico Santa María
Casilla 110-V, Valparaíso, Chile.

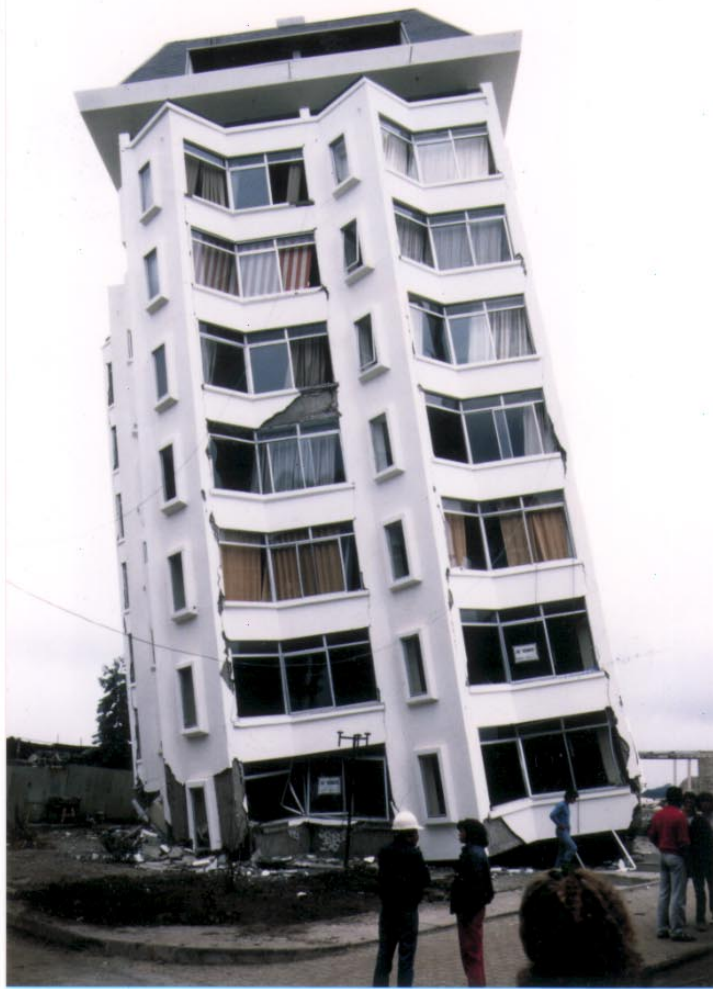
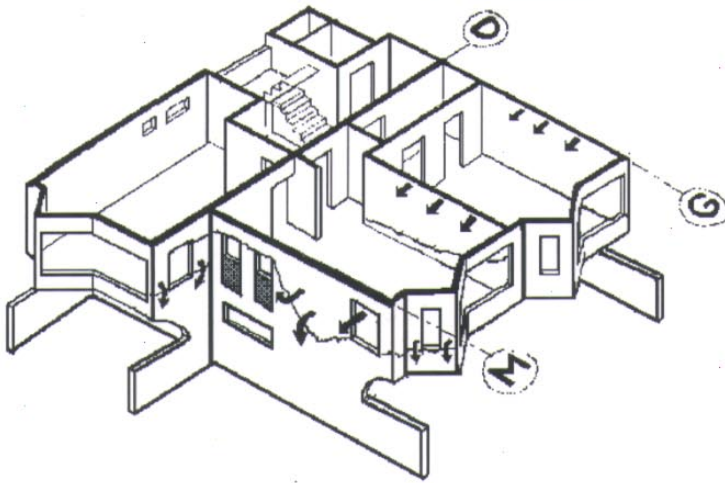
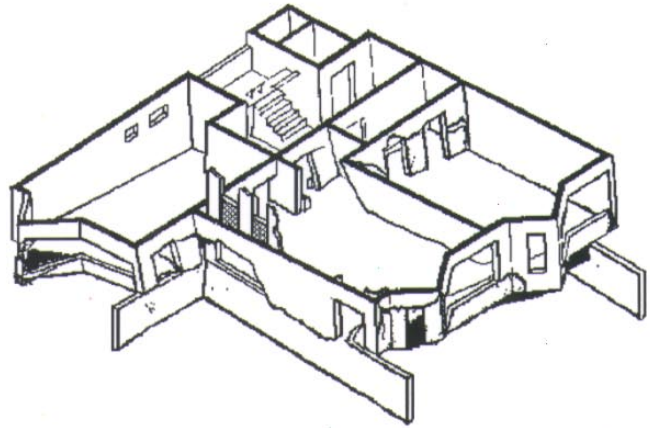
Fig. 1

"El Faro de Reñaca", a 9-story reinforced concrete building located in Viña del Mar, Chile, suffered severe damage during the earthquake of March 3, 1985. The building was left with a permanent inclination of approximately 15 degrees from the vertical, and had to be demolished soon after the earthquake due to a failure initiated at the M-axis wall. A crack opened at mid-height at the first story of this wall, and ran up to the top of the window, as shown in Fig. 1. The portion of the wall above the crack slid forward out of the plane and fell to the ground. No damage was observed in the upper stories.

Riveros (1987) has shown that the failure may have started in a flexural mode in a construction joint near the base of the walls (Fig. 1), thus pointing to deficiencies during the construction. As he observed from photographs and inspections of the site, he concluded the building would have moved mainly along one of its diagonals.

El Faro Building: (a) After the earthquake; (b) First-story schematic view. The arrows show the displacement directions of the walls before the collapse; (c) First-story schematic view after the earthquake.

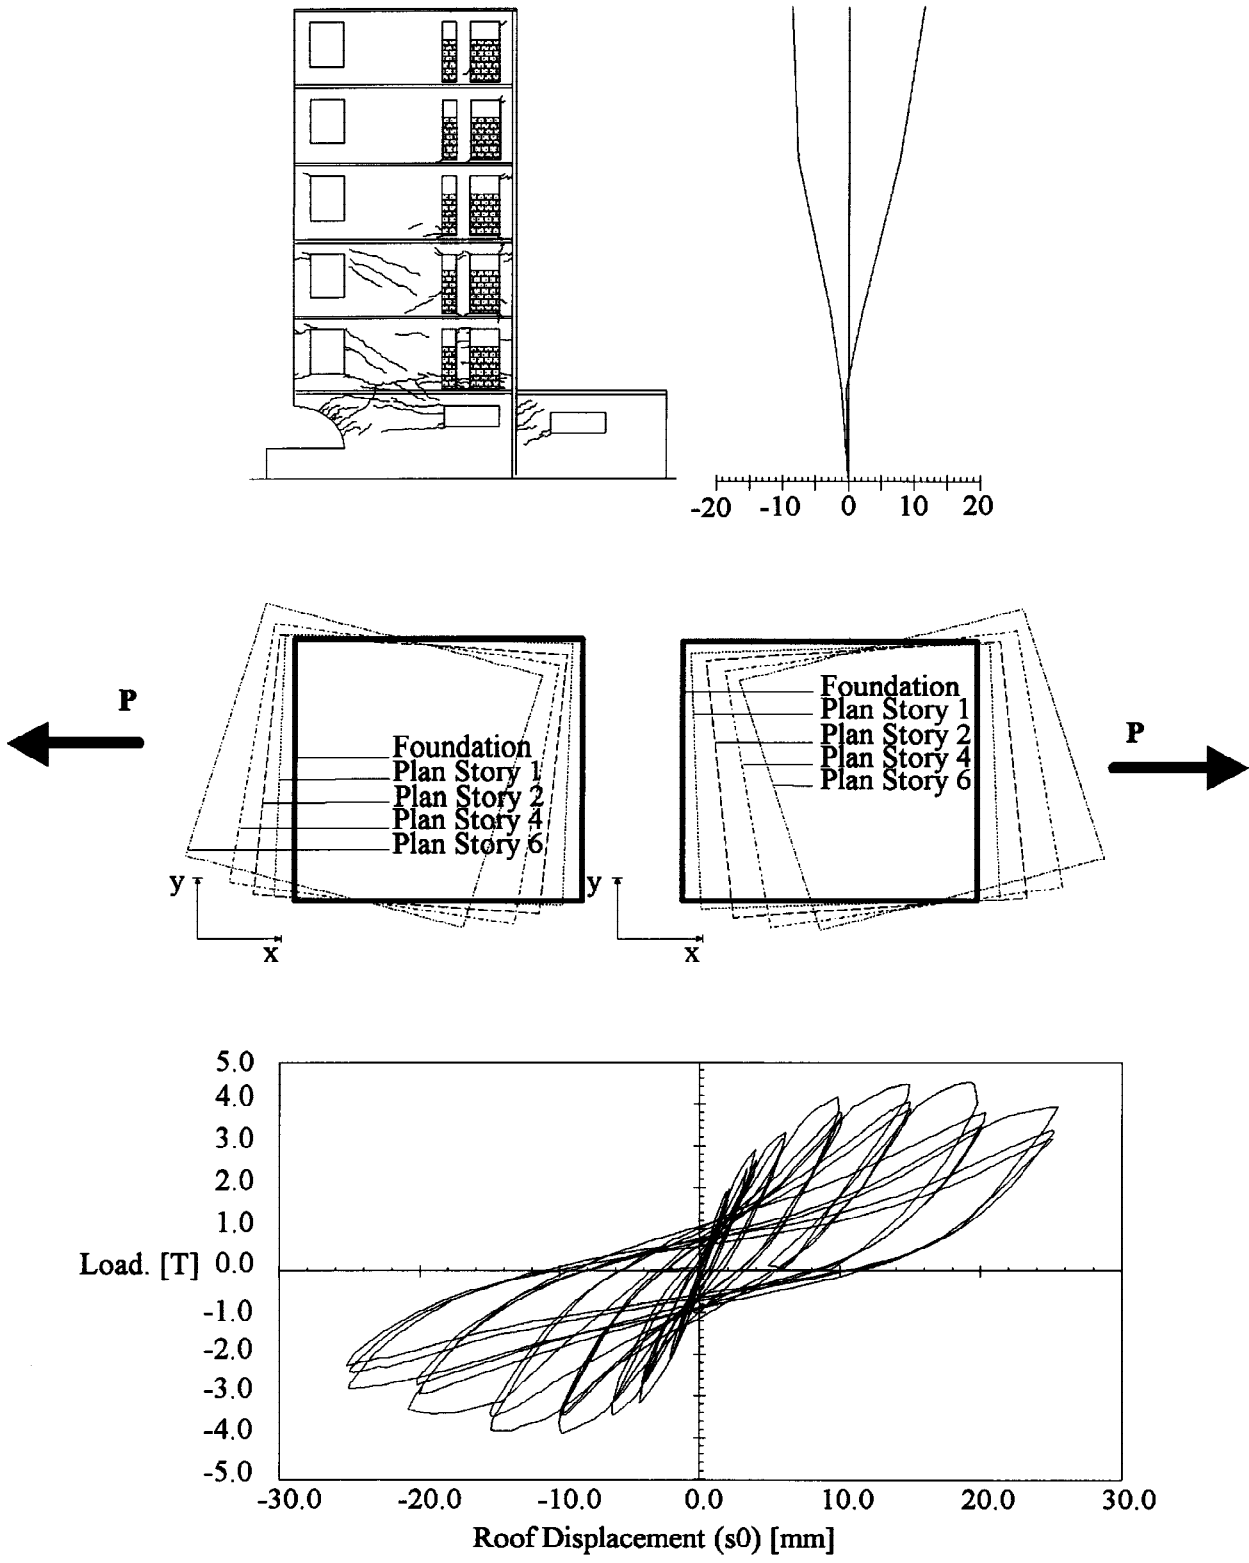
Fig. 4 shows the cracking pattern of the M-axis wall and the distribution of the wall lateral displacements on the building height after the completion the 1.53% overall drift ratio (25 mm) cycles, which represent a stage of high level of deformation. The plan views of the position of each story slab at the same stages, for both directions of the tests, are also shown in these figures. For the sake of clarity, rotations of the plans are not scaled. Finally, the figures show the applied load- lateral top displacement curves obtained during the tests. Fig. 5 shows the lateral displacements and cracking patterns for each wall of the model at the final loading cycle.

Large levels of inter-story drifts were measured during the test. For instance, at the 1.53% overall drift ratio cycles, a relative displacement of 3.6% of the story height was measured at one of the plan corners at the second level of the model.

Fig. 4 1.53% overall drift ratio (6 mm) cycles: Cracking pattern and distribution of wall displacements on the height for M-axis wall; Schematic plan view of the position of each story slab; Applied load - top displacement curve

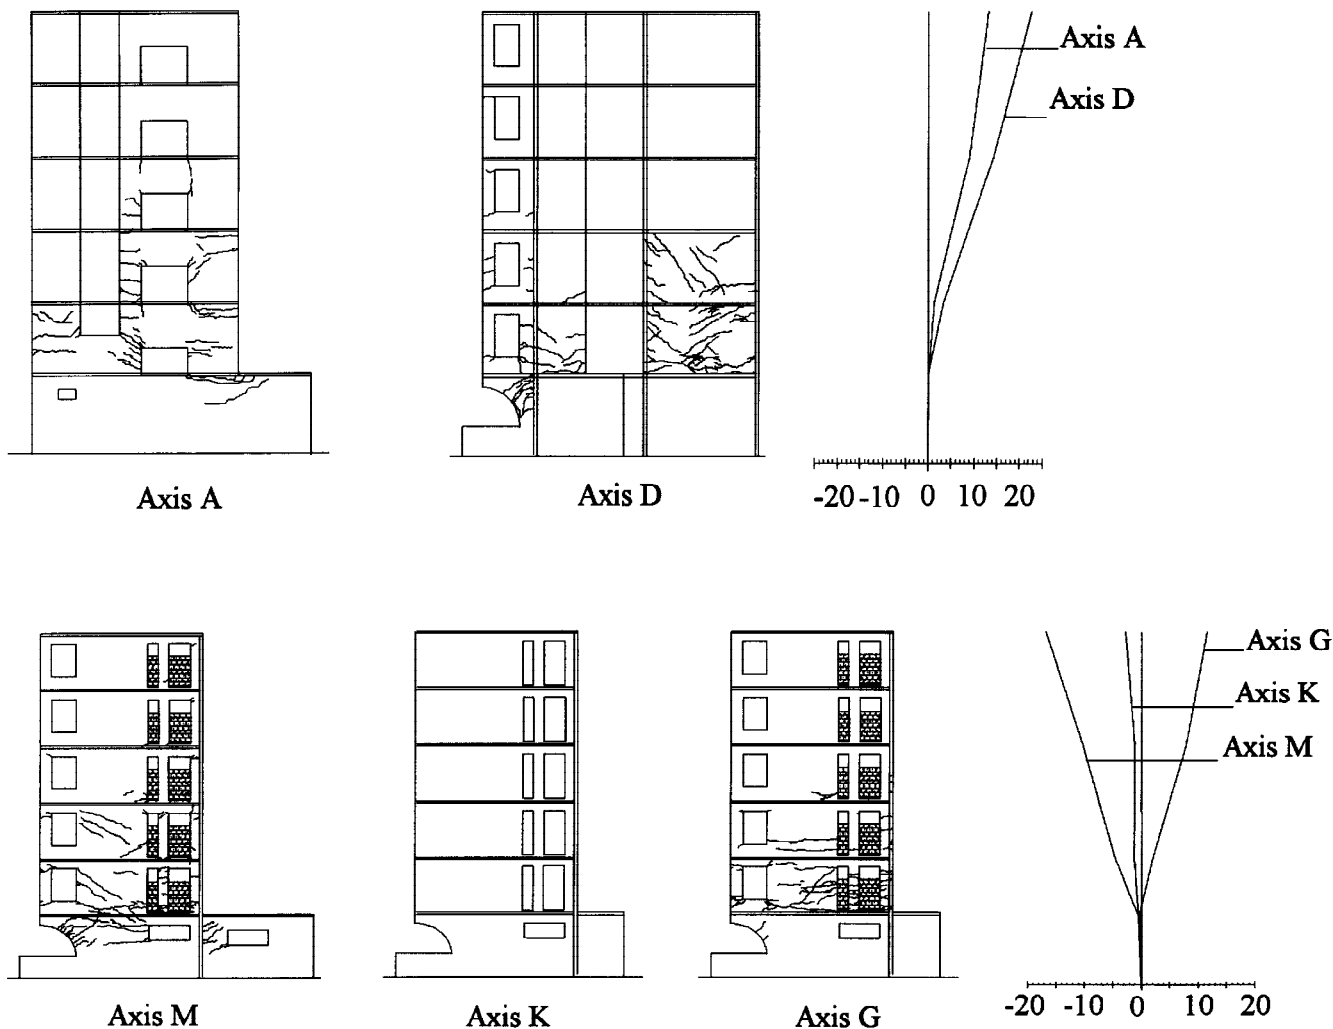
Fig. 5 Lateral displacement distributions and cracking patterns for each wall of the model at the final loading cycle
