SEISMIC PERFORMANCE OF WOODEN DETACHED HOUSES SUBJECTED TO THE 1995 HYOGO-KEN NANBU EARTHQUAKE

YOSHIMITSU OHASHI and ISAO SAKAMOTO

ABSTRACT

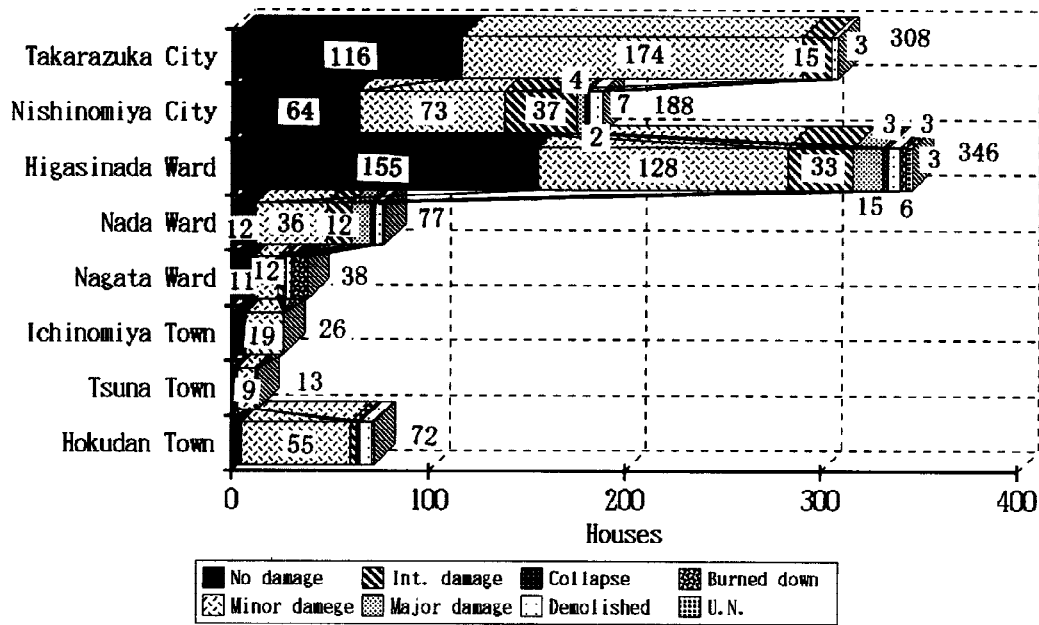
FIG. 2 NUMBER OF DAMAGED HOUSES SUBJECTED TO AREA

Damage Ratio. Figure 2. shows the damage grade of 1068 houses, financed by the G.H.L.C.J. Of the 1068 houses there were 104(9.7%) houses of intermediate damage, 31(2.9%) major damage, and 8(0.7%) collapse. There were also 29(2.7%) houses already demolished at the time of the survey, and 11(1.0%) were burned. The ratio of intermediate damages was approximately 10%, and the damage ratio of major or more severely damaged houses was 3 - 4%.

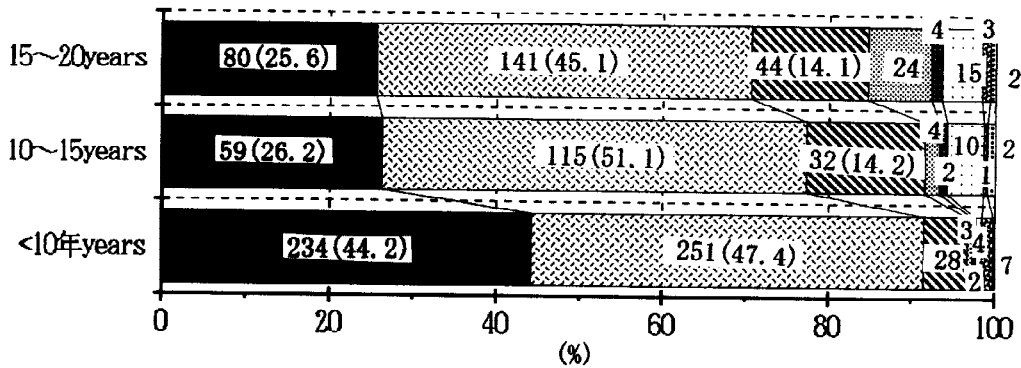
FIG. 3 RATIO OF DAMAGED HOUSES SUBJECTED TO AGE

Difference of Damage Ratio by Aging. Figure 3. shows the difference of the damage ratio by aging. The grade of damage has a tendency to be higher for the older houses. Although the damage ratio differs according to the construction type, and the proportion of the construction type differs according to the age of the house, The figure shows that the ratio of intermediate damages is higher for the houses aged more than 10 years.

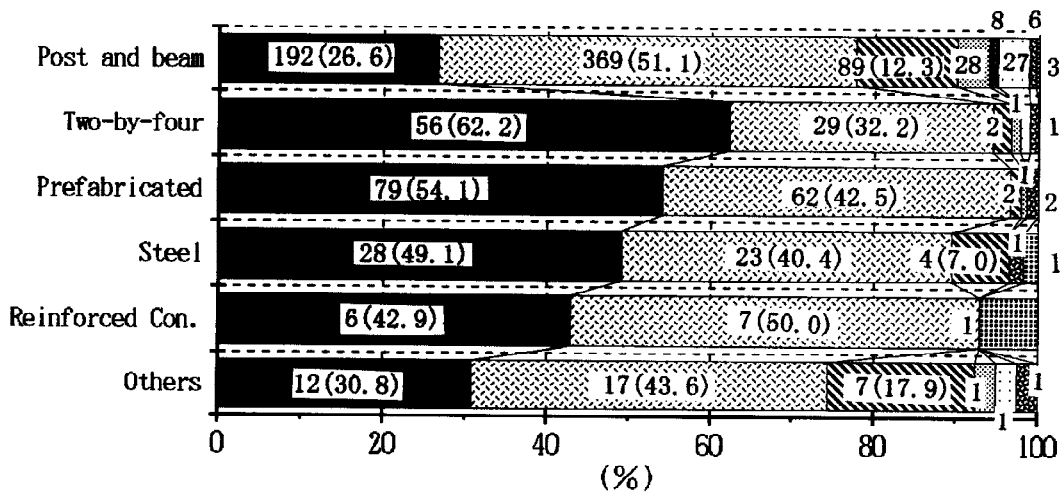
FIG. 4 RATIO OF DAMAGED HOUSES SUBJECTED TO CONSTRUCTION

Difference of Damage Ratio by Construction Type. Figure 4. shows the difference of the damage ratio by structure. The damage ratio of houses of post and beam construction was as follows: intermediate damage was approximately 12%, major or more severe damage was approximately 8%. This fact indicates that one fifth of post and beam construction houses were intermediately or more severely damaged. On the other hand the damage ratio of houses of two-by-four construction and prefabricated houses was low. The ratio

of intermediate damages was approximately 2%, major or more severe damages was approximately 1%.

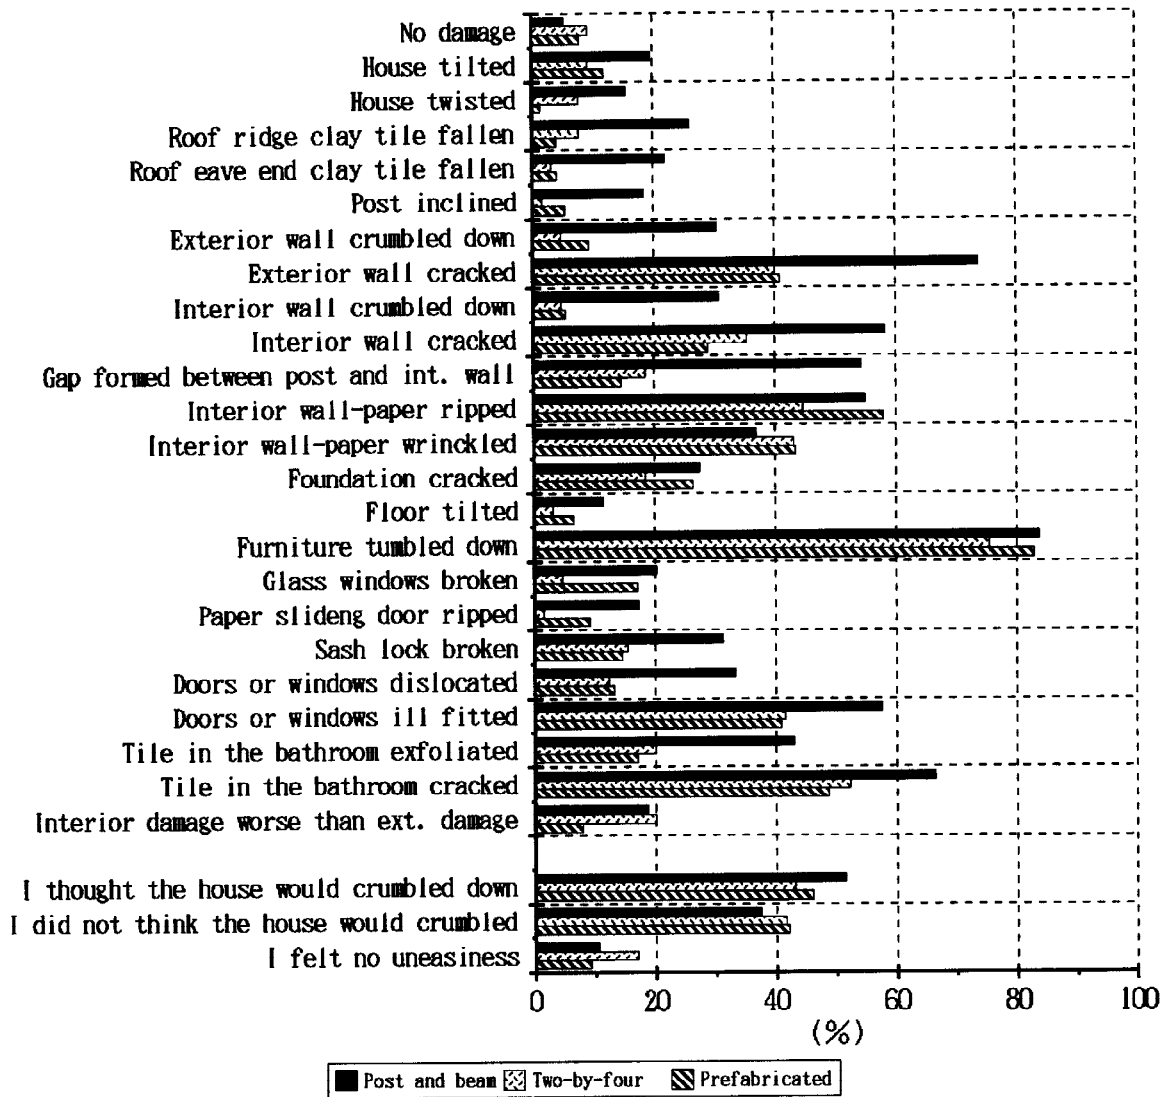
FIG. 5 RESULT OF QUESTIONNAIRE SUBJECTED TO CONSTRUCTION

Difference of Damage Ratio by Construction. Figure 5. shows the difference of the damage ratio by construction. The number of answers to the questionnaire was as follows: 374 post and beam construction, 64 two-by-four construction, 76 prefabricated construction. The ratio of slanted or twisted houses was higher for the post and beam construction compared with the other two. There were very few prefabricated houses which were twisted. The damage ratio of clay roof tile was high for the houses of post and beam construction, but as was mentioned earlier clay roof tile is seldom used in houses of two-by-four houses or prefabricated houses. The same can be said for exterior walls. Assumably gypsum board is used to undercoat the interior wall for all construction type. The damage ratio of interior walls is high for the houses of post and beam construction. Damages such as cracked or fallen out interior walls, indicating large deformation of the skeleton, were identified. On the other hand, many torn or wrinkled paper wall were seen in the two-by-four houses and prefabricated houses. However it must be noted that for the houses of post and beam construction, especially ones with shin-kabe(wall type), any kind of damage can be easily located. However cracked tiles in the bathroom were seen in one half of the houses of two-by-four houses and prefabricated houses.

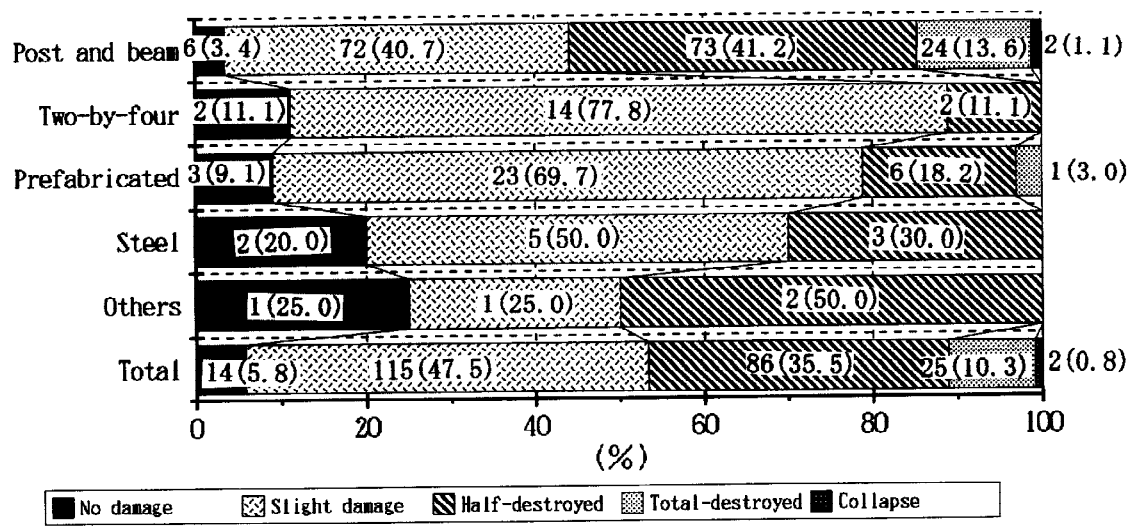
FIG. 6 RATIO OF DAMAGED HOUSES SUBJECTED TO CONSTRUCTION BY QUESTIONNAIRE

Questionnaire and Exterior Survey. Figure 6. shows the answer to the following question, "Which do you think is the grade of damage of your house?". The result of the two corresponding surveys indicates that, the residents, answering the questionnaire, incline to judge the damage more severely than the result of the exterior survey, done by researchers. To compare the result of the two surveys by construction type, here too the results of the questionnaire tend to be harsher than the exterior survey. The damage ratio of partially collapsed or more severely damaged houses was more than 50% of the post and beam houses, 20% of the prefabricated house, and more than 10% of the houses of two-by-four house. The fact that houses of two-by-four construction was judged better by the resident, than the prefabricated houses is an interesting point.

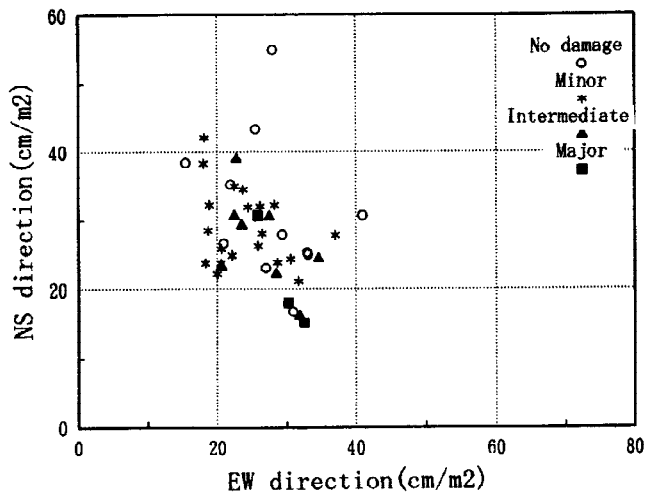
FIG. 7 LENGTH OF WALLS WITHOUT OPENING

Apparent Wall Length. Figure 7. shows the wall length of 42 houses, and the averages of them are 25.9 cm (EW direction) and 28.7 cm (NS direction). Figure 7. shows that the wall length has a tendency to be small at least in one of the directions. Most houses with such wall length were more severely damaged, but the rest were not so much damaged. These houses need to be examined separately.

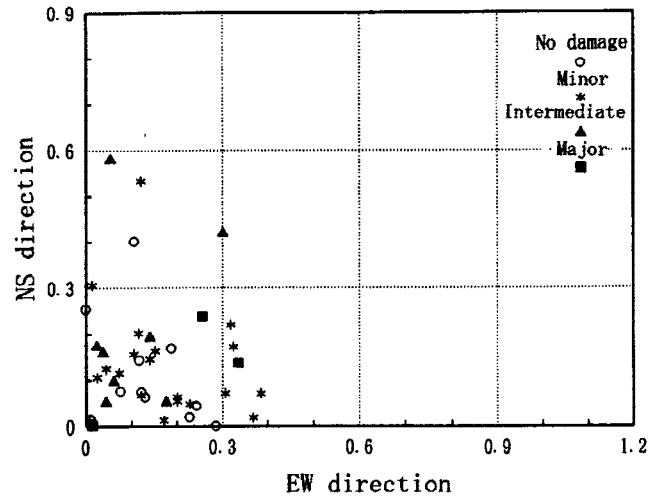
FIG. 8 MODULUS OF ECCENTRICITY OF WALL

Apparent Modulus of Eccentricity. Figure 8. shows the modulus of eccentricity calculated on the

assumption that the wall index of walls without openings is equally 1.0. In 30 houses(41.7%) the modulus is more than 0.15 in both direction, some of them are more than 0.5. Fig. 10. shows the modified wall lengths, that are recalculated considering the effect of modulus of eccentricity as shown in Fig.9. The formula is used to modify the wall length caused by eccentricity in "diagnosis method of seismic performance of wooden house" (The Japan Building Disaster Prevention Association). There seems to be a tendency that most of the severely damaged houses have small modified wall length. However it is difficult to estimate the grade of damage simply by the wall length of walls without openings, for this tendency is not very distinct.
