DAMAGE TO WOODEN HOUSES DUE TO THE 1995 GREAT HANSHIN-AWAJI EARTHQUAKE DISASTER

TADASHI DOI * , HIROYUKI KITAMOTO * and LU HENG JIAN **

* Department of Environmental Design, Faculty of Human Life Science, Osaka City University,
3-3-138 Sugimoto, Sumiyosi-ku, Osaka, 558, JAPAN

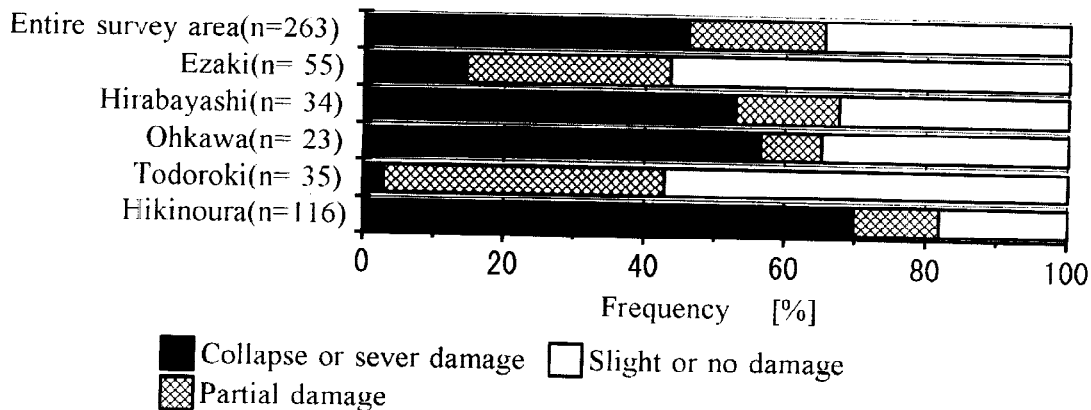
We surveyed 266 wood-frame buildings distributed over the entire survey area of Hokudancho. Among these, useful data were obtained from 263 buildings. When classified by the degree of damage by the criteria shown in Table 1, 121 buildings (46.0%) collapsed or were severely damaged, 51 (19.4%) were partially damaged and 91 (34.2%) were slightly or not damaged. Very high proportion of the buildings in this area were damaged due partly to its location near the seismic fault. As can be seen from Fig.3, however, damage to the structures was not uniformly distributed among different places. The difference may be attributed to the differences in the distance from the fault and in the ground conditions.

Fig.3. Proportion of damage to wooden -frame buildings in Hokudancho, Awajishima Island.

In Hikinoura, for example, over 80% of the buildings were severely or partially damaged. Such a devastating damage may be blamed on the ground condition, because most of the buildings of this area are concentrated in low-lying level land near coastline, in contrast to other areas. When classified by the purpose, 299 (87.1%) buildings were exclusively for dwelling, 8 (3.0%) were houses combined with shops, 2 (0.8%) were wood-frame apartments and 24 (9.1%) for other purposes. As for the roofing material, tile is predominantly used on 255 buildings (97.0%), while sheet metal roofing was used only on 7 buildings (2.7%). This may be due to the fact that Awajishima is a major roofing tile producing area.

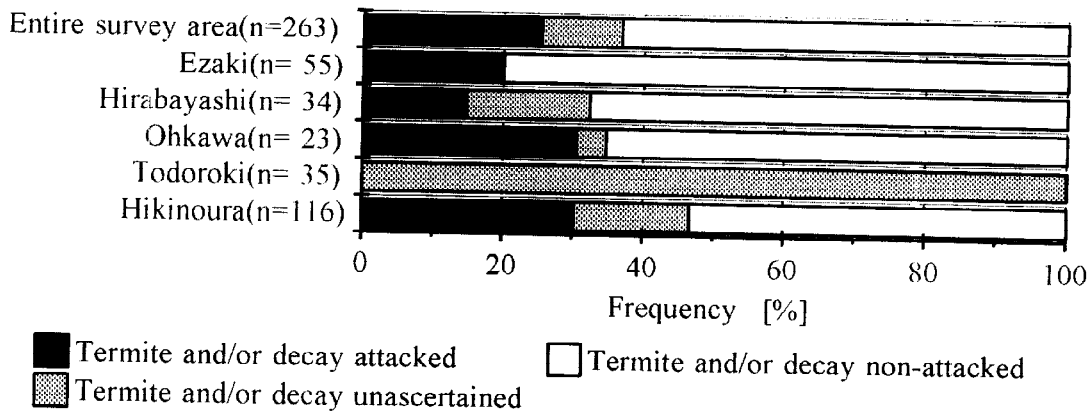
Fig.4. Proportion of wooden-frame buildings affected by termite and/or decay in Hokudancho

and also to the preparation for typhoons. Proportion of buildings affected by termite attack and decay is shown in Fig.4. Although the climate is relatively warm in this region, proportion of buildings affected by termite attack/decay is not necessarily high, indicating good practice of caring the houses by the owners.

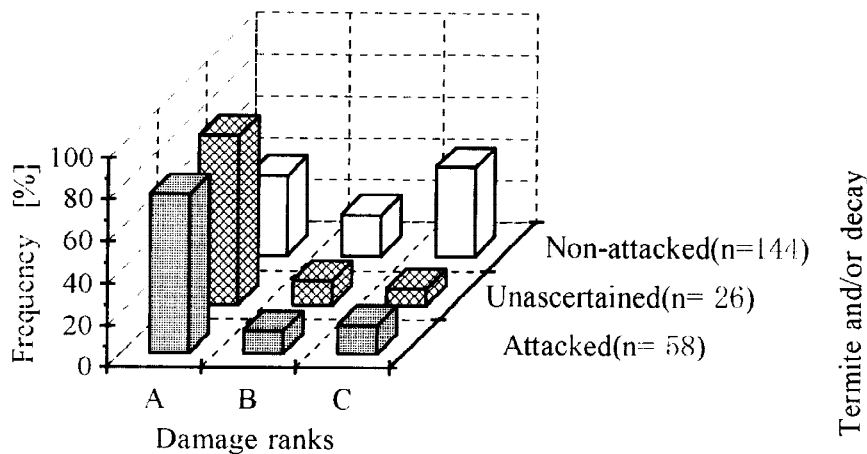
Most of the buildings in the survey area of Hokudancho were tile-roofed, as described above, and therefore it is difficult to tell whether the difference in roofing material caused differences in the earthquake-induced damage. Thus contribution of termite attack and decay to the degree of damage to the buildings will be discussed. Fig.5 shows that 58 of the buildings located in the survey area showed degradation due to termite attack and/or decay. Among these, 75.9% collapsed while 10.3% were partially damaged and 13.8% sustained only slight or no damage at all. Meanwhile, 144 buildings showed no sign of termite attack. Among these, 38.2% collapsed while 19.4% were partially damaged and 42.4% sustained only slight or no damage at all. These figures clearly show that buildings affected by termite attack and/or decay collapsed at a higher rate.

Fig.5. Correlation of damage to wood-frame buildings affected by termite and/or decay. Damage ranks are shown in Table 1.

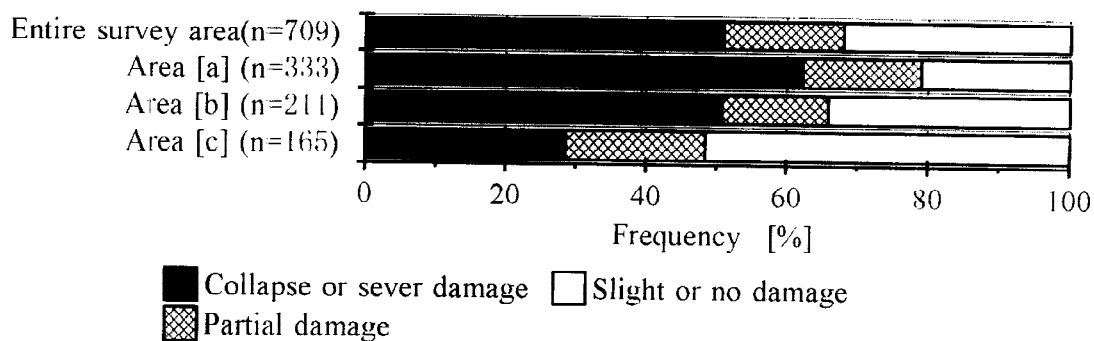
The survey area is within the region registered at 7 on the Japanese closed seismic scale, and over 50% of the buildings collapsed as shown in Fig.6. In area [a] which is bordered by the Japan Railway Tokaido line and the national highway No.2 on both sides, in particular, 60% of the buildings collapsed and 80% of wood-frame buildings collapsed or sustained partial damage. In area [c] to the south which is penetrated by the Hanshin Railway, in contrast, only 30% collapsed. When collapse and partial damage are combined, proportion of damaged buildings is 50%, while half of the buildings sustained only slight or no damage. Extent of damage in area [b] which is located in between is near the average of the entire survey area. In the survey area, degree of damage is found to become less southward from near the mountainous area toward seaside area.

Fig.6. Proportion of damage to wooden-frame buildings in Higashinada ward, Kobe city.

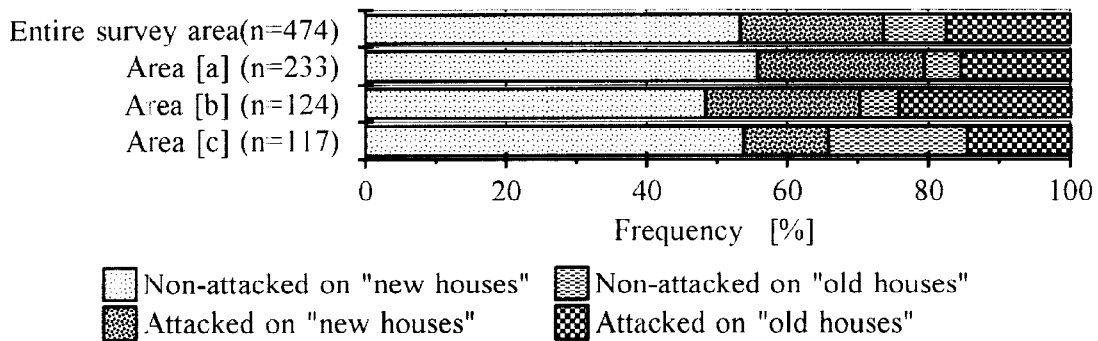
covered by interior and exterior walls. Biological degradation caused by wood decaying fungi and termite, on the other hand, proceed remarkably faster than aging, and therefore results in significant reduction of the strength. Thus lumbers not affected by biological degradation normally maintain sufficient strength even if they are old. Decay and termite attack are often observed at the same time in the same building. The region struck by the Great Hanshin Earthquake was anticipated to be the habitat of the Japanese termite, *Reticulitermes speratus* KOLBE, and, because the mean temperature in January is not lower than 4 °C and the average of the lowest temperatures does not fall below 0 °C, the habitat of the Formosan subterranean termite, *Coptotermes formosanus* SHIRAKI. Slightly higher rate of termite attack and decay was observed in Higashinada ward than in Hokudancho.

Fig.7. Proportions of wooden buildings affected by termite and/or decay in the survey area on Higashinada ward, Kobe city.

Correlation of the years after construction and termite attack/decay was studied by using the estimated age of the building and data excluding those of buildings with termite attack and decay unascertained. As shown in Fig.7, buildings that were less than 30 years after construction (indicated as "new" in the figure) and showed no termite attack and decay formed the largest group. Among buildings that were less than 30 years after construction, 69 to 82% showed no termite attack. Among buildings that were older than 30 years after construction (indicated as "old" in the figure), on the contrary, 43 to 81% showed termite attack.

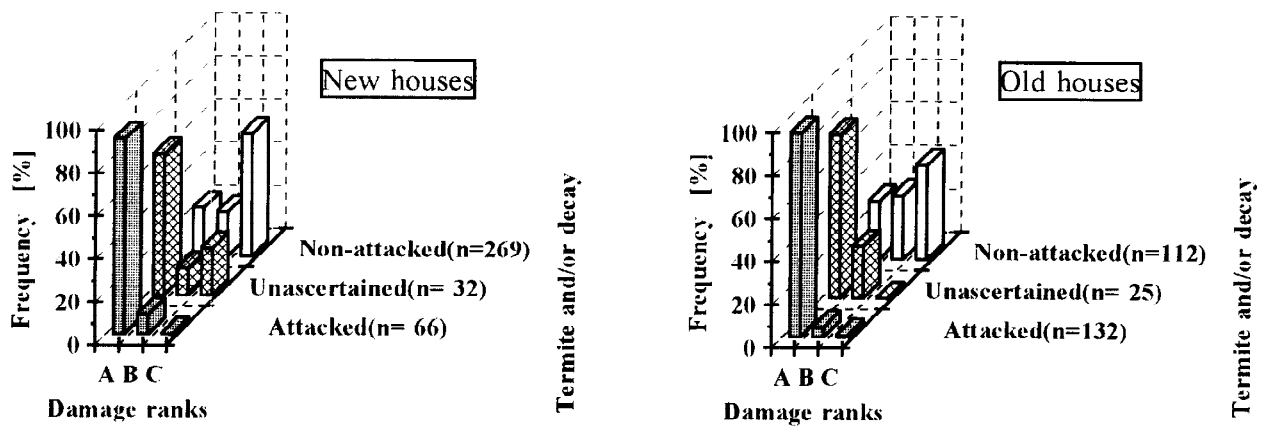
Degrees of damage to buildings with and without termite attack and decay are shown in Fig.8, being classified by the years after construction. It can be seen from this figure, that most of buildings with termite attack and decay collapsed regardless of the years after construction. Those indicated as termite attack and decay being unascertained are buildings so severely damaged that their foundations and sills could not be observed, or had been cleared for the purpose of rescue activities. Among buildings not affected by termite attack in area [a], more buildings older than 30 years were heavily damaged than those less than 30 years in which slight damage is relatively dominant. In areas [b] and [c] to the south of national highway No.2, slight damage to buildings without termite attack and decay is predominant. As these observations suggest, termite attack made major contribution to the damage to buildings.

Fig.8. Degrees of damage to wooden buildings with and without termite attack and decay, classified by the years after construction.
