ANALYSIS OF DAMAGE TO AN SRC APARTMENT BUILDING DUE TO THE FUKUOKA PREFECTURE WEST OFFING EARTHQUAKE

Mitsuyoshi Ishimura¹, Masakazu Terai² and Koichi Minami³

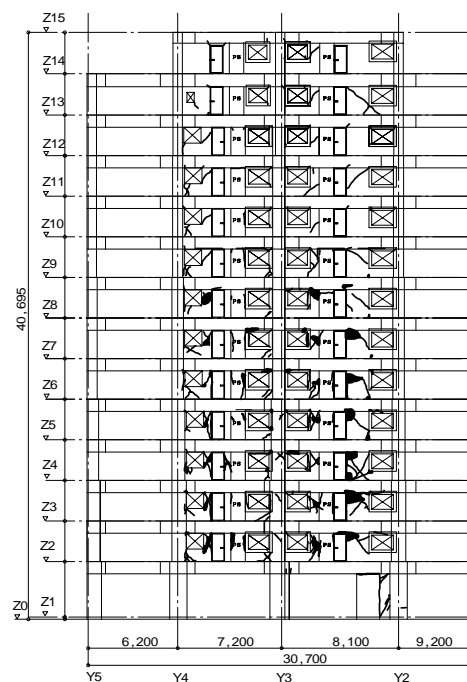
Figure 3 X2 kind of crack situation(unit:mm)

The state of hallway wall cracks on X2 from Y2 to Y4 in the damage investigation is displayed in Figure 3. Looking at the figure reveals several things. First of all, though damage to columns and beams was minor, damage to non-structural walls was considerable. Also, this damage was particularly prominent on the second to eighth floors where crumbling of concrete was observed. It can also be seen that damage decreased as floor number increased from the ninth floor upwards, but damage was still observed up to the highest floor. Based on the results of this investigation and the building design drawing, we conducted allowable stress calculation[2], static elasto-plastic analysis, dynamic elasto-plastic analysis of the mass system model, and dynamic response analysis of the member level, in order to analyze the damage state of this apartment building. From the fact that damage is the greatest in Y-direction non-structural walls, we conducted a comparison between the case of considering this non-structural walling and the case of considering both models with three-way complete slits and a rigid frame model, and attempted to assess the influence that the non-structural walls had on the structure. Regarding non-structural wall analysis, we considered the rigidity level and rigidity zone for the allowable stress calculation and the rigidity zone only for the response analysis.

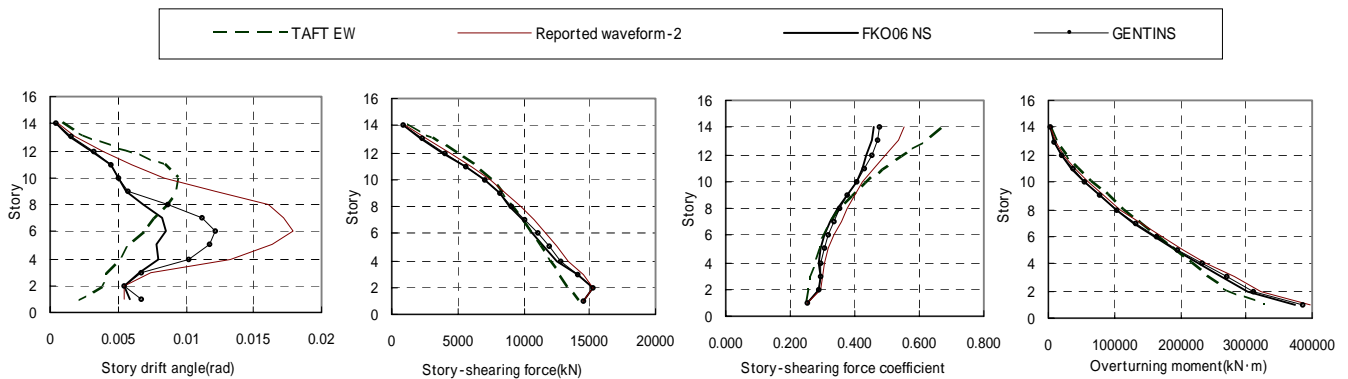
Figure 5 The maximum response in direction of Y of equivalent sheering type model (non-structural wall consideration)

was handled as an instantaneous stiffness proportion. Examples of response calculation results are shown on Table 4, Figure 5, and Figure 6 (TAFTEW, which had a high response level for the observed waveform, and KOKUJI-2, which had a high response level for the reported waveform, are shown). Figure 5 demonstrates that the response to seismic waves for GENTINS in the case of considering non-structural walling is large for this structure compared to the other three observed waveforms. Taking the story drift as an example, the value exceeds 1/100 on floors four to seven. Also, the base shear coefficient was 0.254. It is clear that the impact from the difference of seismic waves had a great influence on the response for each floor but negligible influence on story-shear force and overturning moment. Figure 6 demonstrates that the GENTINS seismic wave response in the 3-way complete slit case was also extremely large, displaying a response that is close to the reported waveform ($Z = 1.0$). Story drift exceeds 1/100 on floors four to nine with the maximum value of 1/59 on the sixth floor. However, the base shear coefficient is from 0.254 to 0.211 of the case without slits, with a result that is approximately 20% lower.

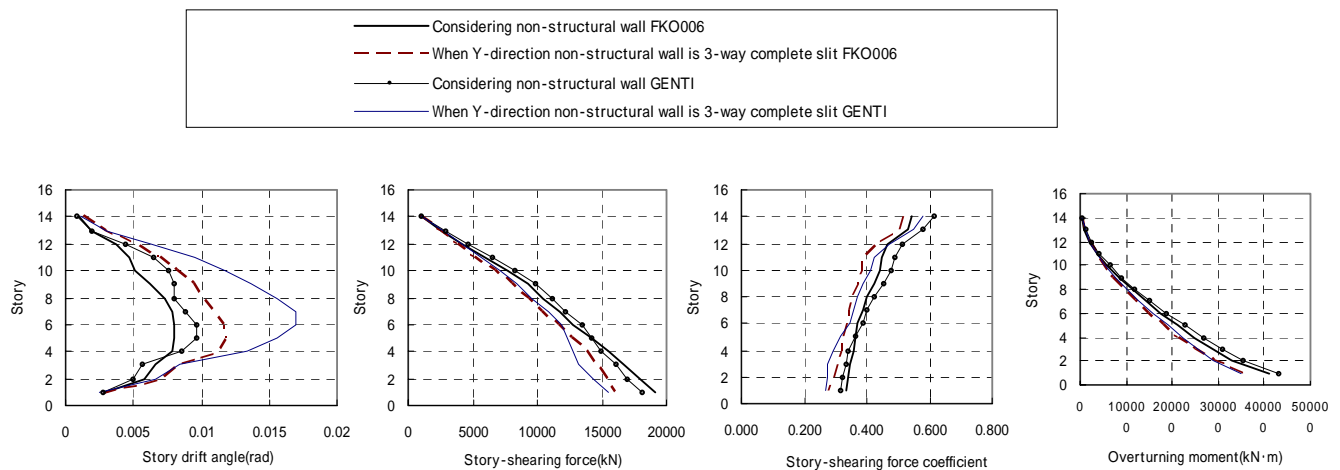
Figure 7 The maximum response in direction of Y of member model type

Y-direction story drift the mass system model is larger on the first floor while the member system model is larger on the fourteenth floor. Other floors have fairly equivalent values in comparison. However, because the seismic waves were entered simultaneously, the member level reaction value was larger than shear force, shear force coefficient, and overturning moment. This result indicates that if design is conducted using the results of a single-directional seismic force, the bi-directionality of seismic force must be considered. Taking the equivalent sheering-type model as an example, story draft is 1/150 and above for floors three to eight in the case of considering non-structural walling and 1/150 and above for floors two to ten in the case of 3-way complete slits. However, the non-structural walling of the structure targeted by this study uses single reinforcement distribution (D10 @ 150) that has no core portion and the structure does not have a drift capacity of a level that can compliment this sort of large story drift. It is conceivable that this led to the formation of large cracks and crumbling and collapsing of concrete [3]. Comparing the case of and non-structural walling and 3-way slits for the maximum base shear coefficient value of the mass system model yields $C_b = 0.25$ for non-structural walling and $C_b = 0.21$ for 3-way slits. Likewise, maximum story drift value yields 1/82 and 1/51, respectively. This data indicates that using slits lessens the operating shear force but increases the drift, and that as long as the drift capacity is sufficient, load capacity can be low. Interpreting these results in a comprehensive manner reveals the following. First, response was as per a model considering non-structural walling at the initial stage in the Y-direction. However, non-structural walling that could not accommodate deformation when such deformation became great crumbled, giving a response that approximates the 3-way slit model. Moreover, the response spectrum map shows that a reduction in the acceleration response spectrum due to a decrease in rigidity level did not occur, and an even further increase in deformation occurred as seen in Figure 5 and Figure 6. However, from the fact that damage to columns was negligible, deformation approximating 1/150 seen in the analysis results from the 3-way slit model cannot have occurred. That is to say, it is likely that the damage to non-structural walling in this area contributed effectively to energy absorption, displayed a responsive condition lying between the non-structural walling model and 3-way slit model, and reduced impact to the columns and beams. This damage to non-structural walling can also be thought of as being effective in reducing story drift to the overall structure [3].
