BOUMERDES ALGERIA EARTHQUAKE OF MAY 21, 2003: DAMAGE ANALYSIS AND BEHAVIOR OF BEAM-COLUMN REINFORCED CONCRETE STRUCTURES

M. Belazougui¹

¹ Director of the Centre National de Recherche Appliquée en Génie Parasismique, CGS.

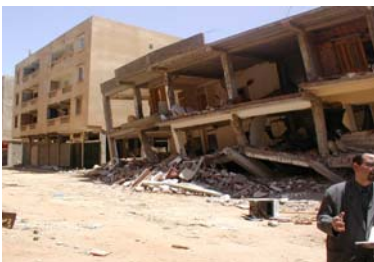
- Presence of soft storeys, generally at the ground zero (first storey) used as car parking or stores , with lack of infill and/or height greater than for upper storeys (Photo 4.1)
- Short columns in « vides sanitaires » (crawl spaces under the first story) and between upper windows of classrooms (Photos 4.2)
- Use of irregular building configurations with severe discontinuities in mass, stiffness, strength, and ductility resulting in torsional effects and stress concentration
- Use of very heavy roofs
- Use of "strong girders / weak columns" and masonry-structure interaction (Photo 4.3)
- Use of important and heavy cantilevers
- Insufficient dimension of the seismic joint (between two blocks of the same building, or between two buildings)
- Use of many heavy ornamental elements at building facades, as well as unnecessary parapets on the roofs

Photo 4.1: Soft (First) storey

- Classify the Algiers and Boumerdes wilayas in higher seismic zone of the seismic building code (that has been done in new version of seismic code "RPA 99/2003")
- New and precise regulatory requirements to avoid the soft story phenomena in first story of current buildings (also included in "RPA 99/2003")
- More severe requirements for beam-column systems in order to lessen the future damages in this kind of reinforced concrete buildings; in addition to the new requirements introduced in "RPA 99/2003", we have to think about other requirements and arrangements to make reinforced concrete columns and beam-column joints more seismic resistant.
- More training and better organization of the building staff and professions to improve quality in design and execution.

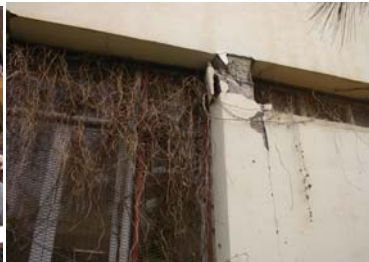
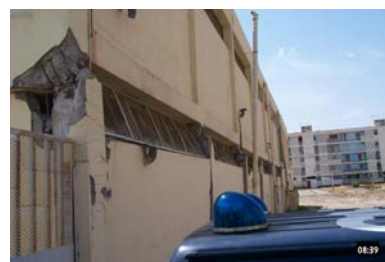
Photo 4.2 (a) and 4.2 (b): Short columns

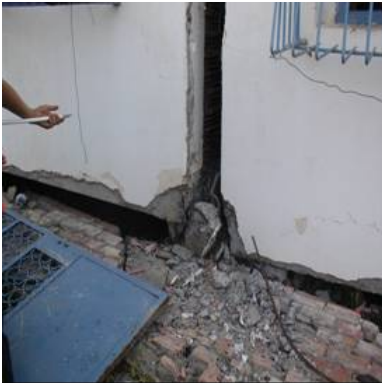
Photo 4.2 (c): Short columns

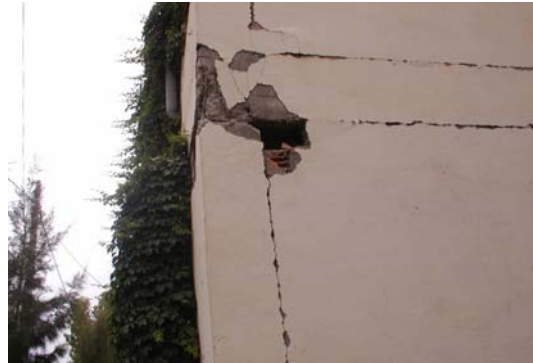
Photo 4.3: Masonry-structure interaction

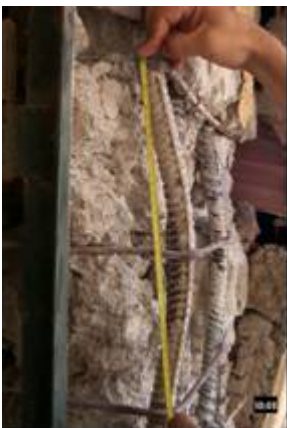
Photo 4.5: Non adequate detailing

4.2.4 Inadequate proportioning and detailing of structural elements (Photo 4.5)

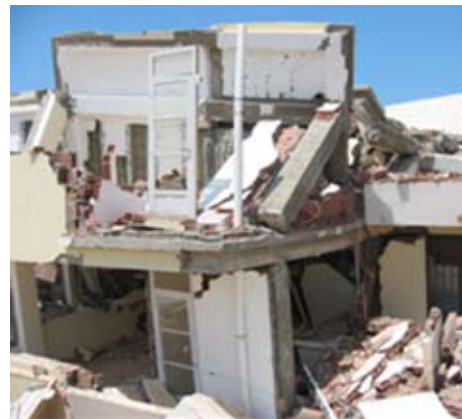
In this framework we can note the very low strength of concrete (average of 14-17 MPA instead of 25 MPA required by the standards for current buildings) and the very inadequate recastings of concrete in columns (Photo 4.4).

Photo 4.4: Poor concrete quality and execution
