DETAILED ANALYSES OF STEEL AND REINFORCED CONCRETE BUILDINGS DAMAGED BY THE 2003 BAM EARTHQUAKE IN IRAN

N. Hosseinzadeh

Assistant Professor, Dept. of Structural Engineering, International Institute of Earthquake Engineering and Seismology (IIEES), Tehran, Iran, Email: hosseinz@iiees.ac.ir

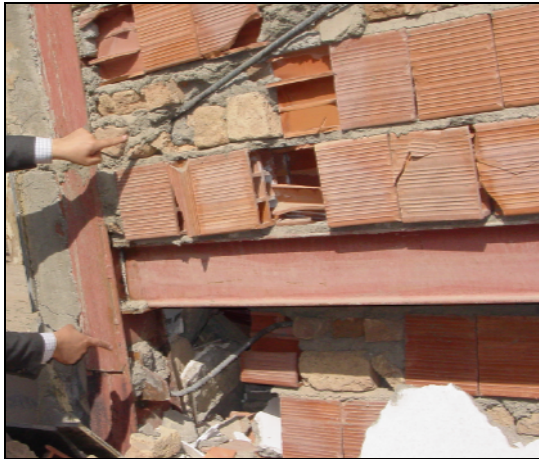
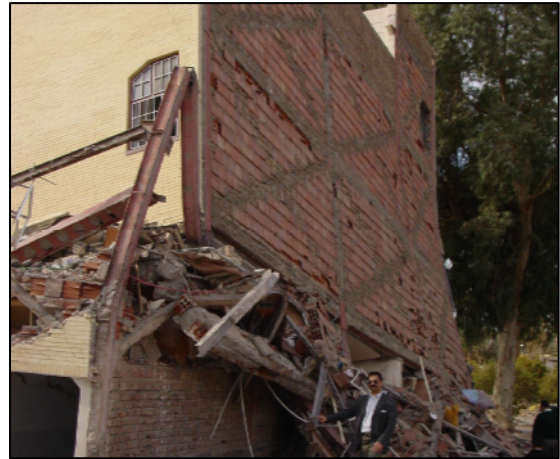
The North and South view of this 5 story residential steel braced building (Kimia building) is shown in Figure 3. The lateral load resisting system of this building was diagonal bracing in East-West direction and a simple frame was considered in North-south direction. As shown in these Figures, the bracings in second and third floors fractured and a lateral movement of about 400 cm, occurred in these floors. The remaining upper floors (4 and 5) collapsed by aftershocks. Failure of the slender rod braces ($\varnothing 18$) with very weak connections led to a dramatic reduction in lateral strength and stiffness of the building in floors 2 and 3.

Figure 3 North view of building ST1 and failure of bracing connections

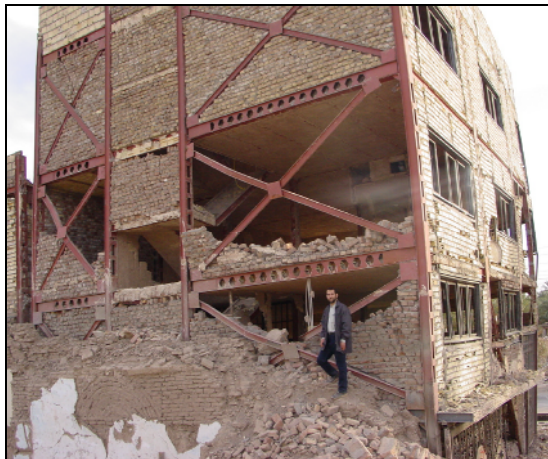
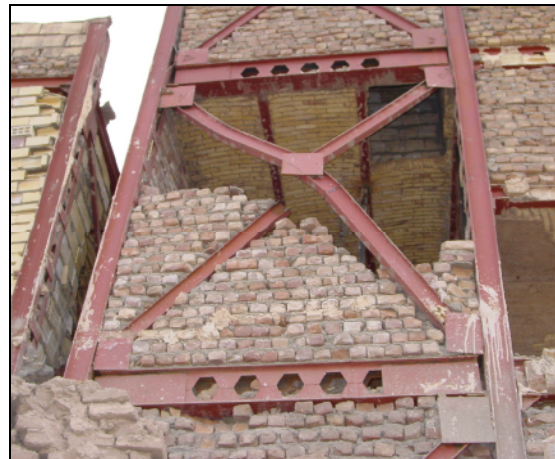
The North view of this 4 story braced building (Residential Building) is shown in Figure 4. Cross bracings in the second and third floors of this building failed during the earthquake. Lateral deformations of about 40 cm occurred in the second and third floors. Fracture of tension brace member connections and buckling of compression members were the main modes of failure of this building. Fracture of connection plate between column and gusset plate was another type of failure.

Figure 4 North view of building ST2 and failure of bracing connections

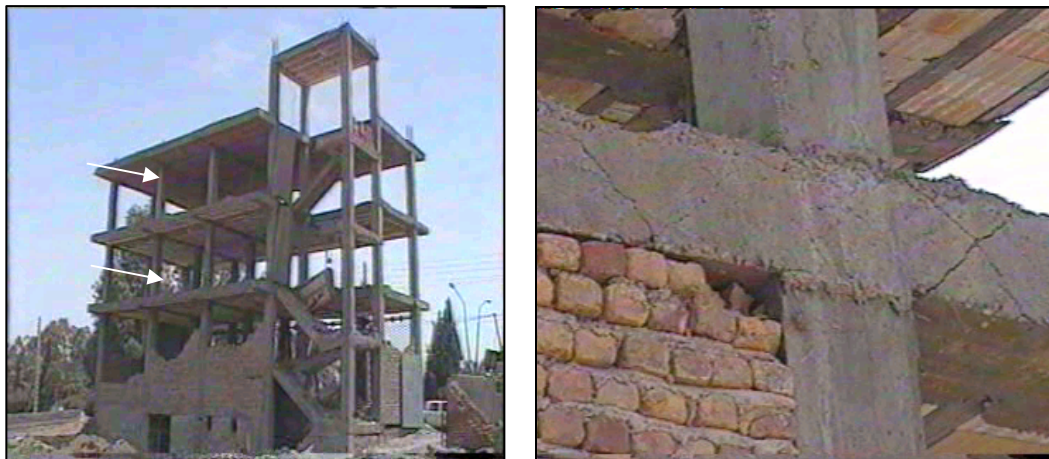
General view of this four-story reinforced concrete (RC) building is shown in Figure 5. This building was under construction, and about 90% of total gravity loads applied during the earthquake. Typical column sections is 35×35 cm with longitudinal bars of 8 ϕ 18, and typical beam sections is 30×30 cm with 6 ϕ 18 reinforcement. A shear reinforcement of ϕ 6@30cm has been used in all beam and column sections. Insufficient development length of the stair case bars in connection to the frame caused the collapse of the staircases in top stories. Diagonal shear cracking of beams is another damage pattern. However, limited and repairable seismic damage has been observed in this building during the Bam earthquake.

Figure 5 General view and diagonal cracks in beam elements of building RC1

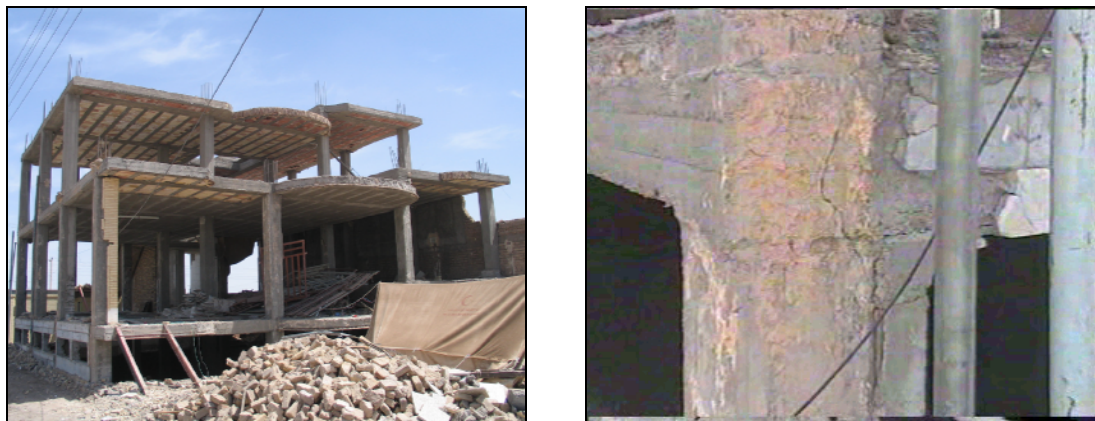
General view of this three-story reinforced concrete (RC) building is shown in Figure 6. This building was under construction during the earthquake. Beam, column and reinforcement details of this building are similar to RC1. Cracking in beam-column connection zone was the only damage pattern observed in this building.

Figure 6 General view and cracking in beam-column connection zone of building RC2
