LESSONS LEARNED FROM YOGYA AND ACEH RECOVERY PROGRAM

Made Suarjana¹ and I Wayan Sengara²

^{1,2} *Civil Engineering Dept. and Center for Disaster Mitigation, Institut Teknologi Bandung, Indonesia
Email:msuarjana@si.itb.ac.id*

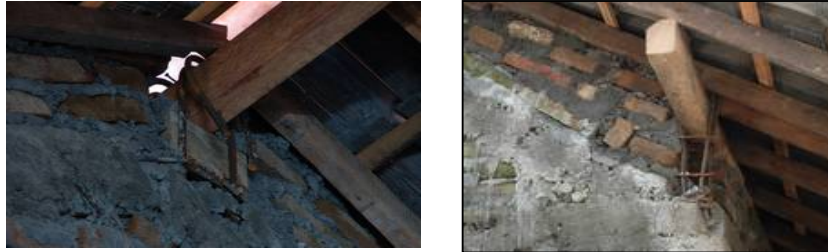
Figure 3. Column reinforcement hooked to the timber ridge and rafter

- In most cases, beam and column reinforcements are terminated without hook and therefore installed with inadequate embedment length. In many cases column reinforcements are not terminated inside the concrete but extended as if function to tie the roof timber frames. This results in two very serious problems, namely ineffective reinforcement hook and timber frames without adequate anchorage to the concrete. See Figure 3.
- Reinforcement hooks, if provided, often with incorrect form (Figure 54)
- Reinforcement splice often located in the highly stressed region and without adequate stirrup (stirrup clearance 18 cm).
- In some cases timber frame joints are not properly bolted or not tied with steel belt where required by design. Almost all without adequate anchor to concrete frames.

In the original design, the detail for timber frame attachment to concrete is not provided. In the construction, in some cases the timber frame are tied, incorrectly, by extended and exposed column reinforcement, in some cases the frame are not tied at all. We propose to use anchor bolt embedded in concrete to tie the timber

elements as shown in Figure 8. Since we propose to use concrete for the roof main frame, only ridge beams and rafters are constructed from timber.

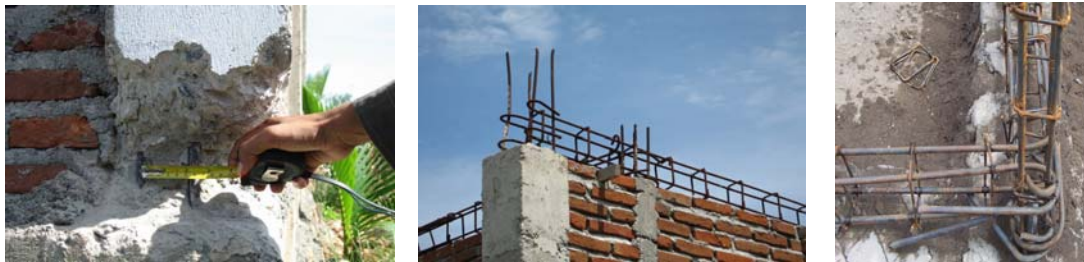
- For Aceh, the large number of houses to be built and variations in structural element sizes could create logistic problem. Some concrete member found constructed with stirrup shape and size intended for smaller members resulted in very close longitudinal reinforcement spacing. The mistakes were camouflaged by concreting with correct column sizes (Figure 4).

Figure 4. Incorrect stirrup dimension and joint details

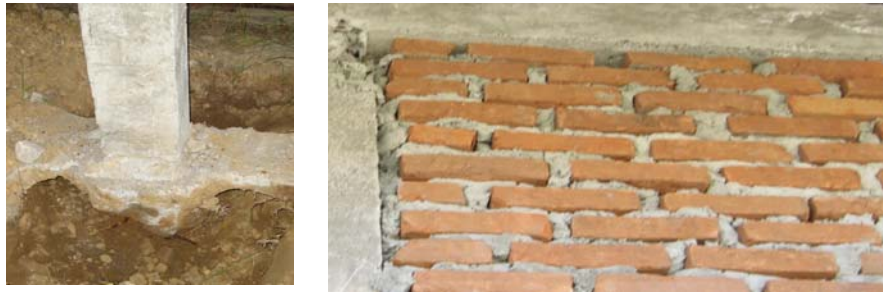
Figure 5. Missing foundation under column and brick detail

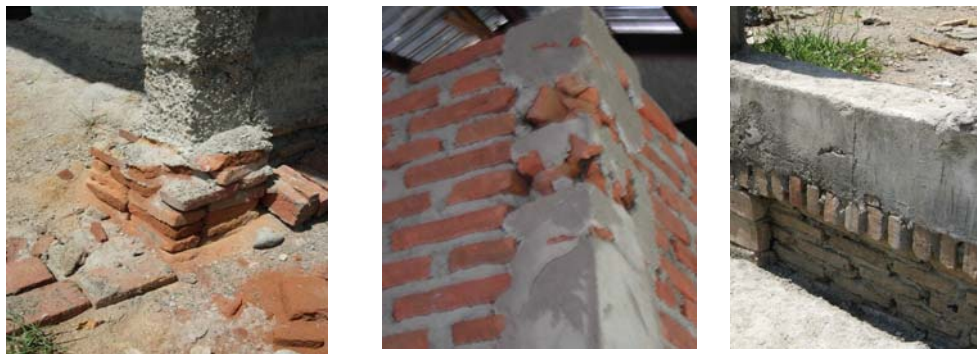
- Thick mortar is very common, sometime as thick as the brick.
- Vertical inter-brick not always filled by mortar.
- Sometimes brick attached directly to concrete frame (column or beam) without mortar for bonding the two materials.
- There are cases where brick used as substitute for stone as shown in Figure 6.

Figure 6. Brick for foundation, as concrete aggregate and for retaining wall

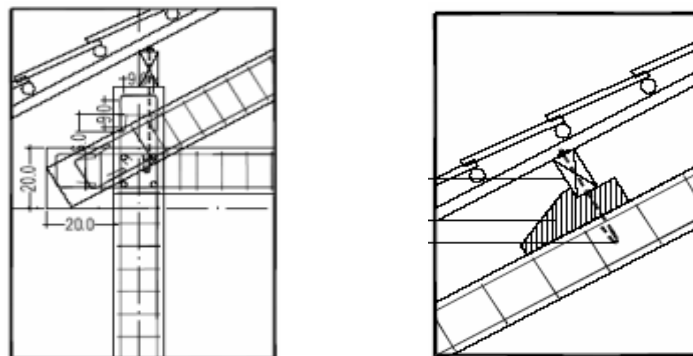
Figure 8. Beam column joint and timber to concrete anchorage details

In the original design, detail for beam column joint and reinforcement anchorage are not provided, resulted in incorrect construction as presented above. For small houses, (150x150 mm²) columns and beams with four diameter 10 mm deformed reinforcement bars are shown to be adequate by the analysis. However the beam and column width do not provide adequate space for hooked embedment length, therefore we propose to extend the column and beam to the opposite side of the joint to provide the required space for embedment length as shown in Figure 8.
