OBSERVED BEHAVIOUR OF EARTHEN STRUCTURES DURING THE PISCO (PERU) EARTHQUAKE OF AUGUST 15, 2007

M. Blondet¹, J. Vargas² and N. Tarque³

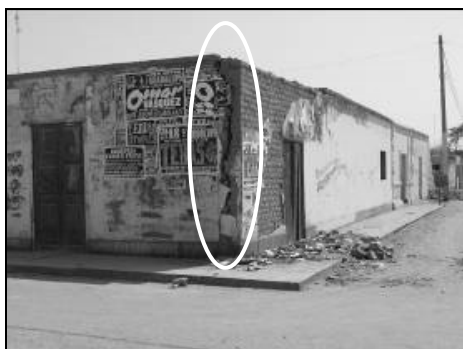
The most common failure observed in earthen buildings, especially in those with thin walls, was the overturning of the façade walls and their collapse onto the street. This was caused because the wall strength in the intersection between the façade wall and the other house walls was too low to withstand the earthquake's movement. The walls usually collapsed as follows: first vertical cracks appeared on the wall's corners causing the adobe blocks in that area start to break and fall (Figure 4). This triggered the walls to disconnect until finally the façade wall turned over (Figure 5). The situation was worsened by the fact that separation joints between the buildings seems to be an uncommon practice in the area. Consequently, the direct contact between the walls during seismic activity leads to their collapse.

Figure 4 Vertical cracks in the wall's corner.

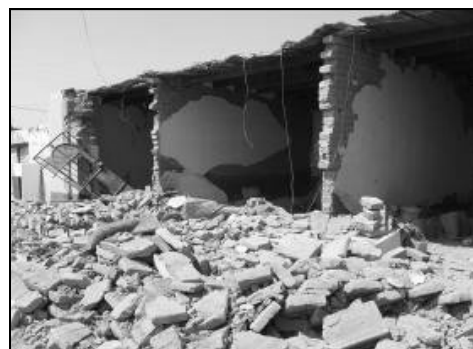
The observations made after the earthquake have shown that the magnitude of the damage that the buildings suffered when their walls collapsed, was directly related to whether the roof's wooden joists were supported on the façade wall or not. If they were supported by the façade, the wall's collapse caused them come off balance, causing the roof to collapse as well. If, on the other hand, the joists were supported by the walls that were perpendicular to the façade wall, the roof didn't fall apart (Figure 5).

Figure 5 Collapse of the façade walls in adobe buildings.

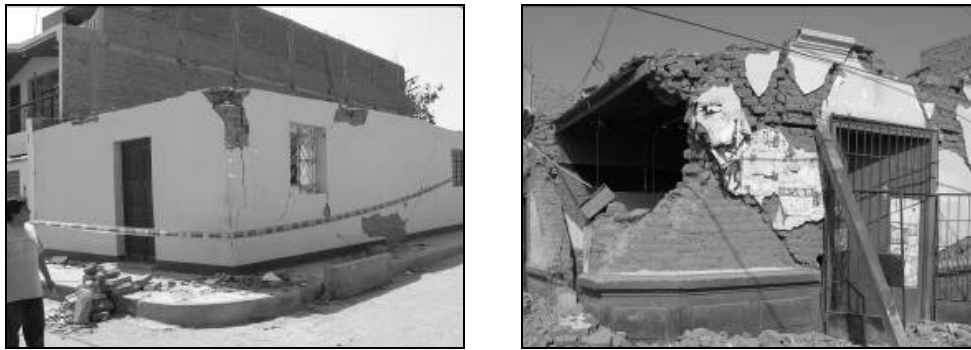
Many adobe buildings located on street corners suffered from heavy structural damage due to the collapse of their two façade walls and roof. The cracks produced on the corner between these two walls are both vertical and diagonal. The diagonal cracks extend from the highest part of each wall's corner down to the house base, forming a 'v' like crack pattern (Figure 6).

Figure 6 Diagonal and vertical cracks shown on corner buildings.

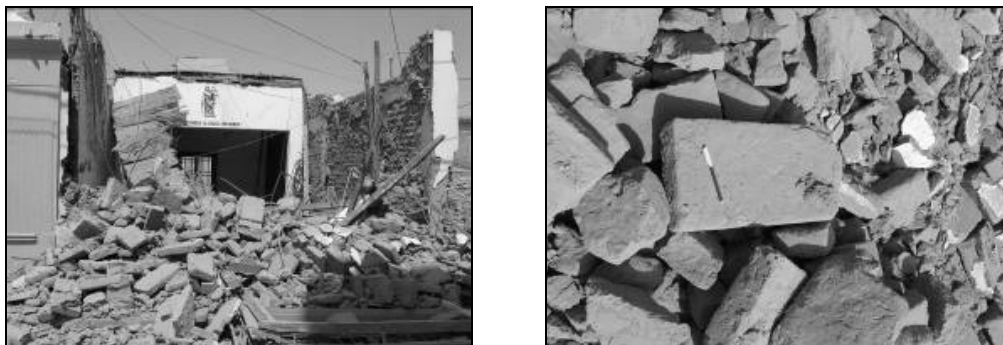
The adhesion between the adobes and mortar in most collapsed or heavily damaged walls (especially in the ones belonging to the more recent buildings in Pisco) is quite poor and weak. When the adobe walls collapsed, most of the adobe blocks that were used for these constructions didn't hold together with the mortar and crumbled (Figure 7). It is presumed that, as it is obtained from a coastal area, the soil used for the making of the bricks and mortar contains too much sand and too little clay, producing as a result a weak bond between the mortar and the adobe blocks. Unfortunately clay is the only soil component that, as a reaction to water contact, causes the soil particles to chemically bond. In some of the houses in the area, it was observed that the adobe used for the constructions would easily crumble when scratched with the nail.

Figure 7 These images show the weak bond between the mortar and the adobe blocks.

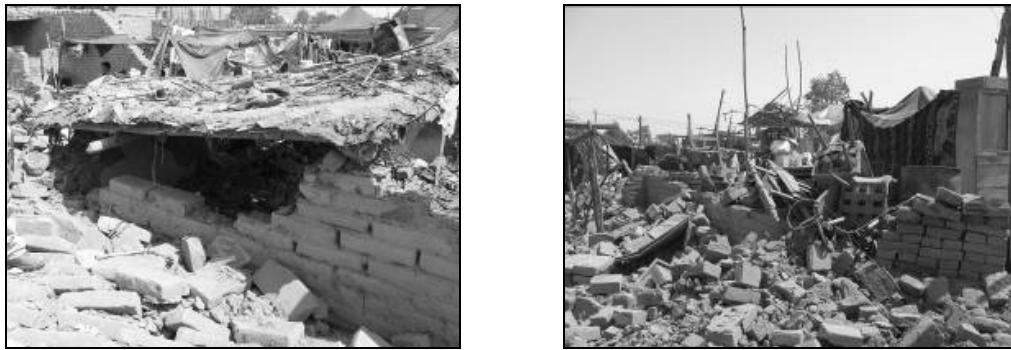
Some of the more recent buildings located on the developing areas around Guadalupe and Ica have been constructed without taking seismic security guidelines into consideration and are, therefore, more susceptible to suffer damage due to seismic activity than the older constructions in the area. The walls on the modern buildings are more susceptible to collapse due to out of plane loads as they are narrower (with a 0,25 m thickness) and more slender than the older walls. Many of the houses in the area only have 1 or 2 enclosed rooms, and many of them have enclosure walls constructed using adobe. The roofs were built using wood that was covered with crushed cane, straw mats, cardboards or sandbags, used as insulation to keep the house inhabitants warm. The floor of the houses is usually moistened soil that has been compacted. Most of the dwellings constructed following this model collapsed during the earthquake (Figure 8).

Figure 8 Collapse of buildings located on developing urban areas.

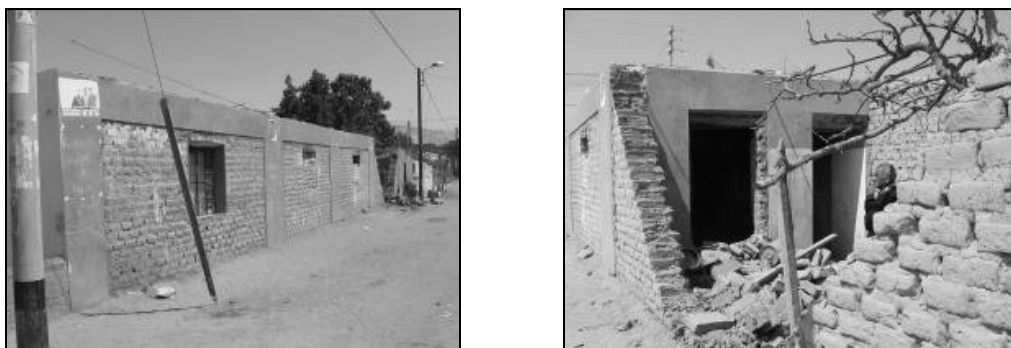
Between September 1998 and January 1999, a pilot plan was introduced by the CERESIS (South American Regional Center for Seismology) - GTZ (German Cooperation Agency) - PUCP project to reinforce adobe dwellings (San Bartolomé et al. 1999). 19 adobe constructions located in different areas all throughout Peru were reinforced to withstand seismic activity. The reinforcement system consisted on electro-welded steel mesh strips nailed to the walls and covered with cement and sand mortar. Vertical reinforcing strips were added to the walls' intersections and horizontal strips placed on the highest part of the walls. Two of these reinforced houses are located in the villages of Pachacutec and Guadalupe in Ica. None of these buildings suffered from any damage related to the earthquake. The reinforcement applied to these dwellings prevented the formation of vertical cracks. After the reinforcement was applied to the house in Guadalupe (Figure 9a), an enclosure wall was built by its owner without taking any seismic reinforcement considerations into account. This wall collapsed as observed in Figure 9b.

b) Collapsed enclosure wall

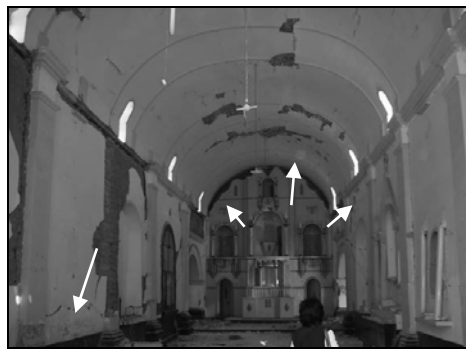
- Horizontal cracks on the lateral walls at about 1/3 of their total height (Figure 11a). These cracks can even break through the earthen pilasters (Figure 11b), causing the walls to collapse.
- Diagonal cracks on some of the lateral walls.
- Detachment of the choir (Figure 11c) and the altar's wall (parallel to the façade) from the church's lateral walls and cylindrical vault ceiling (Figure 11a).
- Detachment of the towers from the rest of the church (Figure 11d).
- Appearance of vertical cracks and fissures on the church towers (11d).
- Humidity related damage.

a) Detachment of the main

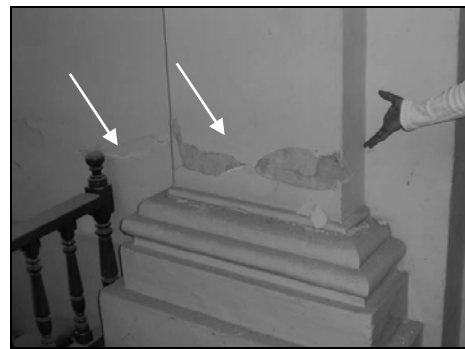
b) Horizontal crack in pilaster

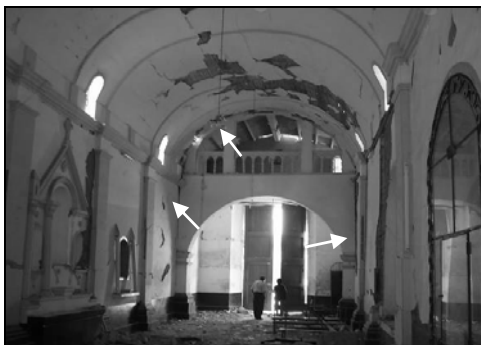
c) Detachment of the choir from the vault

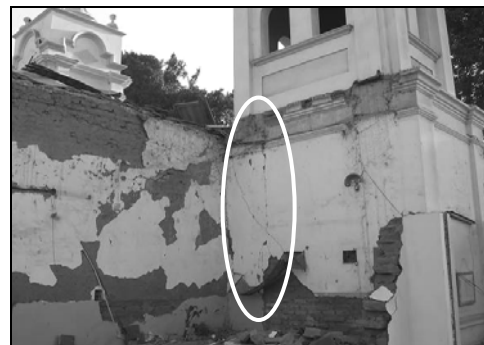
d) Vertical cracks on the intersection between the tower and walls

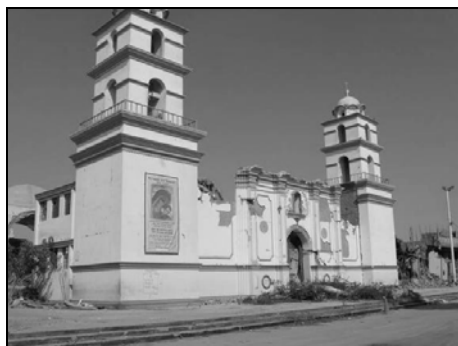
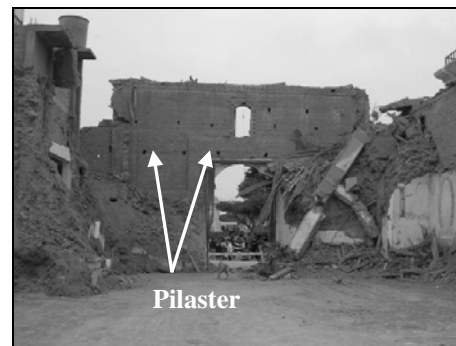
Figure 12 Church “San Clemente”.

This was the main church in Pisco and dates back to the XVIII century. Its façade was constructed using fired clay bricks masonry (Figure 12a) and its most outstanding feature were the two 4-storey high towers and 4 pilasters (that simulated columns) located equidistantly from the main entrance to the church (Figure 12b). The church’s lateral walls were built using adobe. The church had a cylindrical vaulted ceiling that was constructed using wooden arches and crushed cane covered by a mud and gypsum stucco. The roof rested on the lateral walls and the main altar’s wall had been reinforced using concrete frames. This reinforcement was probably a latter addition to the structure, most likely done during a more recent restoration of the church. There were 300 people attending a mass when the earthquake happened. About half of them died when the roof and walls collapsed. It is possible that the church’s collapse initiated with the cracking and overturning of the lateral walls, to which the roof followed.
