Damaging Effects of the Pisco-Chincha (Peru) Earthquake on an Irregular RC Building

O. Kwon

ABSTRACT :

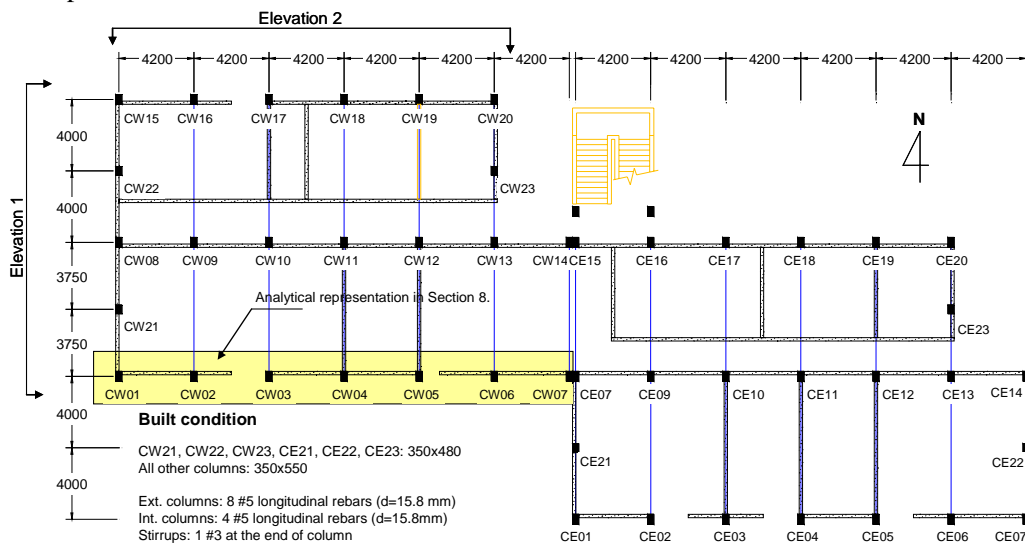
Figure 1. First floor plan of the reference building

The reference building was used as a class room and a chemistry lab. The building was a two story reinforced concrete structure and consisted of 12 bays in EW direction and 3 bays in NS direction, Figure 1. The building was constructed as two independent modules separated at the center of EW direction. Two modules had completely independent gravity load carrying system by separation of slabs and beams at their interface. Stair wall was also an independent module. Span dimension of each bay were 4.2 m x 8.0 m. At the east and west face of the building, additional columns (CW21~23 and CE21~23) were constructed on the first floor to support gravity loads of full-height infill walls on the second floor, Figure 1. The second floor of the building has similar plan with the exception of the existence of many partition walls at certain span of the floor which causes large gravity load on the first floor columns. The load was mainly carried by column CW06, CW07, CW14, and CW13 in Figure 1.

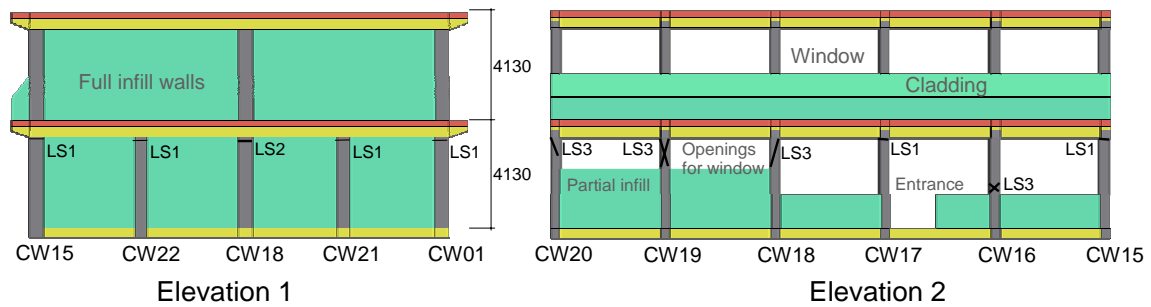
Figure 2. Elevation the west and north face of the building

Figure 2 illustrates the west and north face elevation of the building. Exterior walls facing east and west were story-high infill walls, Figure 2 (a). Partial height infill walls were placed between most columns in north and south face of the building, Figure 2 (b). Most of them had openings for windows. Some of the infill walls had openings used for entrances. Infill walls were made of clay bricks with 175 mm thickness. The second floor slabs were extended as cantilevers. Cladding was constructed on top of the cantilevered slabs to expand usable floor area. Story heights for both floors were 4.1 m. Column dimension of the building were 350 mm x 550 mm for all columns except intermediate columns in west and east face. Eight #5 (dia. = 15.8 mm) longitudinal reinforcement bars were used for exterior columns and four #5 bars were used for interior columns. Minimal amount of stirrups were used in columns; only one #3 (dia. = 9.52 mm) stirrup was used at the end of column and thin smooth wires with 5 mm diameter were used to hold longitudinal rebars in place. Beams were 350 mm x 650 mm including 250 mm thick slab. The lack of damage to the beams and slabs resulted in their rebar dimension not being measured since the rebars were not exposed.

LS1: Serviceability state (insignificant cracks)
LS2: Moderate damage state (loss of cover concrete, exposure of longitudinal bar)
LS3: Complete loss of capacity (buckling of longitudinal rebar, fracture of stirrups, loss of core concrete)

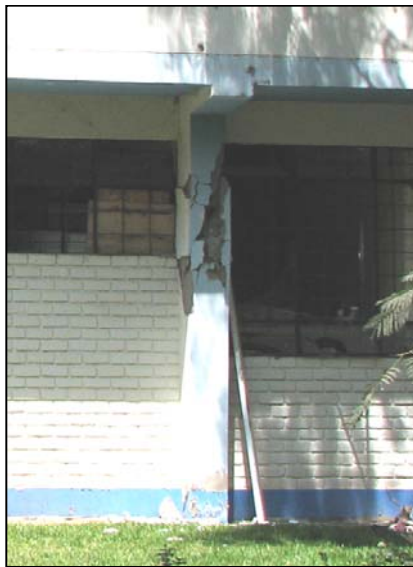
Partial infill walls were constructed between columns in EW direction. Some of the infill walls experienced minor cracks and crushing at the corners. But most infill walls remained intact. The damage pattern of the columns showed that the infill walls shortened the effective length of columns. The shortened columns reduce structural periods, which in general increase seismic force demand. In addition, the shortened columns are subject to non-ductile shear failure rather than ductile flexural failure. Figure 3 (a) shows one example of column failure from the earthquake. The left side of the column has higher infill wall than the right side. The difference in the height of infill walls lead to non-symmetric deformation capacity of the column. Hence shear cracks developed in one direction. It can be easily noted from the marked damage patterns in Figure 2 that columns with less restraint from infill walls, CW15 and CW17, suffered less damages than columns with more infill wall restraint.

(a) Shear failure, CW18

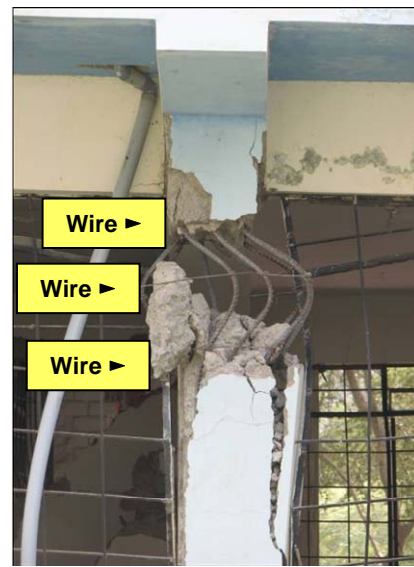
Damaged columns exposed diameters and number of longitudinal bars as well as those of stirrups in columns. Figure 3 (b) shows a close-up view of one of the damaged columns, which revealed stirrups and longitudinal reinforcements. It can be clearly seen that in most columns, smooth wires with diameters of 5 mm or less were used instead of regular deformed reinforcements. The longitudinal bars buckled as the weak stirrups couldn't provide enough confinement to core concrete. In addition, the number of stirrups was not enough to provide resistance to shear force demand. The combination of increased shear force demand from column shortening with reduced shear capacity and ductility from inappropriate stirrups are the most likely cause of the column failures.

(b) Inappropriate stirrups, CW06

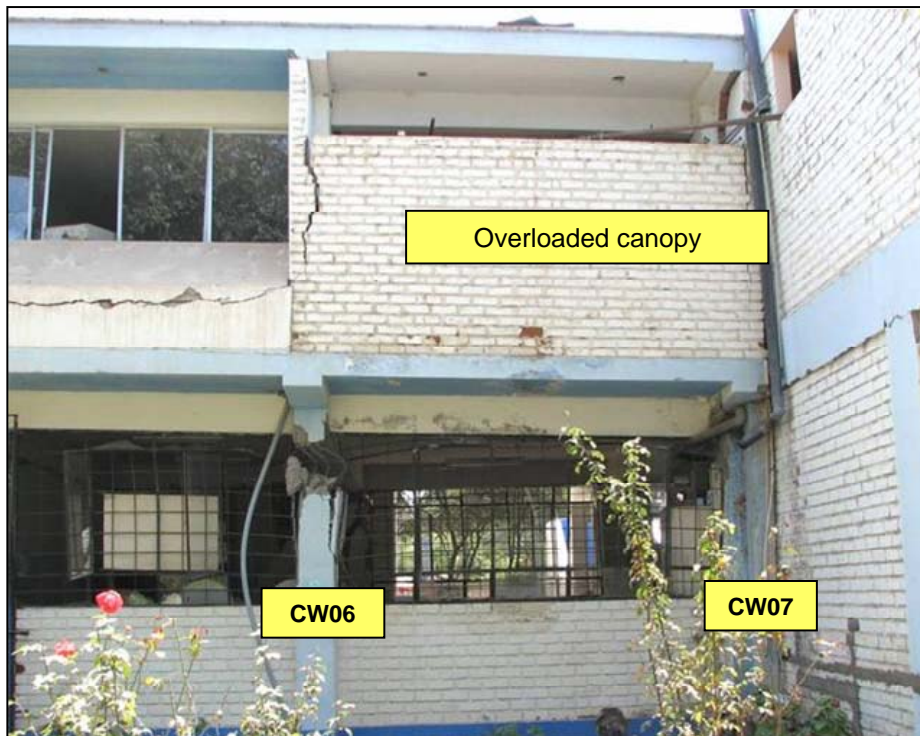
The columns in the west module were much more severely damaged than those in the right module, even though the layout of columns and beams were almost identical. Columns CW04, CW05, CW06, and CW07 in particular were severely damaged and shortened due to loss of core concrete, Figure 3 (c). A closer look at the plans of the second floor and load carrying system revealed that the columns in the west module might have been overloaded in comparison with those in the right module. The west and east face of the building had intermediate columns between major columns to support gravity load of full-height infill walls on the second floor, Figure 1. Hence, it is expected that if there is significant dead load

equivalent to the infill all of full story height, the dead load should be distributed to additional columns. From field observations, however, it was found that the span surrounded by columns, CW06, CW07, CW14, and CW13, was heavily overloaded with partition walls. In addition, there was fairly heavy cladding on the canopy of the overloaded span, Figure 3 (c). These gravity loads seem to be larger than the full-height infill walls on the east and west face. Hence the columns of this span may have carried larger gravity loads than design loads. Crushing and shortening of the columns of this span might have redistributed gravity loads over other columns resulting in subsequent failure of columns.

(c) Overloads from infill walls and canopy
