THE 15 AUGUST 2007 PISCO, PERU, EARTHQUAKE - POST-EARTHQUAKE FIELD SURVEY

J.E. Alarcón¹, F. Taucer² and E. So³

ABSTRACT :

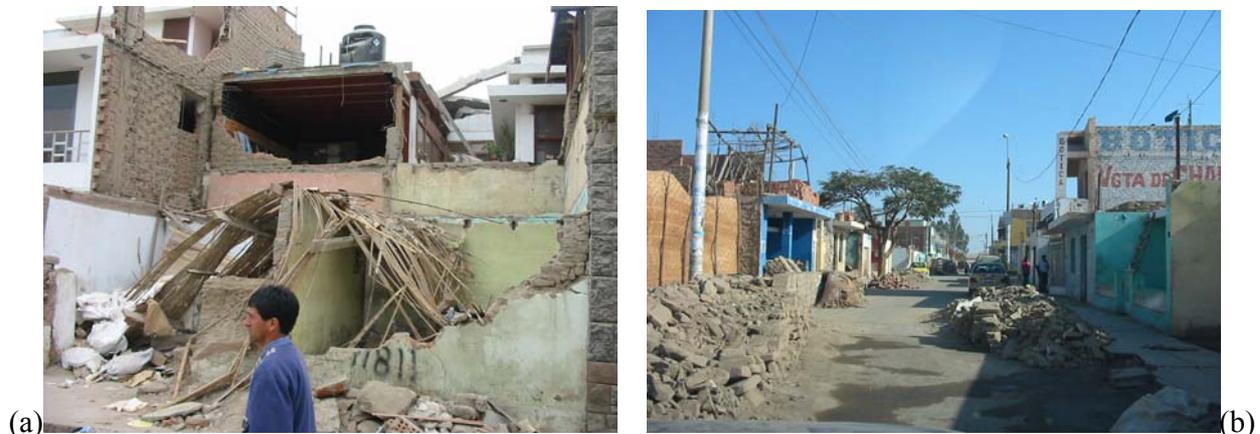
Non-engineered structures in the earthquake affected region can be classified as traditional earth structures, masonry structures and infilled reinforced concrete (RC) frames. Most of the non-engineered houses in the region are made of adobe, from which about 80% of the existing houses collapsed during the event (see Figure 5) or were demolished after it for being severely damaged during the shaking (INDECI personal communication). The collapse of adobe structures is due mainly to heavy mass that induce large inertial forces from the earthquake in combination to the very low strength with respect to the density of the material. These factors usually lead to failure of the material in a brittle manner, thus not allowing for energy dissipation and giving no warning to occupants before collapse. However, during the Pisco earthquake, the characteristics of the ground motions induced (i.e. very long duration distributed in three phases) allowed people to evacuate their

Figure 5. (a): Collapsed adobe house in Ica. (b): Debris of adobe houses in Guadalupe

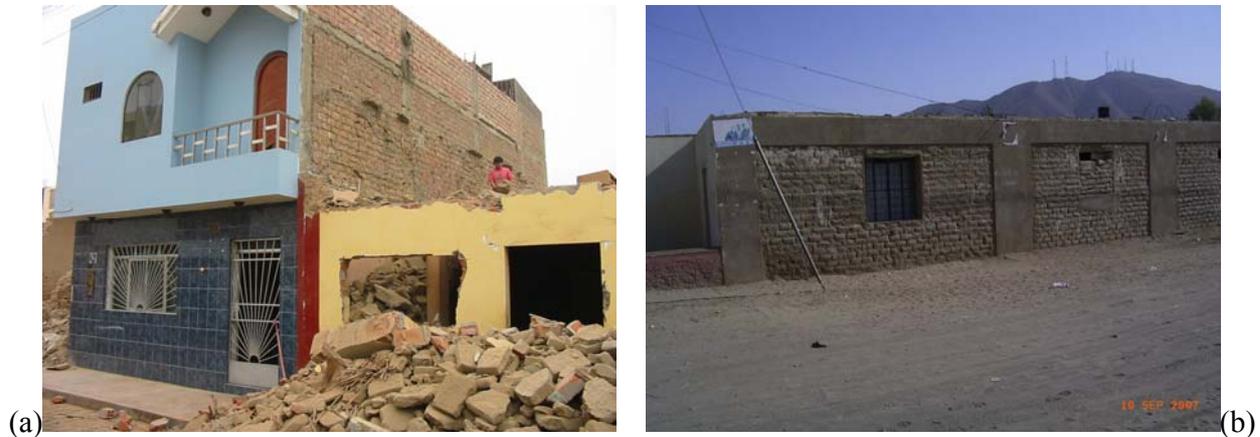
A few examples of adobe houses designed or retrofitted for earthquake resistance prior to the disaster event were found in the towns of Guadalupe, Zúñiga and Huangáscar. They all performed satisfactorily during the earthquake. In the town of Guadalupe, an adobe house was upgraded by the Universidad Pontificia Católica del Perú (PUCP) by means of strips of steel net tied and plastered to the exterior and interior surfaces of the adobe walls (Figure 6b). All other adobe houses near this retrofitted house suffered medium to severe damage or collapsed. In the town of Zúñiga a new two-storey house built by the Japan International Cooperation Agency (JICA) resisted the earthquake with minor damage (for more details the reader is referred to Taucer et al., 2008).

Figure 6. (a): Collapsed adobe house besides a RC confined masonry in Ica. (b): Strengthened adobe house

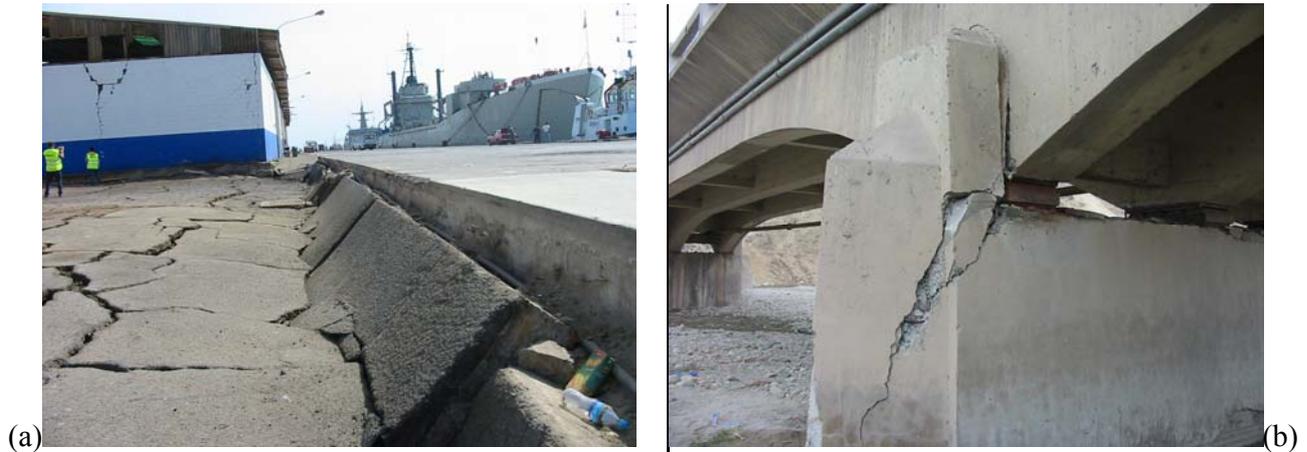
Two key Peruvian ports are located along the affected region: the ports of El Callao and San Martín. The activities of the first port were not affected by the event but damage associated to poor soil conditions was reported in the areas adjacent to it. On the other hand, severe damage was observed to the access to the dock of San Martín port due to settlements and lateral displacements of the underlying soil (Figure 7a). The soil on site is composed of a conglomerate of angular stones of up to 150 mm in size, mixed with sand. These settlements reach values of up to 1.2m with respect to the dock structure (an 18 m wide reinforced concrete 0.55 m thick slab supported on 0.6 m diameter circular steel piles spaced at 4 m) which did not suffer damage. According to information from local authorities, some damage to the dock access was caused during the main shock, but it increased severely with the occurrence of aftershocks during the following weeks.

Figure 7. (a): Severe damage to the dock access in San Martín port. (b): Detail of parapet damage
