## BAM EARTHQUAKE, IRAN: LESSONS ON THE SEISMIC BEHAVIOUR OF BUILDING STRUCTURES

A. R. Manafpour<sup>1</sup>

<sup>1</sup> Structural Engineer, Halcrow Group Limited, Power and Structures, Glasgow, UK

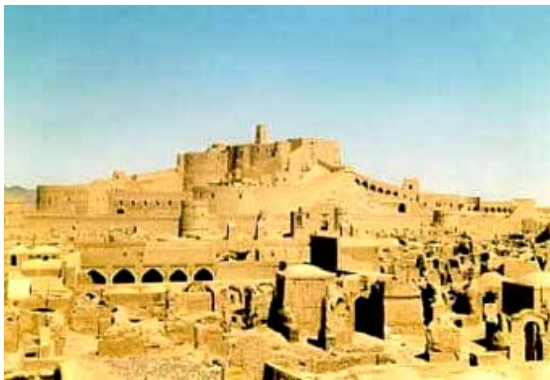
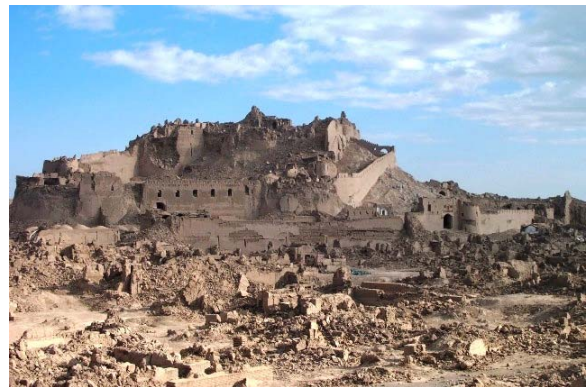
**Figure 3: Damage to the Arg-e-Bam after Bam Earthquake**

The Arg suffered extensive damage during the earthquake. Approaching from the Southwest, some parts of the external walls of the complex were reduced to rubble, barely resembling the shape of the original construction. By climbing on top of their remains one could clearly see the complex's debris filled courtyard. The fact that this structure had been standing undamaged for around 2000 years has been taken by some [1, 22] as evidence that the Bam region had not experienced any earthquake of a similar intensity to the Bam earthquake during this period. Figure 3 shows damage to Arg-e Bam after the bam earthquake.

Before earthquake

After earthquake

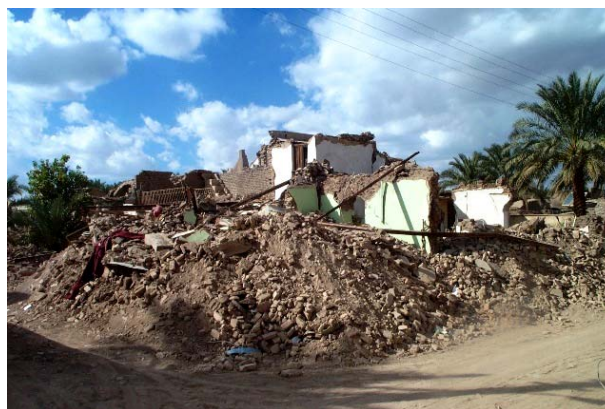
Figure 5 shows an example of damage to adobe buildings in the Bam earthquake. Severe damage to total collapse was seen in Bam city and Esfikan village while in Nartij village most of the buildings were standing with only moderate damage with a smaller proportion suffering collapse. Although most of the buildings with vaulted roofs collapsed within the city,

**Figure 5: Total collapse of adobe buildings in Bam**

few had performed well and remained standing after the earthquake with only moderate damage. Vaulted roofs were also seen in fired brick masonry buildings, again in some cases with good performance. From those vaulted roof mud brick buildings that did not collapse it could be seen that most of the vault infills and end walls, perpendicular to the direction of vault axis, had collapsed. This suggests that the deformation mode of the vaulted roofs and their supports differs from those of the perpendicular walls, and the lack of a shear transfer mechanism between these two parts resulted in the separation and subsequent collapse of the walls.

- Traditional mud-bricks buildings: Most of these buildings completely collapsed during the earthquake. A considerable number of buildings in central and eastern provinces, more specifically in villages, are of this type and will not resist similar magnitude earthquakes. Therefore, it is essential that any earthquake hazard reduction programme in the region take these into consideration.

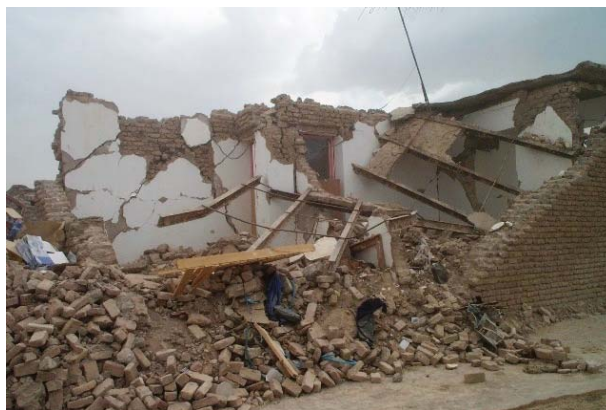
Since the introduction of modern seismic design codes in Iran, masonry buildings are now required to have horizontal and vertical ties. The use of horizontal ties in Iran started in the 1960s and the use of vertical ties began in the 1970s. However this practice took much longer to be implemented in rural regions such as Bam. Many of the older masonry buildings in Bam have been constructed without ties and even some buildings, constructed as recently as six months before the earthquake, were found to be without ties. For masonry structures without ties observed main failure types include: a) horizontal displacement of simply supported joists in jack-arch system resulting in collapse of arches between the joist (b) horizontal movement and slippage of the whole roof system on the walls resulting in total collapse of the building. In addition, poor material properties and workmanship were a common factor and a contributory cause to the damage experienced by many structures. Mortar materials used in older masonry buildings are lime-clay, lime-sand or lime-sand-cement. Although in more recent construction sand-cement is predominant, lime-sand is still used in some private houses. An example of masonry building total collapse is shown in Figure 6.

**Figure 6: A residential masonry building without ties in Baravat. Construction finished about 6 months before the earthquake**

- Non-engineered buildings built of masonry or a combination of masonry and steel without any specific seismic considerations: A good majority of the non-traditional buildings in many parts of Iran are of this type and are vulnerable to earthquakes. An active retrofit and renewal strategy should be formulated.

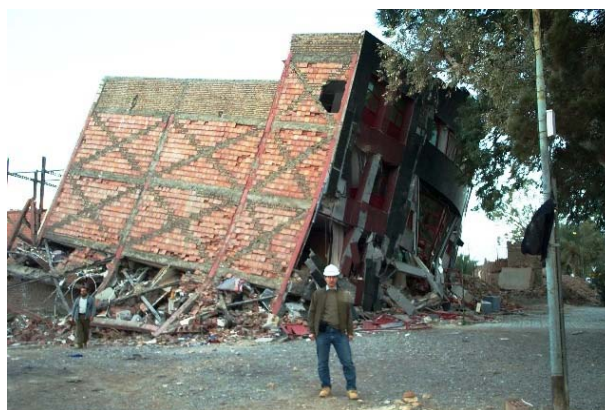
Figure 7 shows damage to Kimia Building which is a combined residential-commercial building with braced steel frames in Bam city centre. The building had 5 stories above ground towards the front but only 4 stories in the rest of the building. Two to three stories were flattened during the earthquake. This building is a typical example of the effect of geometrical, stiffness and mass irregularities which resulted in large lateral and torsional displacements. This combined with poor quality of welding have contributed to total collapse of the structure.

**Figure 7: Kimia building in Bam**

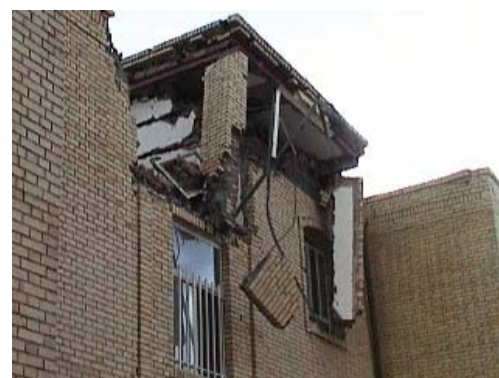
Failure of the rooftop extensions to staircase structures was common in the Bam Earthquake. The largest damage to these structures was seen in masonry buildings where the structure is merely an extension to the staircase walls and covered with a flat or inclined jack-arch roof spanning between the two side walls that run parallel to stair axis in plan. The other walls normally have large openings for a door to the roof top on one side and a window on the other side, which make the structure very flexible and weak in the direction parallel to these walls, unless a proper framing system is implemented. The weakness in this direction has resulted in detachment of the whole staircase extension from the building below, large movements and also instances of collapse. The use of vertical and horizontal ties does not necessarily provide sufficient framing for the staircase extension to resist the earthquake force in the direction perpendicular to the stair axis. Due to the importance of the staircase structures in providing safe evacuation from buildings, and since failure in these structures was a common occurrence in the Bam Earthquake the issue of proper design of these structures and the provision of clear design guidance needs to be considered by local authorities.

**Figure 8: An Example of the performance of staircase extension structures in Bam**
