SEISMIC DAMAGE ANALYSIS ON BUILDINGS OF THE NING'ER EARTHQUAKE WITH Ms6.4

ABSTRACT :

The earthquake mechanism, seismic records, damage index and intensity of the Ning'er earthquake with Ms6.4 are introduced in this paper. Based on the field investigations, damage situations of rural houses and buildings of cities and towns have also been introduced. The failure mechanisms are briefly analyzed. Some seismic fortification measures are proposed.

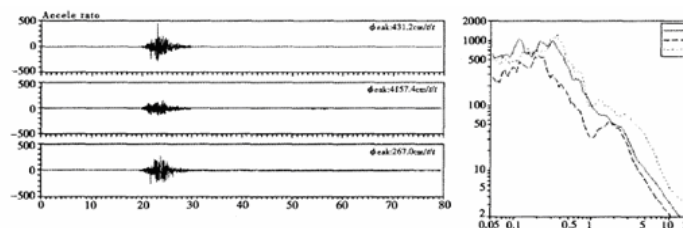
Fig. 2 Dehua_AJ001 acceleration history record and its response spectrum of Ning'er Ms6.4 Earthquake

From the recorded acceleration history and acceleration response spectrum which were showed in Dehua_AJ001(Fig.2) and Zhengxing_AM003(Fig.3), NS components of both earthquake motion records all exceeded the acceleration peak value of 400 gal, which is specified as the strong earthquake's input peak acceleration for seismic response analysis in seismic fortification region of 8 intensity(see "Code for seismic design of buildings" (GB50011-2001)) . This is the main reason for which the buildings were damaged more severely in NS direction in the seismic region. However, the other two orthogonal directions' peak accelerations of the ground motion did not reach the peak value specified in the code (which is 0.85 and 0.65 times of peak value of the first direction when the seismic response analysis of two-way and three-way are carried out). So, from the level of seismic motion's peak value, it is almost at the same level or slightly lower than the medium earthquake acceleration of 8 degree (0.2g) in the epicenter. The predominant period of both ground acceleration records were between 0.2~0.4s. As we know, natural period of most 7-story or lower houses are closed to this range. 99% buildings in Ning'er town are lower than 7 stories, so, it is why the buildings in Ning'er were seriously damaged, although the earthquake duration was short.
