## THE RELATIONSHIP BETWEEN FILL-DEPTHS BASED ON GIS ESTIMATION, EARTHQUAKE DAMAGE AND THE MICRO-TREMOR PROPERTY OF A DEVELOPED HILL RESIDENTIAL AREA

Satoshi IWAI<sup>1</sup>

<sup>1</sup> Professor, Dept. of Architectural Engineering, Hiroshima Institute of Technology, Japan  
Email: s.iwai.i5@it-hiroshima.ac.jp

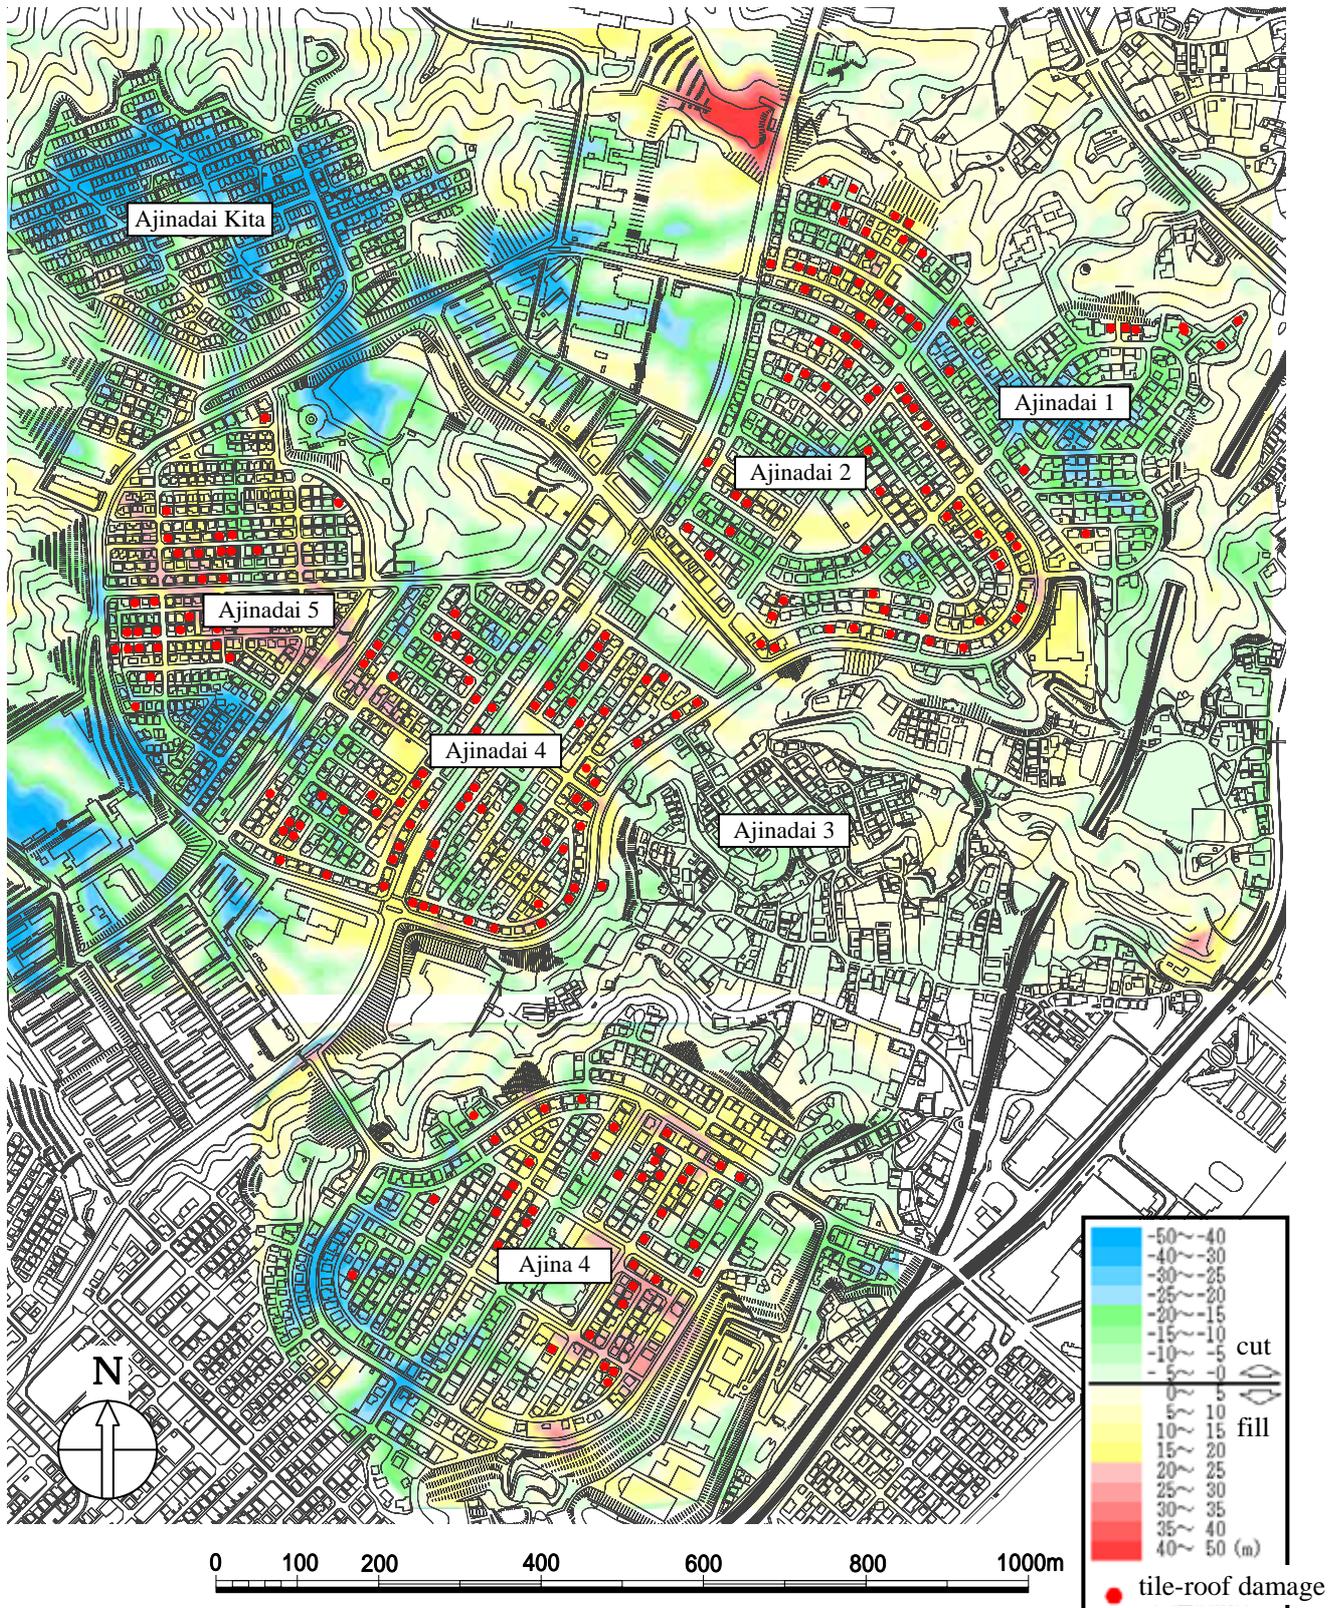
Fig. 2 Fill-depth and cut-height coloring based on GIS estimation and tiled roof damage of houses at developed hill residential area.

Making procedure to classify cut and fill ground is shown in Fig. 1 from the top to the bottom. (1) Scanner-reading data of topographical (analog) maps before and after the housing development were converted into vector data for the DWG file, which is the standard file format of the CAD. All the altitude values were inputted into each contour line data directly (Fig. 1(a), (e)). (2) For input of the altitude value, CAD software was used (AutoCAD2000LT; Autodesk Inc.). A lot of things such as a house or a road irrelevant to altitude are included as line data in the map, so it is necessary to remove them to analyze the topography. Therefore a processing program with Microsoft Visual Basic 6.0 was made to remove the data without altitude information (height 0) and only the altitude data was extracted (Fig. 1(b), (f)). (3) The extracted data has a text format data of X and Y-coordinate of the map position from the plane right-angled coordinate systems, and the Z-coordinate of the altitude inputted. The DWG file which finished coordinate input (X, Y and Z) by the CAD were converted into DXF (Drawing Interchange File) which is a text format. The DXF can be analyzed as a readable text by another program. (4) Using the Windows version GIS (SIS; Spatial Information System, Informatix), these data are divided into a grid (lattice) data of every coordinates at an equal interval with altitude about an arbitrary area before and after the land development. The grid is made by interpolation method as the function of the GIS (Fig. 1(c), (g)). A GIS tool-TIN (the network domain of the Triangulated Irregular Network) Interpolation method is employed. TIN generates grid altitude from a point as an unknown value at a triangular internal point in the lattice generation from neighborhood points. (5) The difference of the altitude before and after the land development from the grid data was used to distinguish cut or fill ground (Fig. 1(d), (h), (j)). Fig. 2 shows fill-depth and cut-height coloring, based on GIS estimation, and tiled roof damage of houses at developed hill residential area. The damage to the tiled roofs of conventional Japanese-style wooden houses was more prevalent among wooden houses on the fill part of improved hills rather than the cut part.

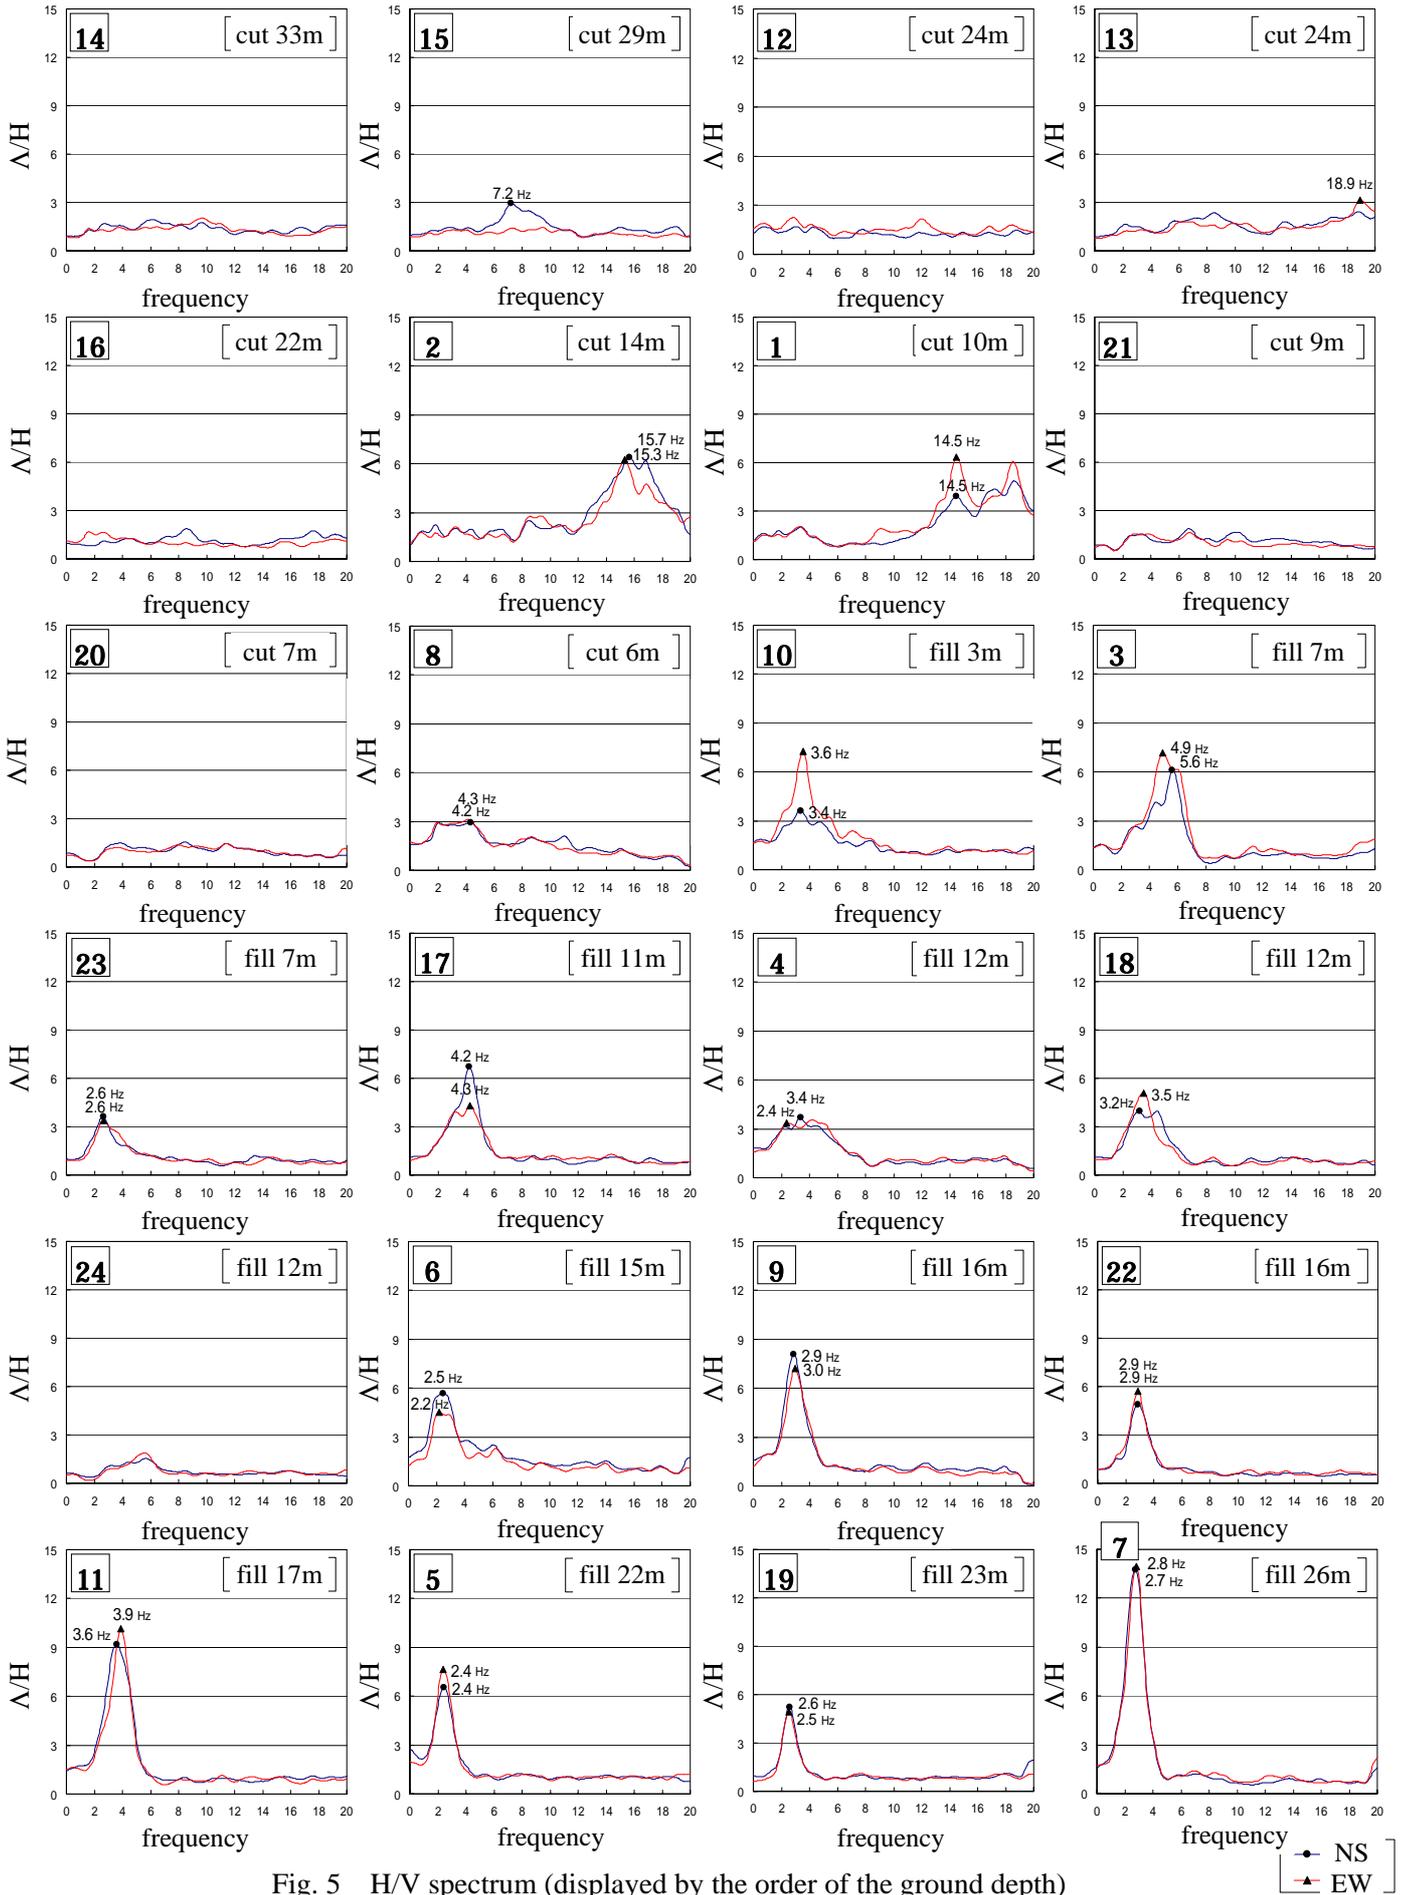
The power spectrum of the velocity record of these horizontal east-to-west (EW) component and north-to-south (NS) component were shown in Fig. 5, corresponding to the type of the ground, respectively. In this figure, the power spectrum are displayed by the order of the ground depths (unit in meters) in turn from the left-top to the right-bottom. An H/V spectrum (a ratio of horizontal spectrum to vertical one) based on the micro-tremor measurement is found to have clearly different characteristics between the fill part and the cut part in the improved hill ground. The vibration characteristic at the site on cut ground is almost flat in frequency range about from 0.5Hz to 20Hz, except a little predominant frequency from 14Hz to 18Hz range. On the other hand, the H/V spectrum has a clear peak in about 3Hz on the fill ground. It is understood to have combined vibration characteristics of both ground in the boundary area between the cut and fill. Thus, the difference between the cut and fill appears to reveal the characteristic of the H/V spectrum. As mentioned above, it has been understood that a spectrum and spectrum ratio characteristics have the pattern by which each feature correspond to three categories dividing by (1) the cut, (2) the fill and (3) their border area. Moreover, a south-to-north component showed the tendency that roughly looked like the east-to-west component. Those features may relate old geographical features before improvement of housing lot. Predominant frequency of surface soil known as "1/4 wave length" law tends to correspond with this result.

Fig. 5 H/V spectrum (displayed by the order of the ground depth)

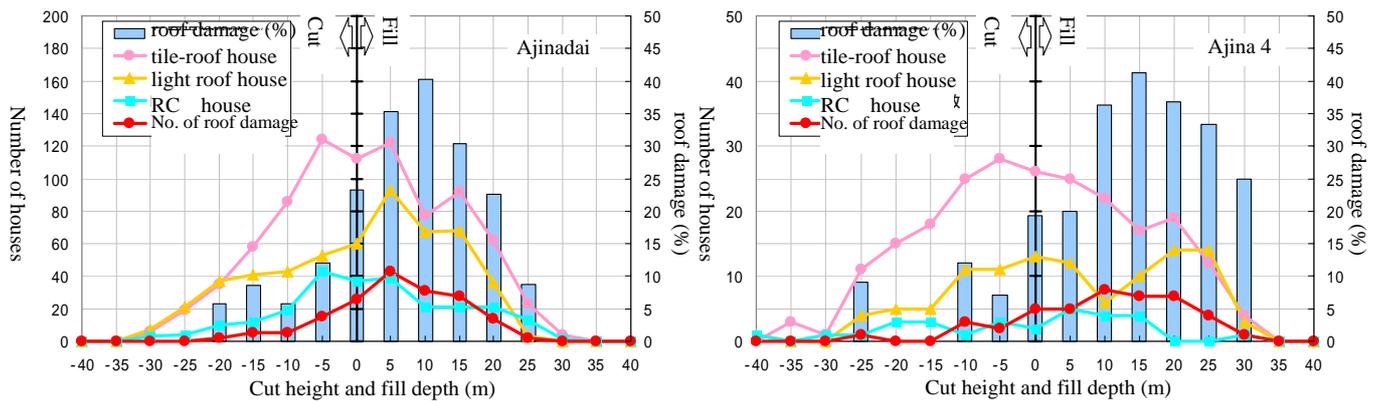
The altitude (vertical) drop of the cut or fill ground affects the tiled roof damage of houses, as shown in Fig. 6. Many tiled roof damage of wooden houses by the 2001 Geiyo Earthquake appeared in the fill ground area, where the predominant frequency shows low and does not reach to 3Hz, as shown in Fig. 7. On the other hand, the tiled roof damage was not seen in the cut area where high predominant frequency is obtained as to exceed 10Hz. The vertical drop of the cut and fill ground affects predominant frequency of the ground, and it is possible that the difference of the predominant frequency of the ground influenced the tiled roof damage of the house. Moreover, about 2-4Hz in frequencies of the fill ground was predominant, and it is so considerably near the natural vibration of wooden houses that it be possible to relate with the amplification of vibration by the resonance. This ground vibration property corresponds to larger roof-tile damage of wooden houses in fill ground on improved hills. Based on survey of the data base on a wooden building, the average value of natural periods was between 0.3-0.4 seconds through many two-story wooden houses of conventional Japanese-style frame construction in many cases. The standard deviation through conventional frame houses is as considerably large as 0.2 seconds. The predominant frequency in the fill is near the natural frequency of a wooden house, and it is possible that the vibration amplification by the resonance caused the tiled roof damage of a wooden house.

Fig. 6 Cut and fill soil thickness and the tiled roof damage ratio

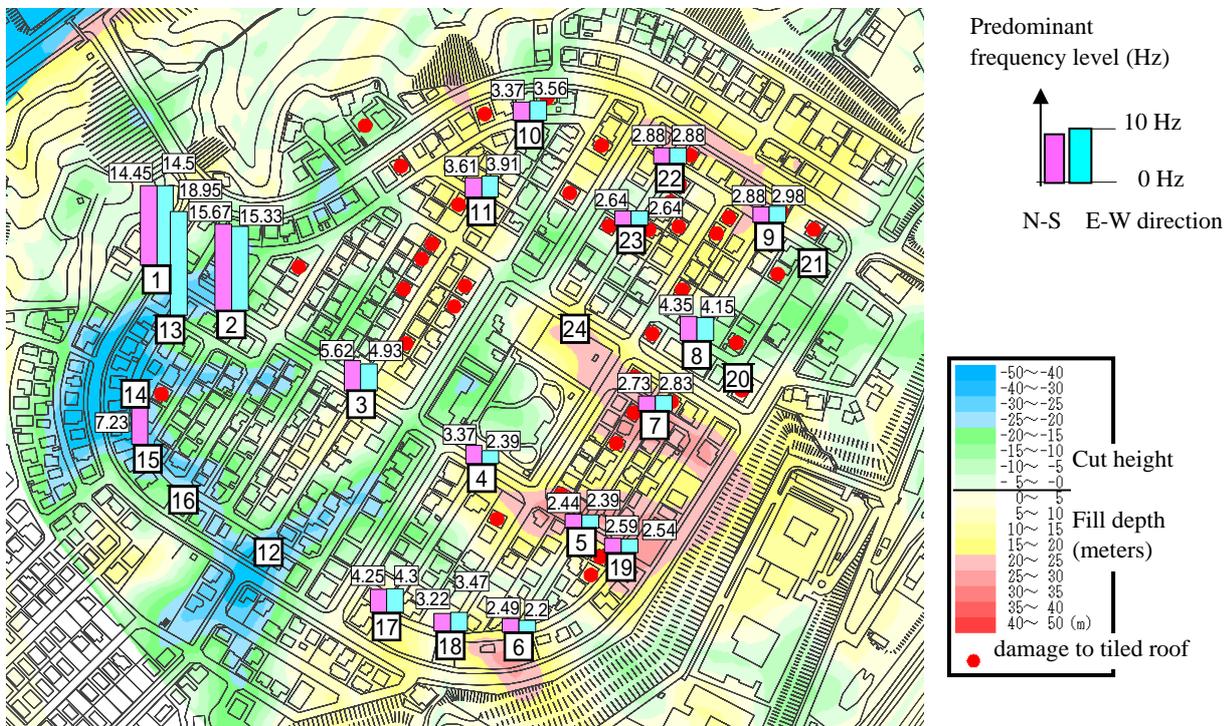
Fig. 7 The relationship between fill-depths based on GIS estimation, earthquake damage and predominant frequency of a developed hill residential area.
