Characteristics of Earthquake Distribution in Kunlun Mountains and Designs of Qinghai-Tibet Railway Engineering

Liu ZhengPing

*Senior geology engineer , Division of Geology and Subgrade Design, the First Survey and Design
Institute of China Railways Group Co., Ltd., Xi'an , China
E-mail: TYY_LLEAF@163.com*

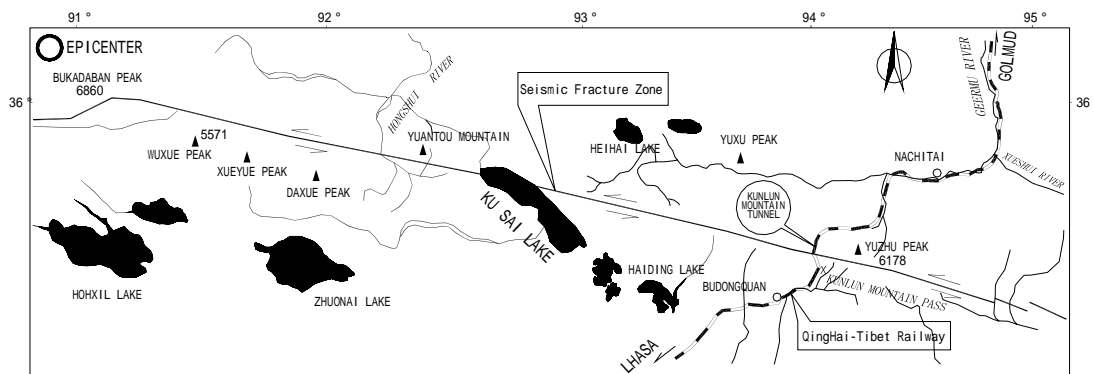
Figure 1.1: Sketch map of the KMPF

After the earthquake of Richter scale 8.1 happened, a surface fracture zone about 426km long along the fault was formed. After the survey and research on the surface fracture zone, we think that its location is completely consistent with the KMPF, which crosses the Qinghai-Tibet highway from east to west and their dislocation characters are same completely. In other words : the fault is the seismic fault which develops nearly from east to west direction and locates at the southern foot of Kunlun mountain. (Figure 1.1). Characteristics parameters of seismic fault (the KMPF) are listed in the table 1.1.

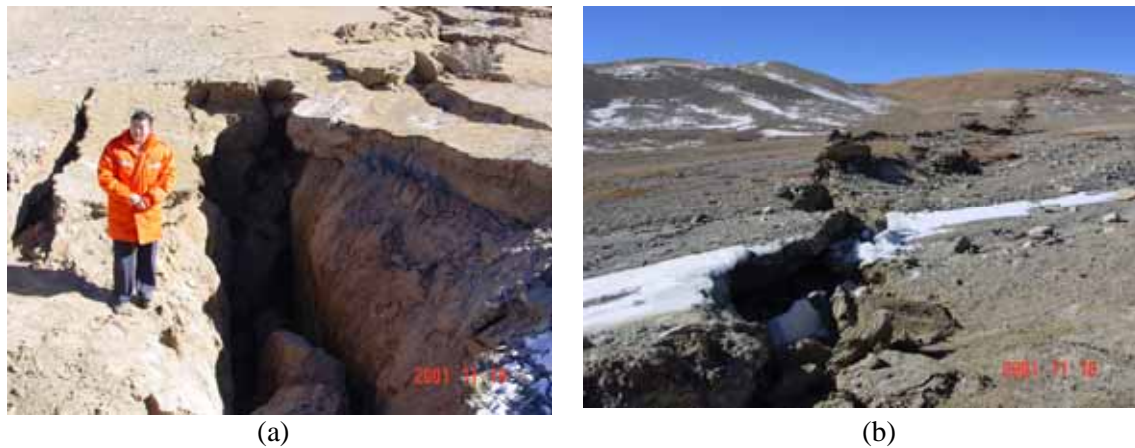
Figure 3.1 : Distribution characteristics of surface fracture zone in Kunlun Mountains
 (a) configuration of surface fracture zone ; (b) distribution of surface fracture zone

There are secondary fractures at the both two ends of fracture zone which make the existed KMPF develop again. At the 4 km distance north to Kunlun Mountain pass the ground fracture athwart crosses the Qinghai-Tibet highway and railway in the direction of N80°W with strip-shape distribution. The seismic fault totally inclines to north with 50° ~ 78° inclination. The surface fracture zone, with maximum width of 32m, maximum horizontal displacement of 6.4m and maximum vertical displacement of 4m, is composed of series of purely shearing and strike-slip faults of direction N80°W in the feather pattern. The discontinuous steps swell up to bulges with several meters high or stretch into recessed cracks with dozens of meters in depth (Figure 3.1). All such structural forms demonstrate significant views.

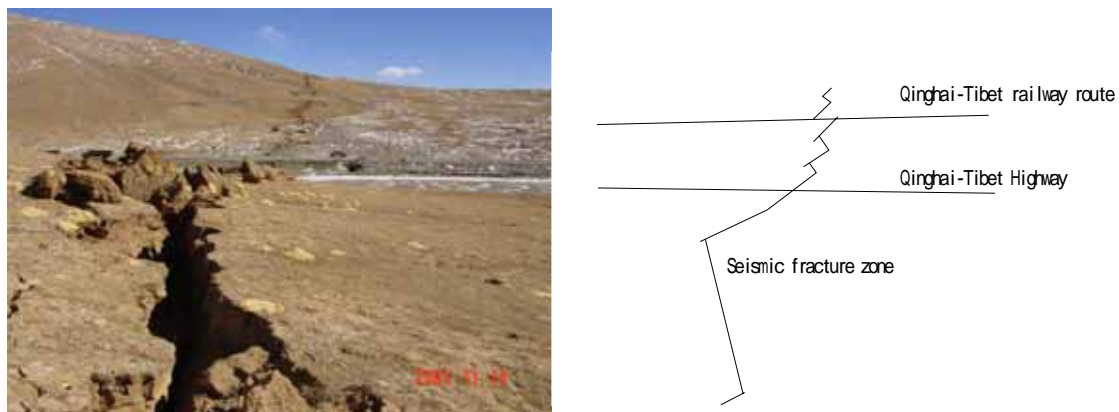
Figure 3.2 : Photo and sketch map of the seismic fracture zone near the railway

The KMPF near the Qinghai-Tibet highway under construction is located in the south slope of the Kunlun Mountains. The Course of surface fracture zone across railway is DK979+528 with 50° angle and the coordinate is N 35°40.314' and E94°03.171' (Figure 3.2). The width of surface fracture zone is 15~20 m near the railway. The fault plane is steep and approximately vertical, and the tensile faults develop in direction of N50°E in patulous en-echelon pattern . Tensile offset of each fault is 1.2~2m with maximal depth of 4.4m. There are seven secondary faults on the road surface of under-construction railway with sinistral offset of 0~0.5m and width of 23.5m.

According to the configuration of seismic fracture zone, geography position, the round-inflexion of tensile fault and increase of tensile quantity along slope, etc, it is shown that there is a little gravitational sliding function in the period of seismic faults movement, so that the ground fracture is enlarged increased greatly at this zone.

(2) Within the affected areas of the fault, the railway was designed to cross the fault zone with large angle. The angle between the two was 50°. Large constructions were not built, but embankments and culverts were built within 600m distance of fault.

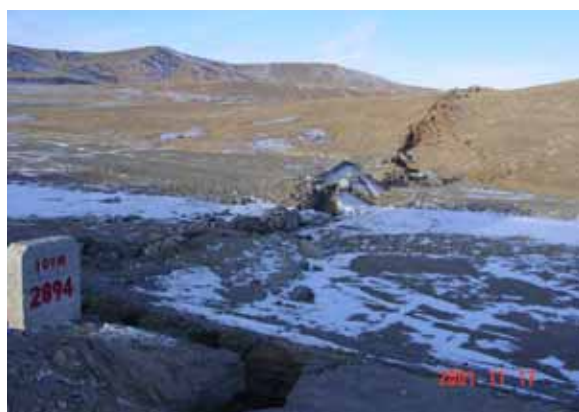
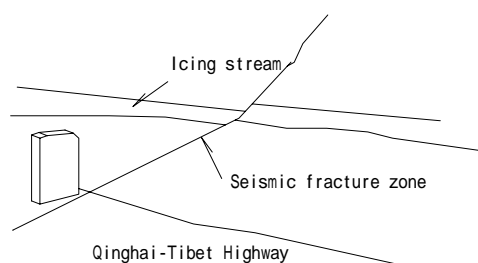
Figure 3.3 : Photo and the sketch map of the sinistral offset of the icing-stream near the highway

The course of fracture zone across the Qinghai-Tibet highway perpendicularly is GK2894+000. The road surface humped and the structure was damaged near the site. The ground fracture zone is 7.9m in width in the west of the highway, in the direction of N85°W and across an icing stream, ice-surface cut broken with sinistral dislocation of 4.8m between east and west bank (Figure 3.3), running from south to north.

On the hillside inclined to south in the west bank of the stream, the seismic fracture zone is about 15m width with the north part of fault uplifting a little. 7~8 small gullies were consistently cut sinistrally with dislocation of 3.8~4m, in which the new fault plane strike is $12^{\circ} \sim 78^{\circ}$ and the scratch plunge angles is 28° .

In the east of the highway, the seismic fracture zone is of 13.5m width, composed of secondarily strike-slip faults in feather pattern in direction of N80°W, and the pressure bulges distribute along sinistral fracture, whose edge is totally controlled by arc-shaped thrust fault in direction of N40°E with 1.1m height. Sinistral dislocation can also be seen at the east bank of a gully with 4m offset.

The Qinghai-Tibet highway is cut by surface fracture zone of 25m in width, in which the four major secondary faults develops. Although their sinistral offsets of the four secondary faults are small, the total seismic offset at both sides of the fracture zone reaches about 4m.
