Cyclic soil tests to propose appropriate seismic design methods for sliding type and slump type failures of road embankments

Kazuyori Fujioka¹ and Susumu Yasuda², Syotaro Shiratori³

¹ Acting Division Chief, Dept. of Road Research, Nippon Expressway Research Institute Co. Ltd., Machida, Japan

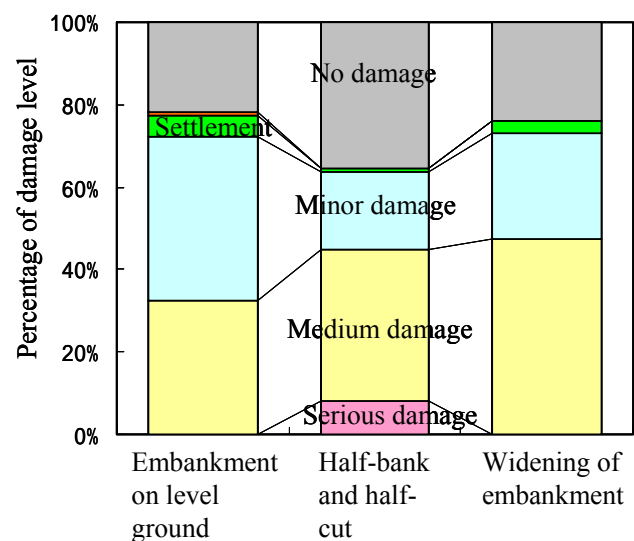
Figure 3 Classification of damage level of embankments

Serious damage occurred at half-bank and half-cut embankment only. In the embankments on level ground, medium or minor damages dominated.

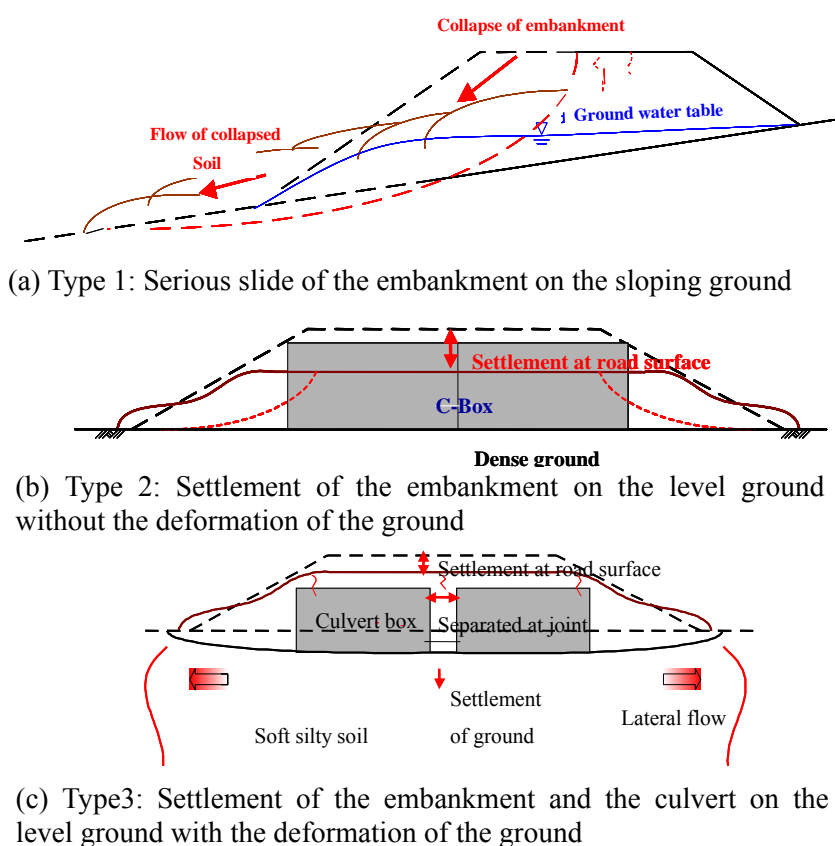
(1) Type 1: Serious slide of the embankment on the sloping ground as schematically shown in Figure 4 (a).

(2) Type 2: Settlement of the embankment on the level ground without the deformation of the ground as schematically shown in Figure 4 (b)

(3) Type3: Settlement of the embankment and the culvert on the level ground with the deformation of the ground as schematically shown in Figure 4 (c)

Figure 4 Classification of the damage to the embankment of Kan-etsu Expressway according to the mechanism of failure

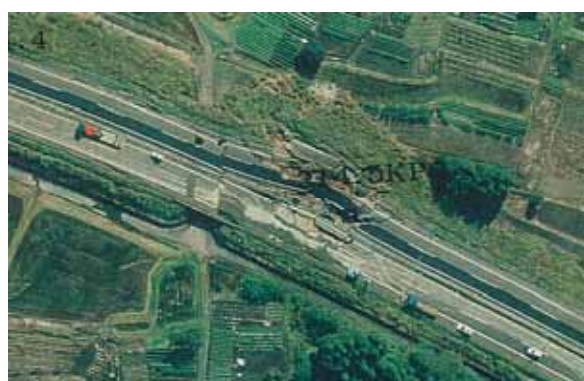
Serious slide of embankment occurred between Koiede IC and Kawaguchi IC as shown in Figure 1. The expressway was constructed on gentle slopes of hills. As the expressway crosses several small valleys, embankments were constructed by filling soils on the valleys. Severe slide occurred at these sites as shown in Photo 1. Detailed soil investigation was conducted at 214.35 KP where the most severe damage occurred. Figure 5 shows the cross section at the site. Embankment was constructed on a gentle slope of about 5 degrees. A thin gravelly clay layer is deposited on the surface of the slope. Dense gravelly soils are underlaid. Filled material is clayey gravel with 20 to 30 % of fines. SPT *N*-values of the fill were 2 to 10. According to the measurement of ground water level conducted about two month after the earthquake, water level was about 2 m

Photo 1 Serious slope failure on the sloping ground at 214.35 KP

comparatively easy to induce excess pore water pressure due to shaking. Therefore it is estimated that some excess pore water pressure was generated in the saturated part of the fill and caused slide and subsequent flow towards downstream.

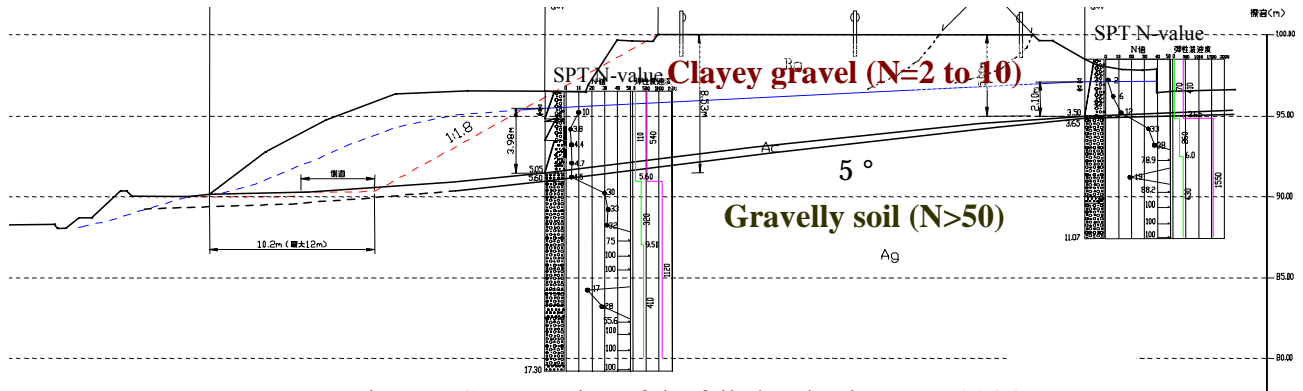
higher than the bottom of the fill. However, the measured water level is not accurate because retaining sheet piles had been constructed for emergency treatment before the measurement of water level. In addition to the soil investigation, laboratory tests and analyses were carried out to demonstrate the mechanism of failure. As shown in Figure 4 (a), lower part of the fill was saturated. The filled soil contains not so much fines and

Figure 5 Cross section of the failed embankment at 214.35 KP

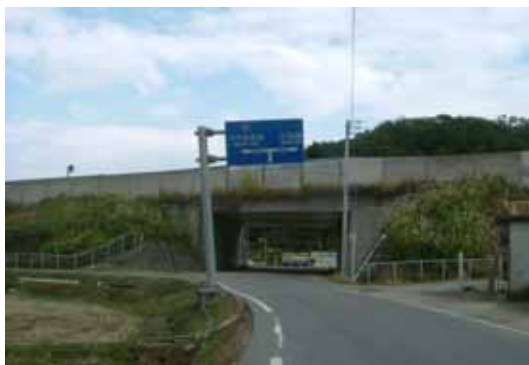
Photo 2 shows C-Box Kawaguchi 11. Large differential settlement of 70 cm occurred between the embankment and the culvert box as shown in Photo 5. The culvert box consists of two concrete boxes. The culvert itself settled 10 cm only and joint of two concrete boxes opened 10 cm. Therefore it can be said culvert box settled and stretched slightly as schematically shown in Figure 4(b).

Photo 2 C-Box Kawaguchi 11

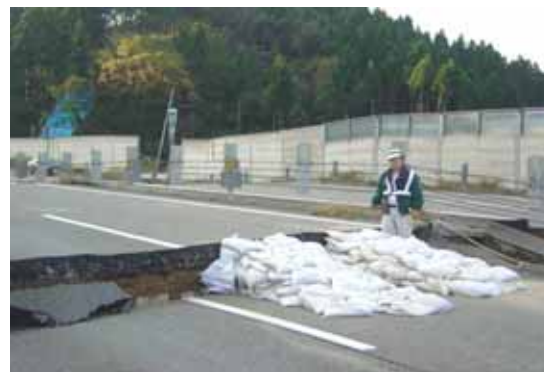
Photo 3 Differential settlement between embankment and culvert at C-Box Kawaguchi 11

Based on the soil investigation and additional laboratory tests, it is estimated the settlement of the embankment occurred due to decrease of shear modulus of the filled materials.

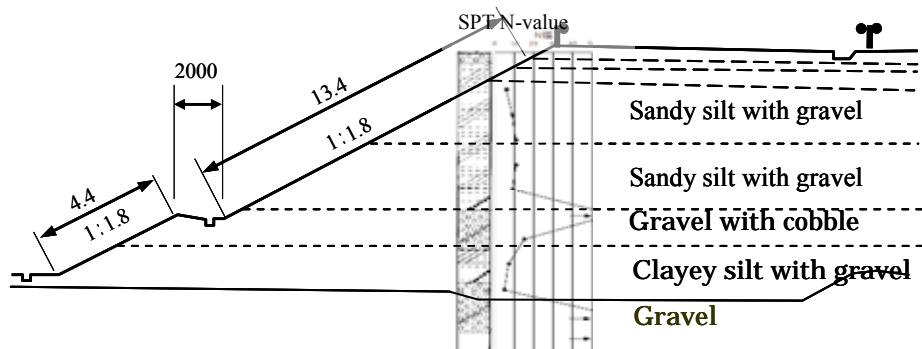
Figure 6 shows boring data and the estimated soil cross section of the embankment adjacent to C-box Kawaguchi 11. Subsurface soil of the foundation ground is dense gravel with SPT *N*-value of more than 50. Height of the embankment is about 10 m. Filled materials are sandy silt with gravel, gravel with cobbles and clayey silt with gravel. Fines content of these soils was 50 to 60 %. Measured water level was about 3 m higher than the bottom of the embankment. However, it is not clear whether the water was perched water or not.

Figure 6 Soil cross section adjacent to the culvert at C-Box Kawaguchi 11

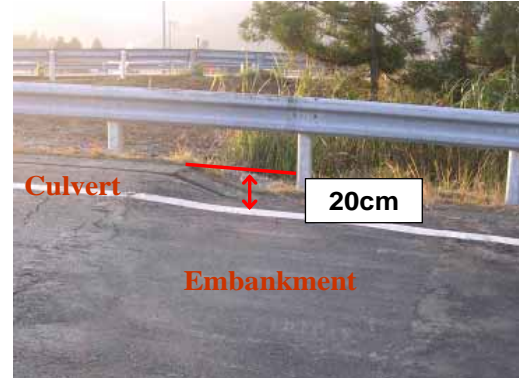
Around Ojiya IC, differential settlement of several ten cm occurred between embankments and culverts as shown in Photo 4. Moreover culverts settled several ten cm and stretched as shown in Photo 5. Embankment soil fell down through the opened joints. Embankments, culvert boxes and grounds deformed as schematically shown in Figure 4 (c).

As mentioned before, large settlements of embankments and culverts occurred at these sites. Differential settlements between embankments and culverts were 20 cm and 70 cm at C-Box Kawaguchi 22 and C-Box Ojiya 2, respectively. Settlements of culverts were 48 cm and 30 cm, respectively. Therefore, total settlements of embankments were 68 cm and 100 cm, respectively.

Photo 4 Differential settlement at C-Box Kawaguchi 22

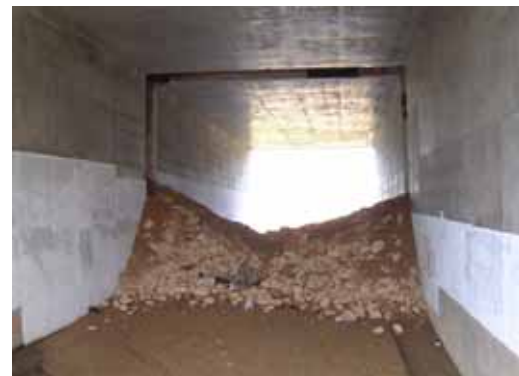
Photo 5 Separation of joint at C-Box Ojiya 2

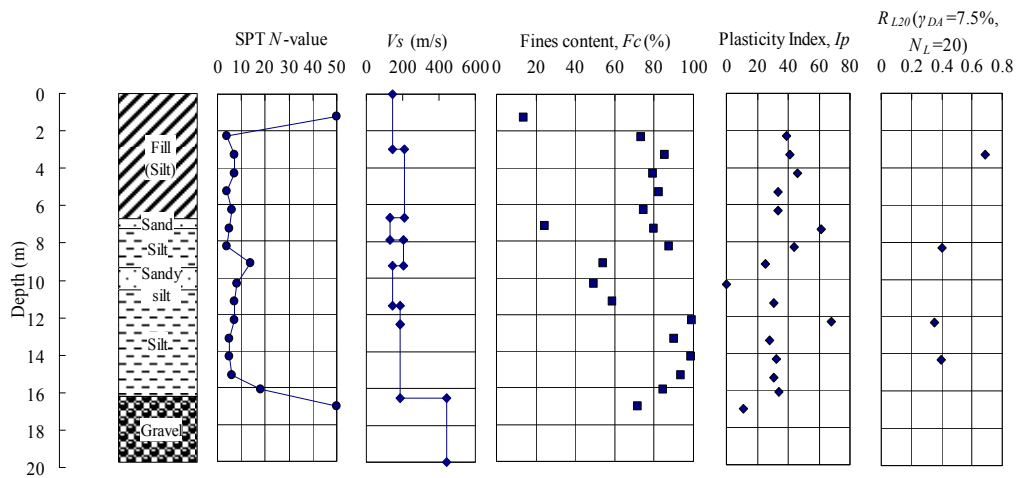
At C-Box Kawaguchi 22, thick soft silty layers, with about 5 of SPT N -values, are deposited from original ground surface to the depth of 16 m. A thin soft silt layer with 2 m thickness is deposited under the embankment at C-Box Ojiya 2. Then, silty sand, silt, sandy silt and silt layers, with 10 to 20 of SPT N -values, were underlaid to the depth of 24 m. Figure 18 shows estimated cross section at C-Box Kawaguchi 22.

Figure 8 Soil profile and tests results at C-Box Kawaguchi 22

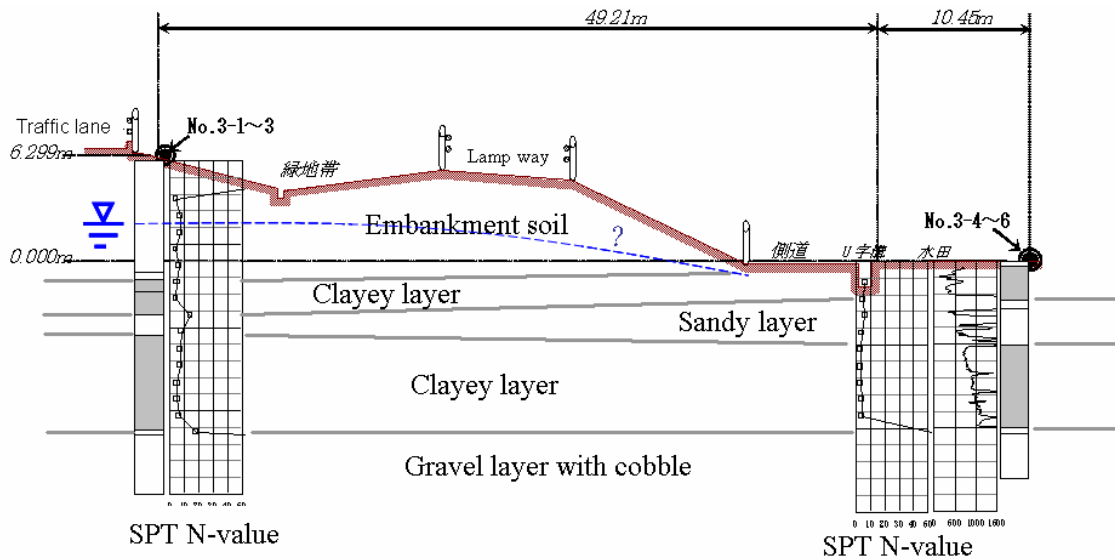
the measured values, then it was concluded that the settlement of the embankments and culverts occurred due to the reduction of shear modulus of the filled soils and foundation soils (Inagaki et al., 2005).

Figure 9 Cross section of the embankment adjacent to C-Box Kawaguchi 22
