## SEISMIC STRENGTHENING OF A SCHOOL BUILDING DAMAGED BY THE 2004 NIIGATA-CHUETSU EARTHQUAKE

This paper deals with the strengthening of a school building damaged by the Niigata-Chuetsu Earthquake (Magnitude 6.8) of 2004. The building locates in the seismic zone where the intensity is registered 6+ on the 7-grade Japanese intensity scale.

The building was a 3-story reinforced concrete frame with total floor area of 2369m<sup>2</sup> constructed in 1968. Numerous shear cracks were observed in columns and bending cracks in beams due to the earthquake and some columns were broken and failed completely.

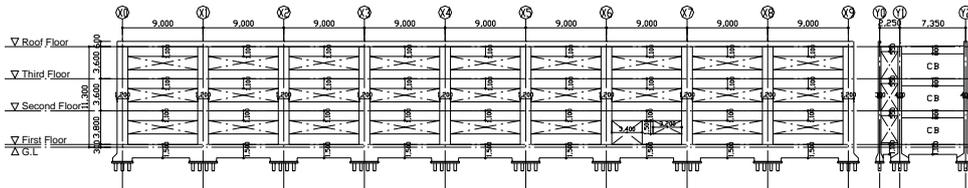
moment resisting frame structure while span direction was a rigid frame combined shear walls. Columns of Y2 direction are a short column with an inner height  $h_0$  of 2400mm and a depth  $D$  of 1200mm ( $h_0/D=2.0$ ) as shown in Fig. 2.1. Multi-story shear walls were the main components of span direction while the wall distribution was not uniform so as to result in a large eccentricity at the first floor. Also arrangement of walls and openings were different from the original design sacrificing the designed seismic performance. Design strength of concrete,  $F_c$  was  $17.6 \text{ N/mm}^2$  but measured values ranged from  $13.1$  to  $17.0 \text{ N/mm}^2$  at the first floor,  $11.9$  to  $19.8 \text{ N/mm}^2$  at the third floor and  $15.1$  to  $15.2 \text{ N/mm}^2$  at the second floor, most are significantly lower than the design strength. Grade of the steel bar was round steel ( $\sigma_y=294\text{N/mm}^2$ ).

Fig.2.1 Elevation and Section of Typical Side

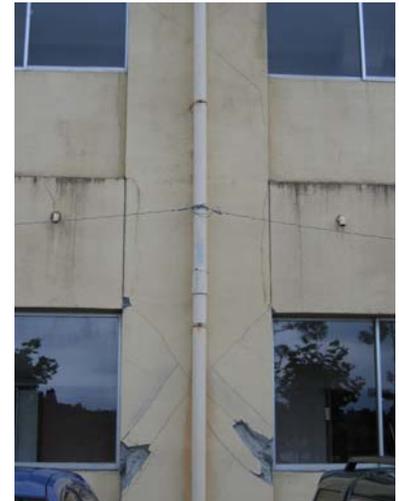
A number of short columns at Y2 axis exhibited shear cracks while bending cracks were found in beams. The shear walls in the span direction also showed shear cracks. The largest damage was found in columns of the first floor. Of thirty columns, two columns marked degree IV, crack width larger than 2 mm, as shown in Photo. 2.2, and one column marked degree III, crack width between 1 to 2 mm. Hence the degree of damage to the upper structure was worked out to be “Slight”.

Photo.2.2 Damage to Column

Columns and beams damaged by the earthquake must be repaired and therefore the following seismic strengthening plan was formulated.

Structural slits are introduced to the spandrel walls at Y0 axis and reinforced concrete braces with embedded steel plate, hereafter referred to as S-RC braces, capable of reinforcing columns and beams at the same time are added to Y2 axis after removing the extremely brittle columns that may act as a main structural element.

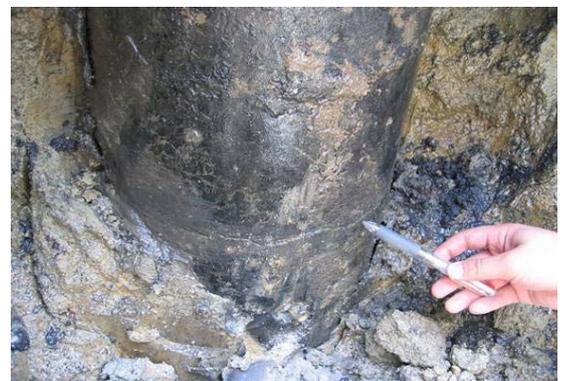
After the earthquake, an uneven settlement was found centering around X9 axis leading to excavation of piles and level surveys of the first and second floors. The pile inspection showed a bending crack of 0.2 to 2.0 mm wide at 500 to 600 mm from the top of a pile as shown in Photo. 2.3.

The level survey showed a settlement from Y0 to Y2 axis. A large drift angle  $q$  was found at X5 structural plane between Y0 and Y1 at the first and the second floors,  $\theta=1/225$  and  $\theta=1/188$  respectively. Settlement along the longitudinal direction was also recognized at Y0 structural plane X4 direction but the drift angle was as low as  $1/1800$  to  $1/1500$ . The largest drift angle was  $\theta=1/900$  found in the first floor at Y0 structural plane between X7 and X8 direction. The maximum settlement of the first floor was 31 mm. Hence the degree of damage to the foundation was worked out to be “Moderate”.

Photo.2.3 Bending Crack of Pile (2mm Width)

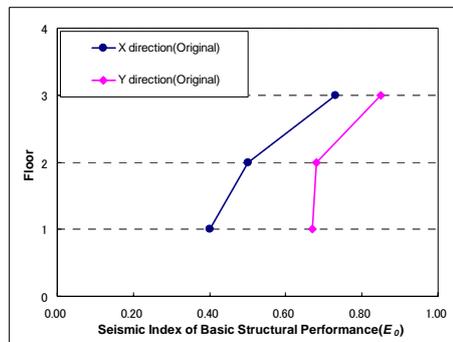
Fig.3.1  $E_0$ —Index

A major fracture mode of each floor was shear fracture of the short columns whose brittleness leads to an ultimate ductility index ( $F_u$ ) of 0.8. Hence the index  $E_0$  ranges from 0.40 to 0.73. Taking into account for the irregularity index of  $S_D=0.93$  and the aging index of  $T=0.81$ , the seismic index  $I_s$  of the building is worked out to be from 0.30 to 0.54, which is lower than seismic evaluation index of  $I_{so}=0.7$ . The building is thus of poor seismic performance at entire floor.

Fracture mode of the multi-story shear wall without openings is rotation of foundation ( $F=3.0$ ) while that with openings is shear fracture ( $F=1.0$ ). Thus the ultimate ductility index ( $F_u'$ ) in estimating  $E_0$  yields 1.0 and  $E_0$  ranges from 0.67 to 0.85. Finally, the seismic index  $I_s$  becomes 0.49 to 0.63 which is less than  $I_{so}=0.7$ . The building is thus of poor seismic performance at entire floor.

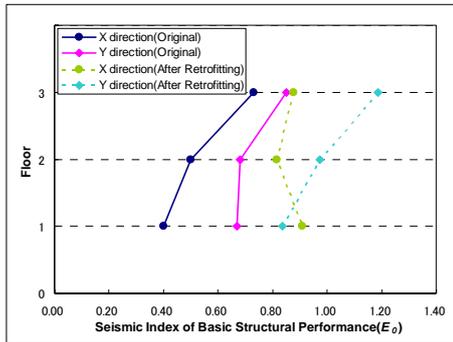
Fig.5.1 Comparison Between Before and After Retrofitting  $E_0$ -Index

Distributions of indexes  $E_0$  and  $I_s$  before and after the strengthening are shown in Fig. 5.1~5.2 where it is demonstrated that the strengthening described in section 4 was able to increase index  $E_0$  1.2 to 2.3 times greater than before for X direction and 1.2 to 1.4 times greater than before for Y direction. Index  $I_s$  was also increased 1.4 to 2.7 times greater than before for X direction and 1.5 to 1.7 times greater than before for Y direction. Thus the Index  $I_s$  showed remarkable increase exceeding  $I_{so}=0.7$  and the building now has a satisfactory seismic performance

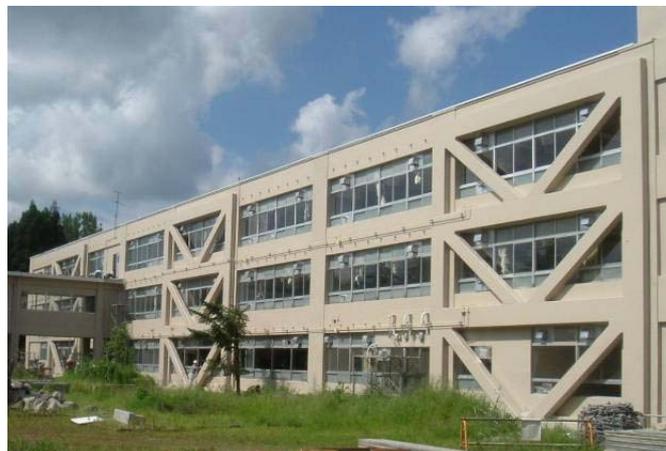
Photo.6.1 View of Building after Retrofitting

Seismic evaluation for the strengthened building confirmed the  $I_s$  index for X and Y directions of all the floors exceeded the assessed value of  $I_{so}=0.7$ (shown Photo.6.1).

During the Niigata-Chuetsuoki Earthquake (Magnitude 6.8) of 2007, with the intensity of 6+, the strengthened building was not subjected to any damage.
