## H/V MICROTREMOR MEASUREMENTS IN PISCO, PERU AFTER THE 2007 AUGUST 15 EARTHQUAKE

### ABSTRACT :

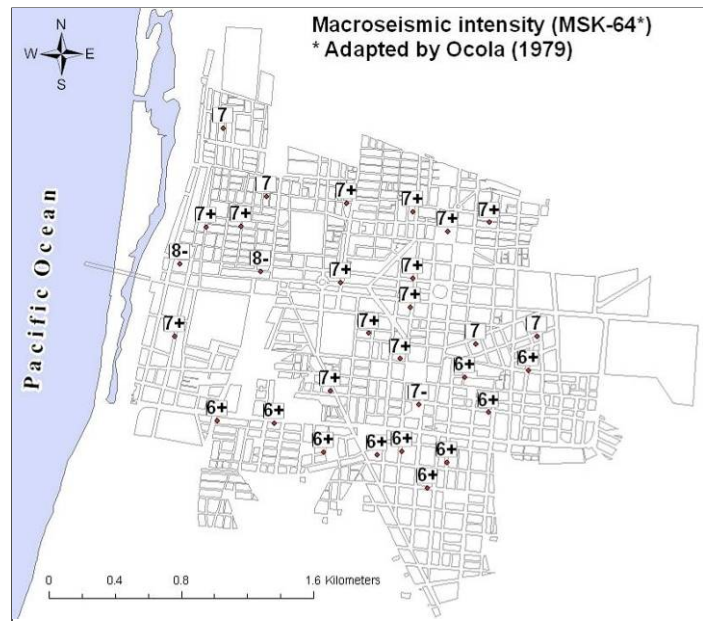
According to the National Institute of Civil Defense (INDECI) the death toll in the city was 338, 70% of the whole earthquake dead toll, as of October 10, 2007 [3]. The most spectacular part of the damage was the complete destruction of the San Clement church, which caused 30% of the fatalities in this earthquake. Pisco is located directly above the central part of the estimated fault plane (see e.g. [1]) and a local intensity of 8- (MSK-64) was estimated by Agüero et. al. [5] (see Figure 1), who evaluated the damage to some 30 buildings. Below, we compare this figure with our microtremor result.

Figure 1. Macroseismic intensity (MSK-64) distribution (adapted from Agüero et al. [5]).

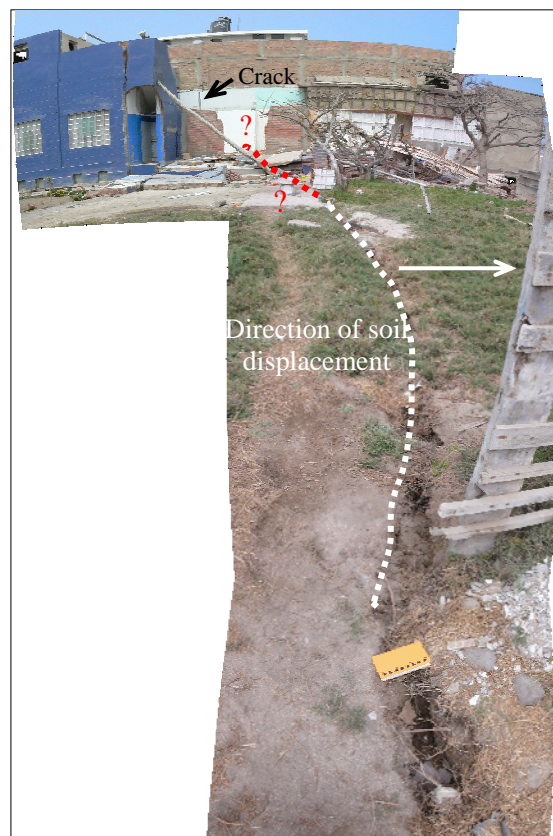
Liquefaction induced lateral spreading caused a lot of damage in the western parts of Pisco, which are closest to the ocean, where the ground water level is high and the soil is poorly graded. Ground cracks several meters long and decimeters wide cracked the confined masonry structure shown in Figure 2.

Figure 2. Soil displacement crack next to old building. The crack probably continues in front of and/or beneath the building and then up through the confined masonry wall as marked by the black arrow. (The curvature of the building top is due image distortion, it should be a straight line.)  
The sewage system in Pisco, whose conditions were already poor before the earthquake, was drastically affected

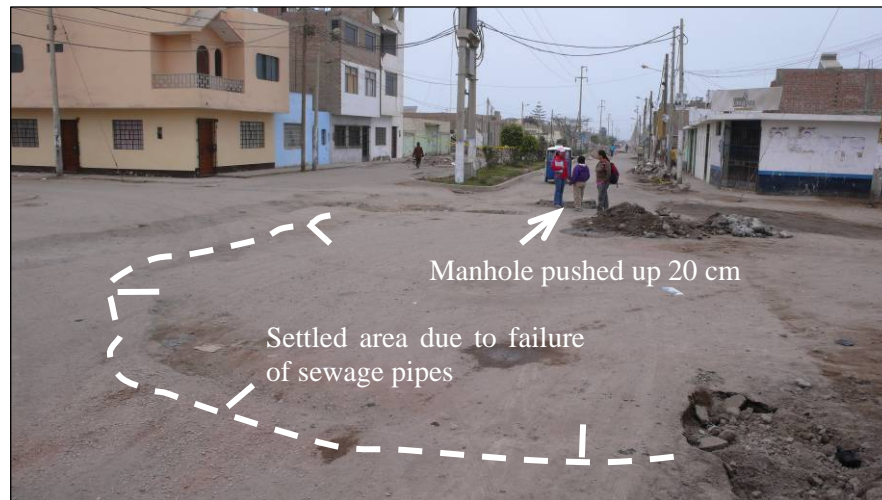
due to ground deformation and liquefaction. As shown in Figure 3, broken sewage pipes which caused ground settlements, and pushed-up manholes were widely observed in Pisco. The engineers at a temporary city office were trying to cope with cascading failures. We were told they repaired in one location and as soon as they pressurized the system, the pipes in other locations would fail. Unfortunately a map with pipe failure locations was not available at the time of our visit. Such a map would be useful to compare with the other figures shown below as to evaluate the relation between local geology and the pipe damage.

Figure 3. Central and southwest areas of Pisco had broken sewer pipes causing ground settlements and pushed up manholes were observed in many locations.

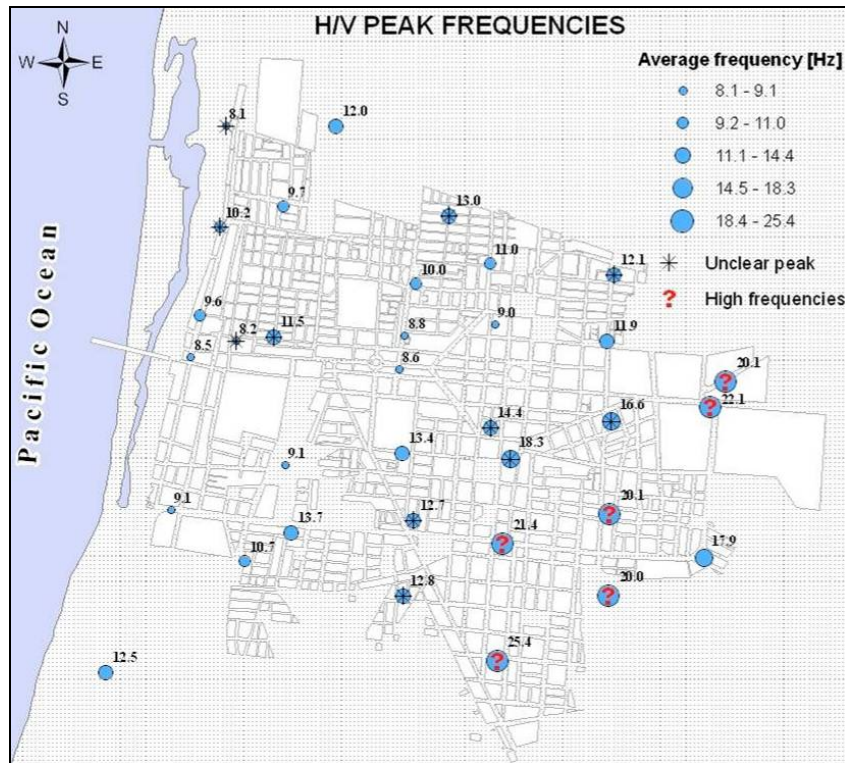
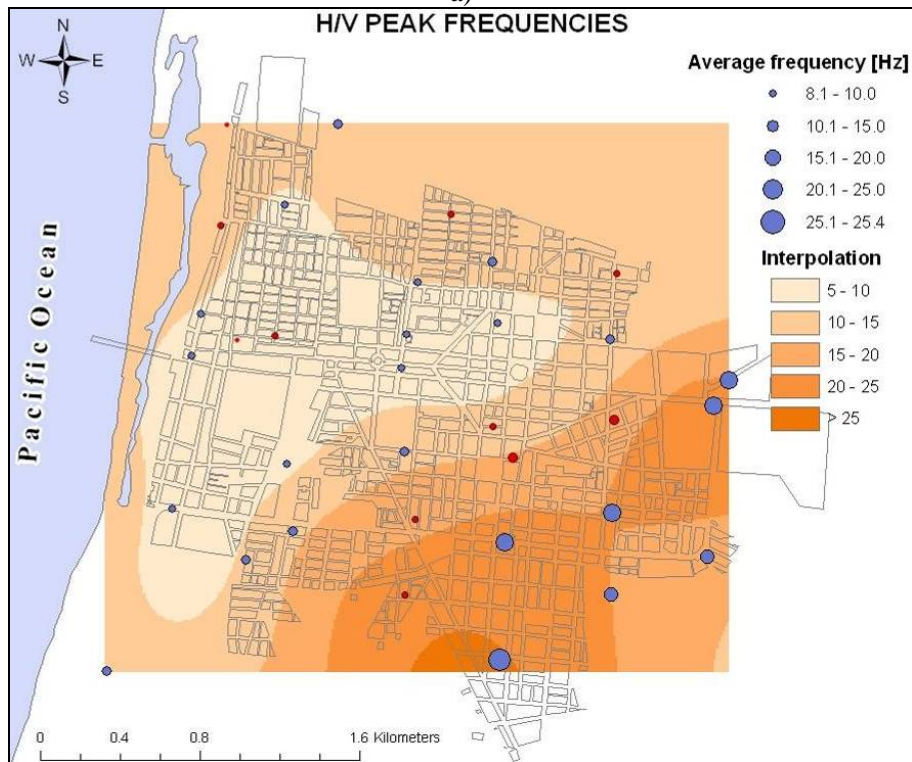
In Figure 7 blue circles mark observations sites with easily identified peaks, while the red circles mark the ones with less distinct peaks. Based on the reliable points (blue circles), a straightforward spline-type interpolation depicts a North-West to South-East trend of increasing frequencies.

The H/V frequencies (see Figure 7) reflects well the geological/geotechnical description (see Figure 4 and Figure 5) and become very high when moving towards the eolian deposit in the south. The geotechnical description says that south-east soil deposit consists of about 1 m thick layer of clayey gravel above a poorly graded gravel. In the central part and toward the coast where the soil are softer well and poorly graded sands ([6], see Figure 5.) the H/V frequencies are relatively low.

In the south-east parts of Pisco the MSK intensities (see Figure 1) are 6+ coincide with the very high H/V frequencies (see Figure 7). In general the adobe buildings in Pisco should have natural frequencies beneath 15 Hz. Since the natural ground frequency is above this value in the south-east it is possible that ground shaking contained mainly frequencies that would damage the buildings to a smaller degree, hence the lower MSK intensities. I.e. so called resonance effects were reduced. On the other hand the 7+ or 8- MSK intensities are within or near the clear yellow area in **Figure 9** (frequencies 5-10 Hz).

Figure 7. H/V peak frequencies and interpolation color contours. In b) Blue circles mark observations sites with easily identified peaks, while the red circles mark the ones with less distinct peaks.

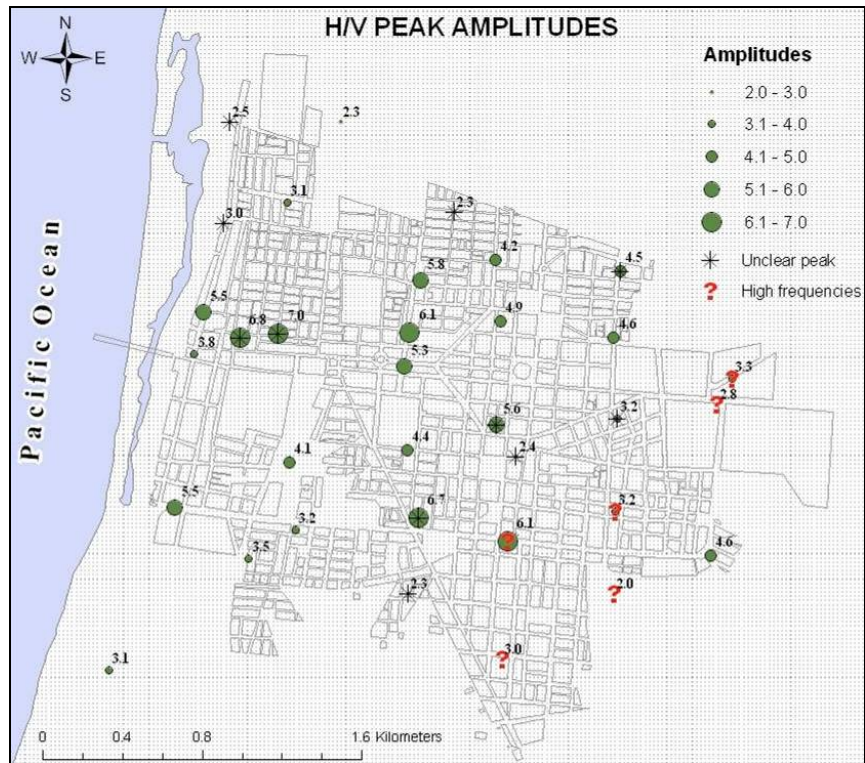
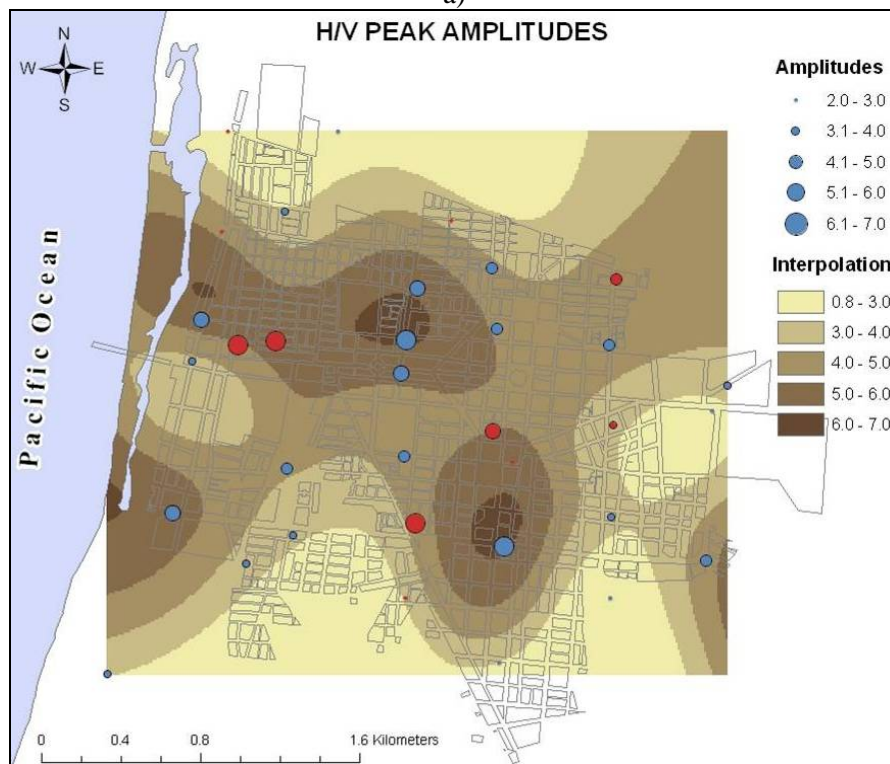
Figure 8a) shows the H/V amplification values with asterisks marking the location of points for which it was difficult to identify the peak and with question marks marking points where the peak frequency were out of the sensor range. Figure 8b) shows the interpolated contours again with blue circles marking observations sites with easily identified peaks, while the red circles mark the ones with less distinct peaks. It is difficult to identify a general pattern and the influence of the non-reliable points may change the geometry of these contours. However, there are higher levels of amplification in the central part and towards the coast.

Figure 8. H/V peak amplitudes and interpolation color contours. In b) Blue circles mark observations sites with easily identified peaks, while the red circles mark the ones with less distinct peaks.

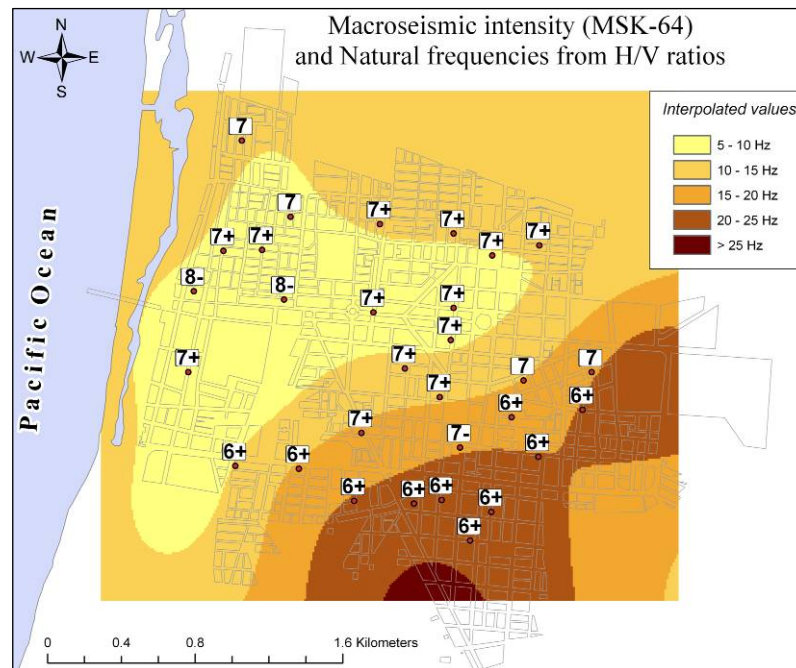
**Figure 9** shows the MSK intensities from Figure 1 plotted on top of H/V frequencies contours. There is partial agreement between the location of the 6+ intensities and the location of higher frequencies in the South-east part of Pisco.

Figure 9. MSK intensities plotted on top of H/V frequency contours.
