## IDENTIFICATION OF LIQUEFACTION FAILURES BASED ON AERIAL IMAGES

J.A. Buchheister<sup>1</sup> and M. Rezaeian<sup>2</sup>

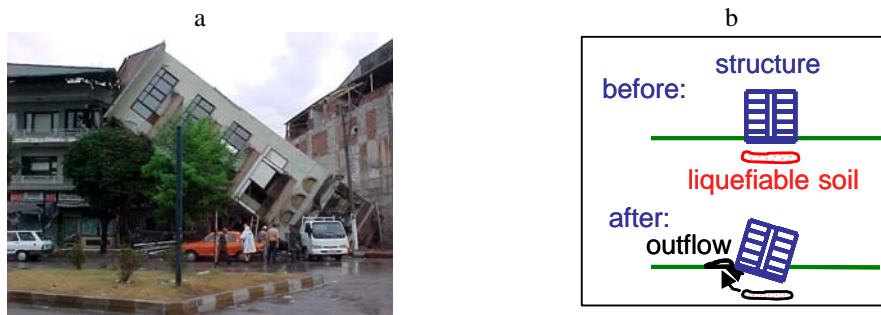
Soil liquefaction is defined as the soil changes from a solid to a liquid state mainly during excitation e.g. an earthquake. The consequences of soil liquefaction can be noticed considerably at a structure. The structure tilted or/and settled not uniformly. In Figure 1 the building shows an enormous inclination due to the rotation of the whole building and settles more at one side than at the other. Other consequences of soil liquefaction that happen in the free field are sand volcanoes and sand boils. Usually the damage in the free field e.g. on agricultural land is limited such as sand spread over the fields combined with small settlements. Whereas the damage to structures e.g. buildings can be severe. Both indices are clearly visible as phenomena of soil liquefaction.

Figure 1: (a) Tilted and settled building in Adapazari (Peer 2000), (b) sketch of liquefaction underneath a building (Buchheister 2007)

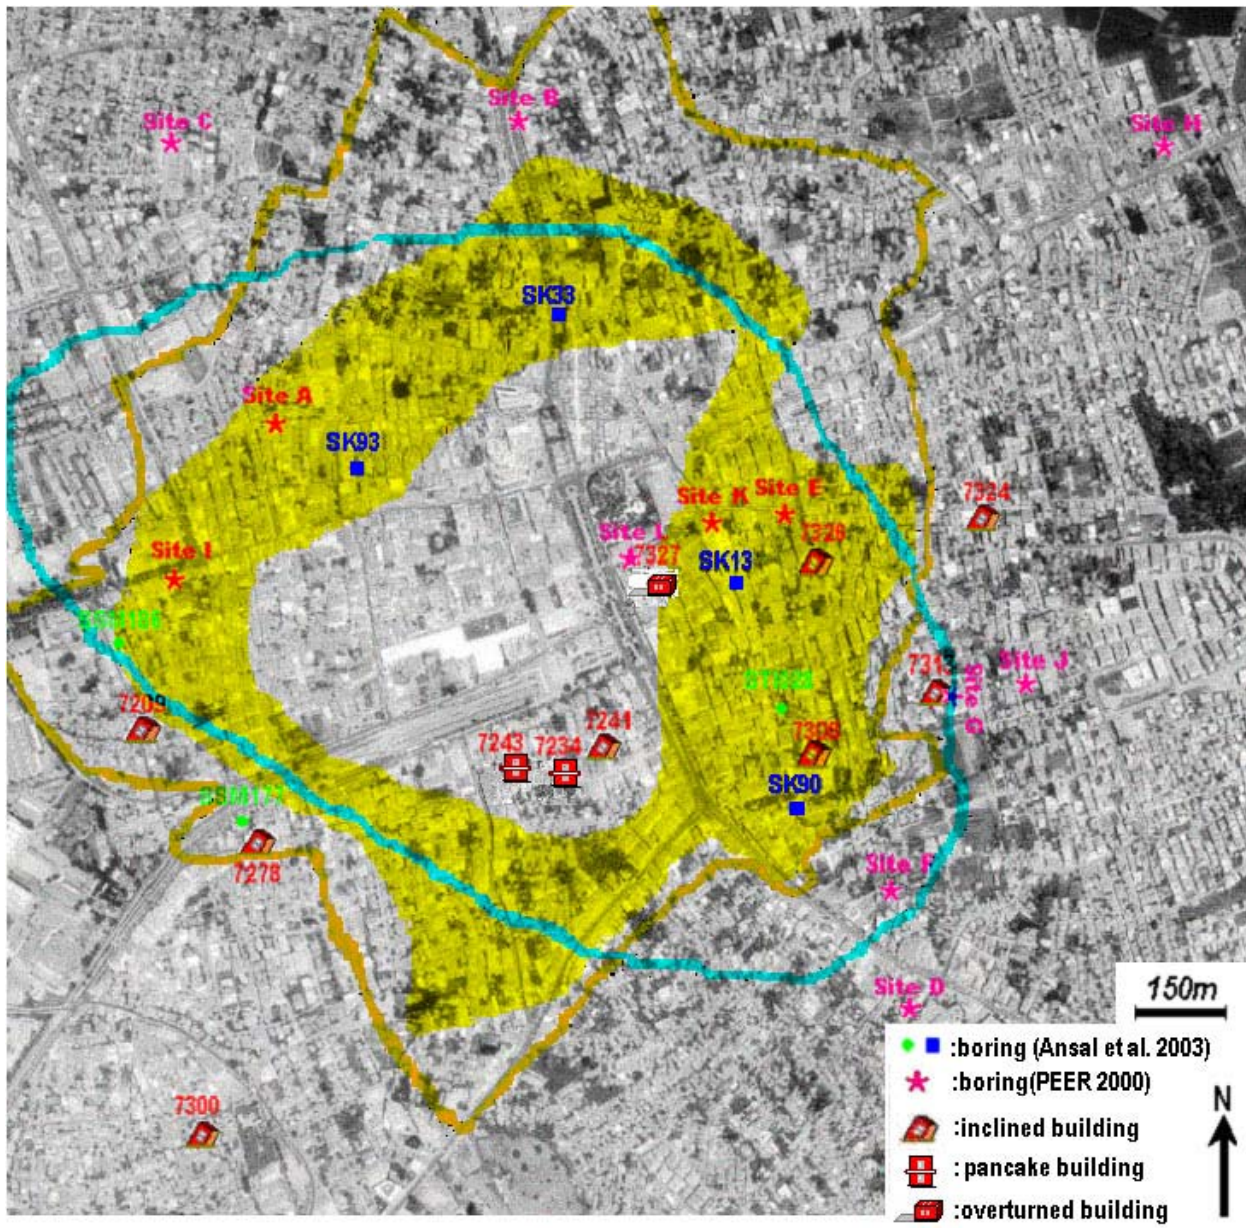
Figure 3: Aerial image indicating boring information and damaged buildings related to soil liquefaction in Adapazari city centre, Turkey (yellow lines=research area and yellow fill=liquefied area after Yasuda, 2004, blue circle=15%-30% collapsed or heavily damaged buildings and the 33%-67% presence of silt and sand layer after Bakir et al., 2002)

Yasuda (2004) defined a research area in Adapazari (yellow lines in Figure 3) that is affected only by liquefaction (area filled yellow in Figure 3). Bakir et al. (2002) found that inside their investigated area (blue lines in Figure 3) 15% to 30% of the buildings are collapsed and heavily damaged. The authors showed that the amount of sand and silty sand in the described boreholes is equivalent to 33% to 67%. This high ratio indicates a high liquefaction potential of the prevalent soil layers as the ground water level is only several meters below the ground surface that means those layers are presumably saturated. It stands out that a connection could be made between the damaged buildings and liquefaction prone soil layers in the described area.

1. *Three borings at site K and E and sk13 and two buildings 7327 and 7326.* All borings show liquefaction prone layers. Building 7326 tilted (Damage classification 9a after Table 1) and 7327 overturned (Damage classification 9b after Table 1) due to soil liquefaction in the zone identified as the area with numerous liquefaction failures. Unfortunately, the coordinates of the corner points of building 7327 could not be detected after the earthquake. Building 7326 has a maximum differential settlement of 4.97m +/- 78cm of accuracy and a maximum inclination of 15 degrees. According to the coordinates of the corner of the building a rotation is noticed after the earthquake, which is not discussed in the used classification of damaged buildings. The building not only settled vertically and tilted but also translated and rotated. Both buildings are classified as ground failure type GF3 after Table since the tilt and differential settlements are major.

2. *Two borings SSM177 and SSM 186 and buildings 7278 and 7209.* Both borings show layers of silt and low plasticity clay and silt that give a safety factor smaller of 1 in a depth of 2.2-7.2m. Both buildings show an inclination of approximately 29 degrees indicating an overturn or another type of damage that cannot be identified by the image clearly. On one hand liquefaction is possible according to the borings but on the other hand the inclination of the buildings based on the aerial photos is not clear. According to the liquefaction zone, no liquefaction failure is expected here but the buildings are very close to the boarder of this area. In terms of the near distance from the building to the boring the building damage can be also due to liquefaction.

3. *Boring G2 from site G and building 7313.* Here the boring is very close to the building, which is a huge advantage in terms of accuracy. The building 7313 inclined by maximum 8.8 degrees and shows differential settlement of 4.2m +/-78cm. Concluding this building shows liquefaction failure even though it lays outside the investigated area of other authors.
