Strategy for Earthquake Disaster Preparedness Design based on Structural Assessment and Geohazard Vulnerability Map

Pundong and Imogiri in Bantul, Yogyakarta, Indonesia as Study Areas

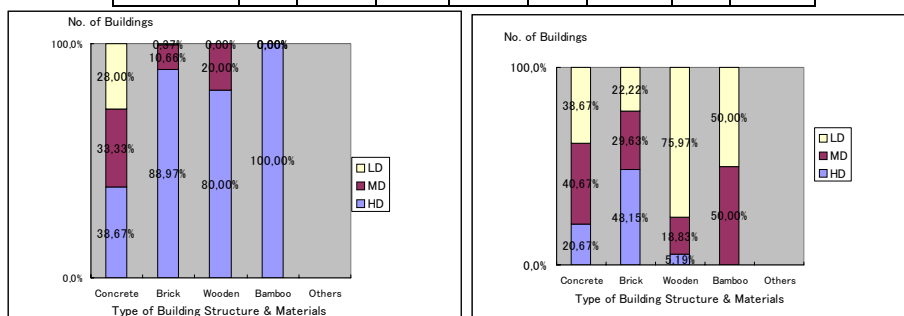
Figure 3: Building damage levels according to type of building structure & materials, in Pundong (a) and Imogiri (b)

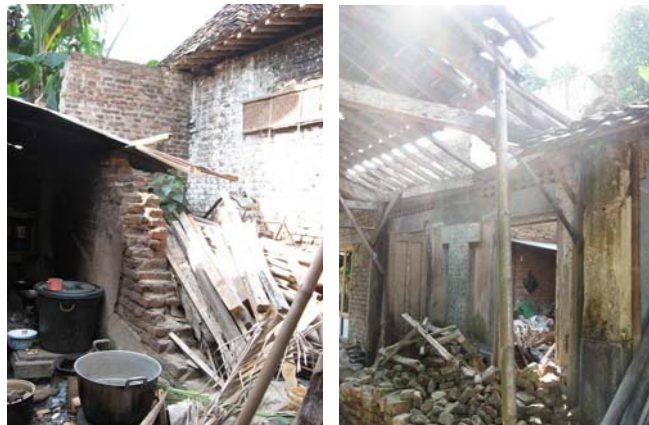
In Soronanggan-Watu-Gedong three-subvillage cluster at Pundong Subdistrict, most of the buildings are made from brick/stone (76.8%). In this type, around 89% was heavily damaged. The total numbers of Reinforced Concrete (RC) buildings is 75 buildings (21.2%), among this numbers 38.7% severed heavy damages. While in Karangasem subvillage (Imogiri Subdistrict), 45% of the total buildings are reinforced concrete (RC) buildings and around 46.2% is wooden building. Among the total number of RC building, almost 40.7% was moderately damaged while 38,7% was lightly damaged. In wooden building, almost 76% was lightly damaged (severed minor damage). The wooden building that severed heavy damage reached 5,2%. Then, among the total numbers of buildings made from brick/stone (27 buildings), 48,1% were heavily damaged. The rest are moderately and lightly damaged. Although the subvillage located close to the fault system but it is categorized into the ring two level of vulnerability.

Figure 4. Most of buildings in Pundong made of brick and concrete, severed heavily damage.

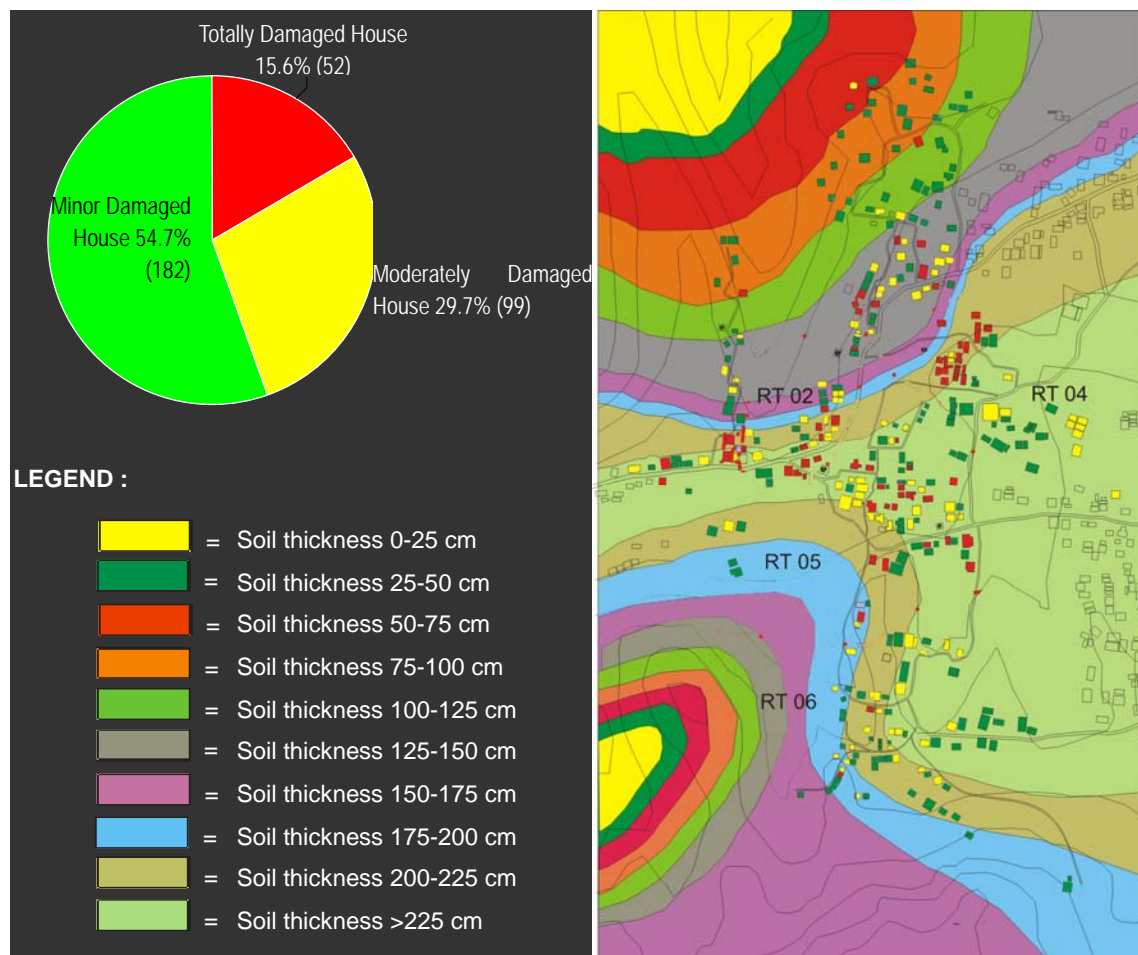
Figure 5. Building damage mapping in Karangasem, Wukirsari Village, Imogiri combined with soil mapping

According to the result of geological survey, the heterogeneity of the rock composition made the hilly area relatively safe since there is no accumulated soil comparing with the valley area. The thick soil accumulated in the valley part of the sub-village has easily been shaken by the earthquake comparing to the hilly one. As the result, the houses particularly the weak house structures were easily destroyed. In figure 4 it can be seen that the heavily damaged building mainly are located in the area with he relatively thick soil. Still in Imogiri area, the topography of the other part is hilly but on hard rock, and the building structure has strong sub structure which

relatively fixed on the hard rock layer. In the damage mapping, it is shown that the buildings located in the hilly area mostly suffered minor damages. It can be learned that, besides the structural vulnerability, the soil condition and characteristics are also becoming the determinant factors for the vulnerability of the area. Regarding the structural assessments, it is learned also that the chronology of the collapsed building in the studied areas were usually started from the frame structure located just below the roof (usually because of the inexistence of supporting elements, such as ring balk) so that all the weight of all elements of roof become the burden to the elements under the roof. More specific to the study area, most of the heavily damaged houses in Pundong Area are because of: a) the use of 1 brick with clay which has no strong force against lateral force (from seismic force), b) the new houses (± 10 years) do not have full element of structure, such as the absence of ring balk). Since that, the damage of the house was begun from roof structure which causes total damage of the entire house.
