REPAIRING OF SHEAR-DAMAGED RC JOINT PANEL ZONE USING CHEMICAL EPOXY INJECTION METHODOLOGY

O. Kaya¹, C. Yalcin², A. Parvin³ and S. Altay⁴

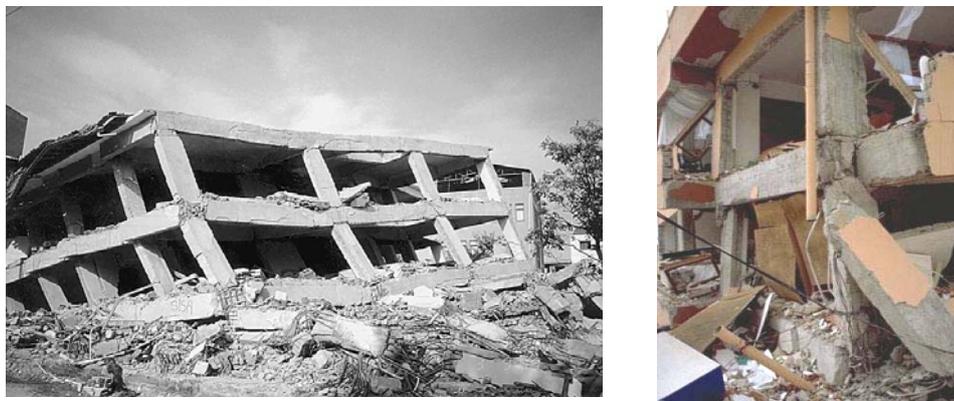
Aftermath earthquake site investigation reports generally point to one particular weakest link in the buildings, which is a failure in the beam-column joint regions (Beres, 1994, Ghobarah, 1997, Antonopoulos, 2003). Figure 1.1 clearly shows this phenomenon. In the presence of transverse beams, column ends usually fail. However, in the case of exterior frames, beam-column joint panels fail before the column ends. Although infill walls provide some damping in the building to certain extent, when they are totally collapsed, the empty frames are exposed to lateral forces, and consequently, they cannot resist for longer periods.

Figure 1.1 Typical beam-column joint failure in 1999 Kocaeli earthquake (El-Amoury, 2002 and Sezen, 2000)

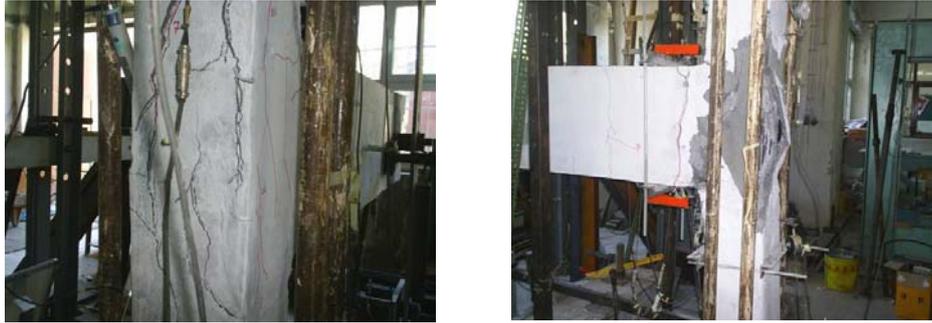
During the 1.00% drift cycles, the first diagonal crack occurred at the top corner of the beam-column joint region. The recorded loads were 45.3 kN and 63.2 kN for push and pull directions, respectively. After this drift level, the load carrying capacities started to decrease. The first crack on the bam widened further to about 2.5 mm at the drift level of 1.40%. During this drift level, the vertical cracks were observed at the back side of the column at joint region. The reason of these cracks was due to buckling of column longitudinal reinforcements.

The test was ended at 2.75% drift level when the cover concrete at the back side of the column spalled off completely and the column longitudinal reinforcing bars were buckled. Figure 4.3 shows the observed damage and Figure 4.4 illustrates the force – displacement relationship.

Figure 4.3 Cracking of joint region at the end of the test
