A MEXICAN CITY CASE STUDY (MORELIA, MICHOACAN) ABOUT BUILDINGS AND INFRASTRUCTURE DAMAGES FROM ACTIVE GEOLOGICAL FAULTS

KEYWORDS: Geological fault, vulnerability, damaged building

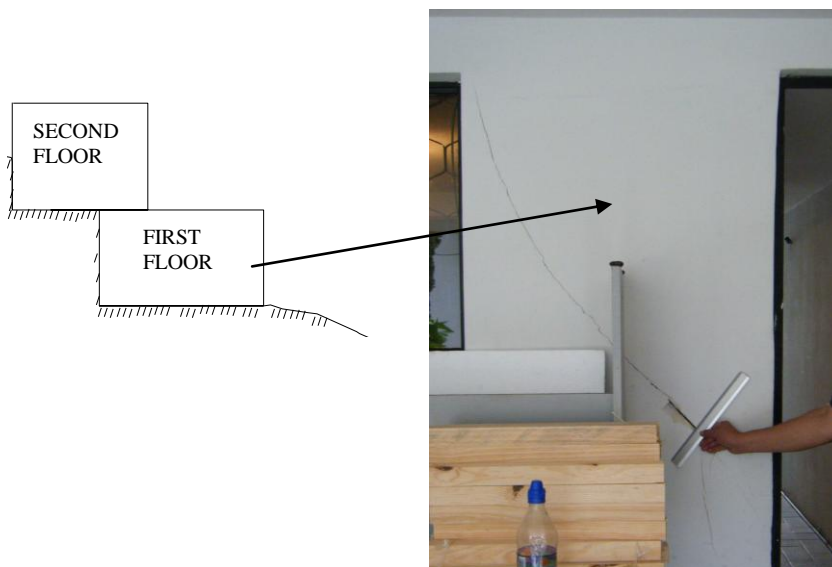
The virtual central point is located at $19^{\circ}40'49.10''$ N and $101^{\circ}10'47.02''$ W (© 2007 Google Earth™). Building has been developed all around the scarp, from bottom to top. In the lower part, houses are from one to three stories. Damages are kept under control by considerable maintenance and repair expenses. Fissures are repaired each two months on average. There is a building called IMCED which is representative of two stories houses which are common in this area. The first floor of IMCED is on the ground and the second one was built on the upper part of the ground. This is a typical way of house construction in the area, by “taking advantage” of the slope. Transversal walls to the slope exhibit diagonal fissures due to shear forces (see Figure 3). The floor presents cracks in some areas. Land slope instability is the main problem, damaging the structure by the house sliding, separating the upper structure from the foundation.

Figure 3 Representative two stories house wall damaged (IMCED).

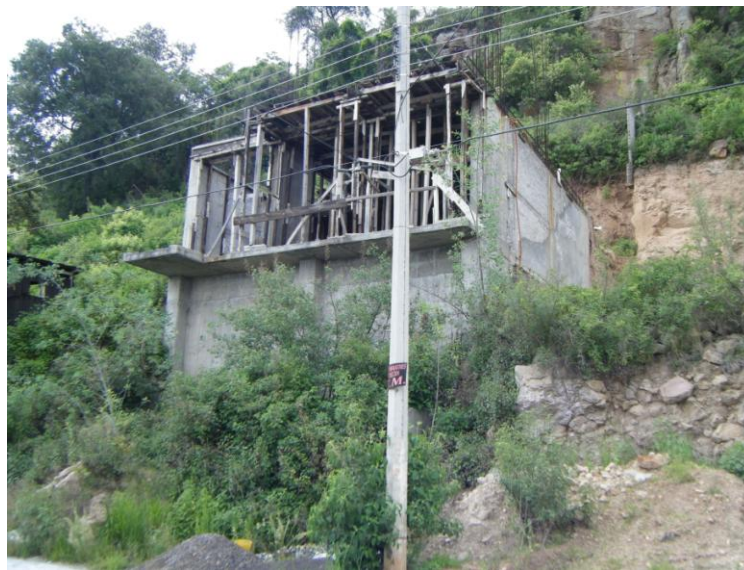
In the upper part of the scarp, buildings are from one up to six stories, where ground subsidence used to be the main problem (see Figure 4). In the middle of the scarp, two houses (Franz Liszt St.) experienced such a subsidence event on September, 2006: Authorities said the problem was caused by faulty construction, assuming none responsibility on damages, although they had granted the corresponding building permits. Nowadays one of those houses is non-habitable. Following the road up the scarp, some houses exhibit structure displacements from its foundation (4 cm on average). Roads are repaired each two month according to inhabitants comment. Potential danger comes up from a normal fault and historic seismic activity evidence, land slide and falling blocks [Arreygue-R et al, 2002]. This area offers a beautiful view of the city, and it is an expensive neighborhood, so that owners may afford to pay for repairs like cracks on floors, cracks on walls, cracks on foundation and even to make major repairs like building and rebuilding contention walls and so. Some owners have decided to sell their houses, but on the other hand, three new buildings appeared on last year. One of those buildings is made out of steel, meanwhile the others are made by reinforced concrete frames.

Figure 4 Construction on progress along the scarp (zone II)

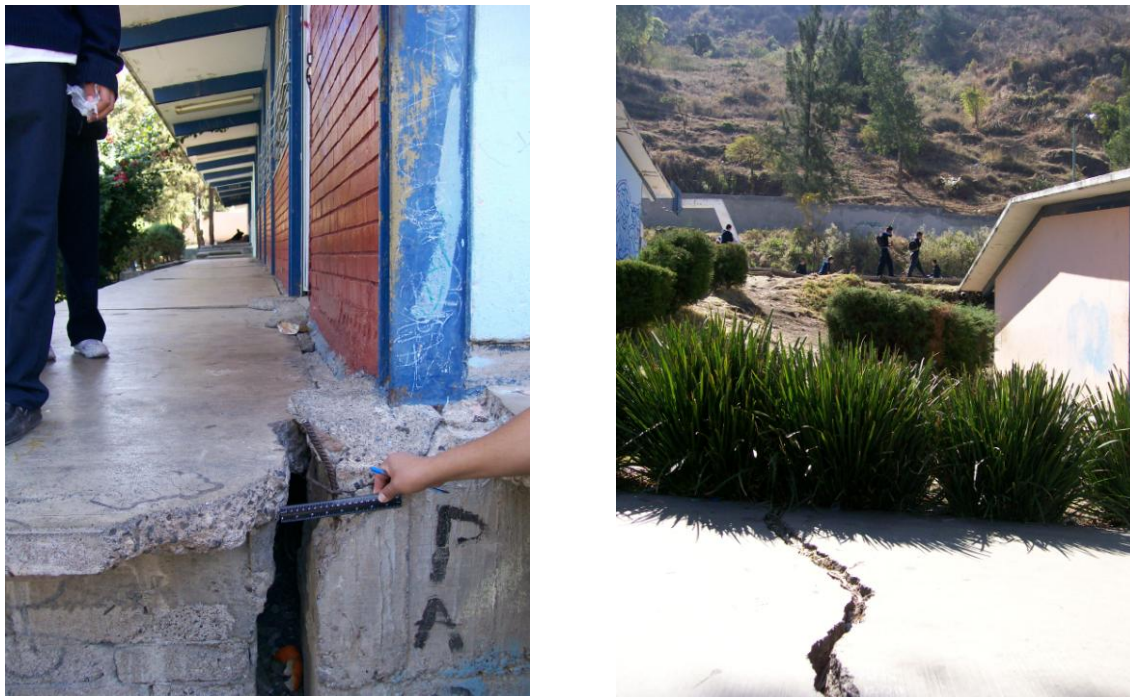
The fault does not affect all the buildings, but just a couple of them and most pavement areas. Subsidence in damaged buildings caused three to five cm. cracks in their foundation and problems with floor coverings. Their footing beams have fissures due to the stress provoked by the subsidence and displacement of the building. This issue has been attended by cross-bracing selected steel frames in the buildings.

Figure 5 Middle School playground damages

The cross-bracing solution has worked up to now. Anyway, owners have accepted to be doomed to repair pavement and stairs in the playground area each four or six months, pouring asphalt and concrete in the cracks, and remaking sidewalks and steps (see Figure 5).

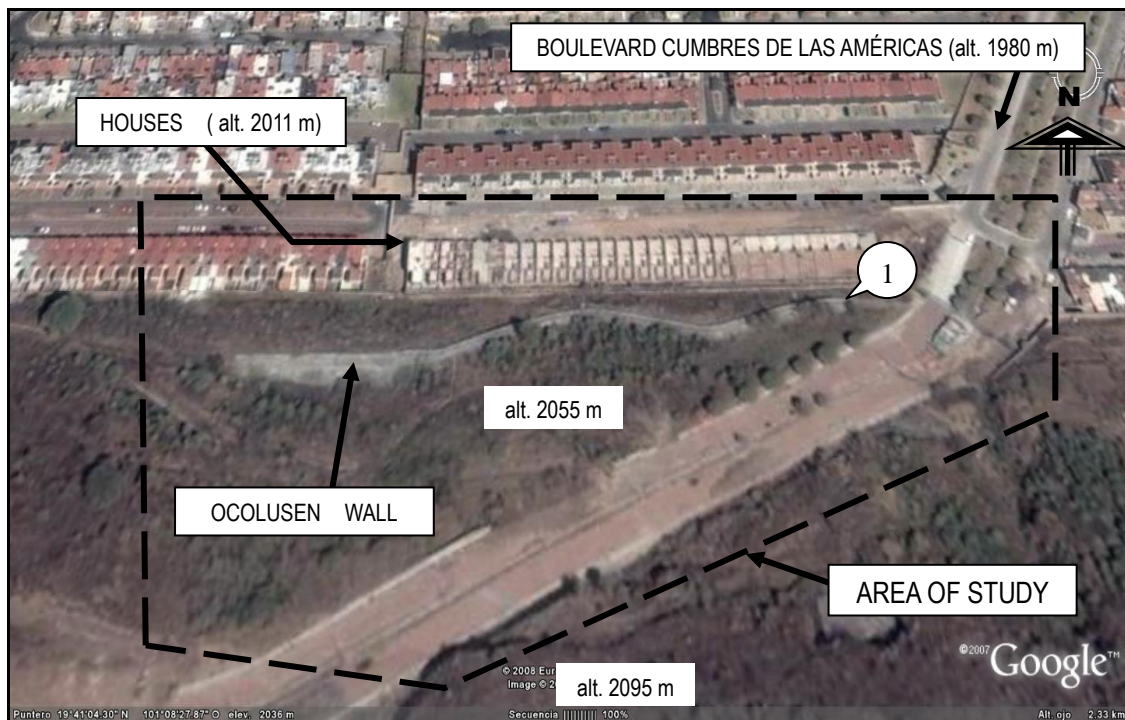
Figure 6 Ocolusen retaining wall area overview

As previously said, the retaining wall was built to protect a house complex (Lomas de Ocolusen neighborhood) from complex landslide. The wall is made up by mortar-bound stone, with an approximate length of 200 m, and it is oriented in a NE-SW direction. At this point the scarp presents a height difference between the upper and lower blocks of the fault of about 130 m. In this area, the ground contains pyroclastic rock and presents rototranslational slide and toppling effects [Arreygue-R et al, 2002]. Figure 6 offers a Google Earth commented image about the area.

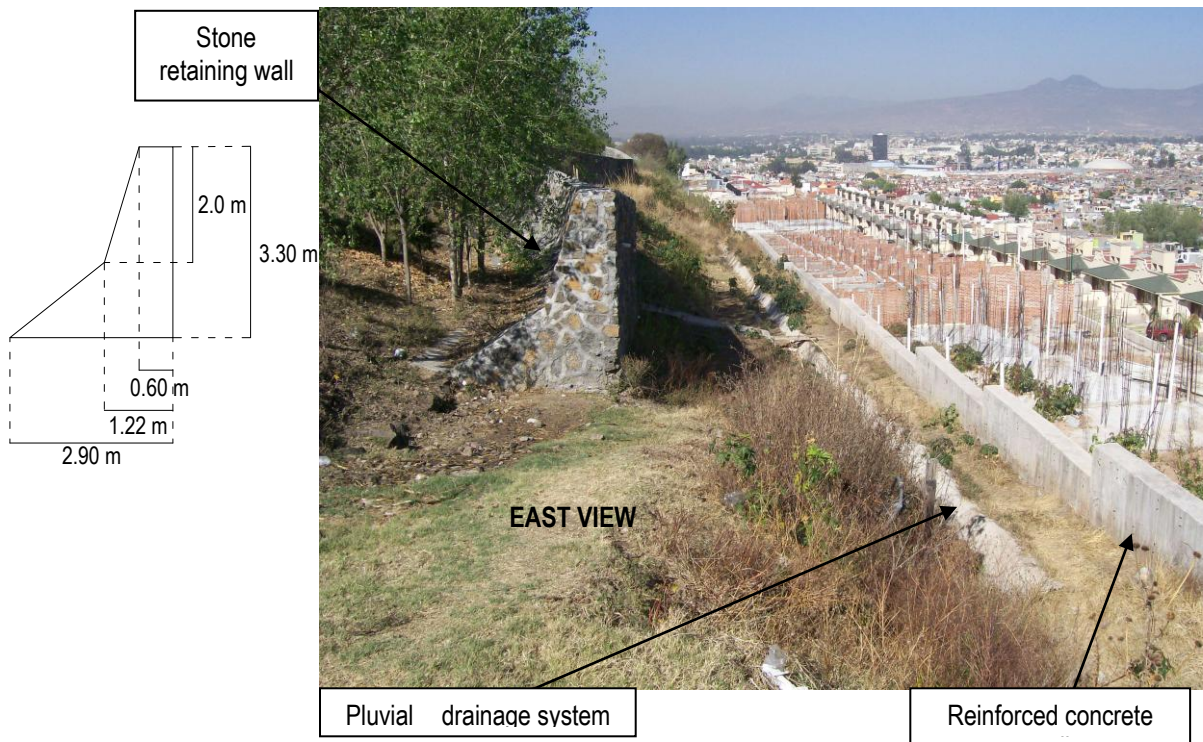
Figure 7 Ocolusen retaining wall geometry

Point 1 in Figure 6 was also located by the GPS. The position was 14 Q 0275631; UTM 2178008. The cross section of the wall is showed in Figure 7, in which it is also possible to view another retaining wall (reinforced concrete) a couple of meters below the stone one. The image shows the distance between the wall and the house complex. There is an open concrete channel between the walls to conduct rain water downstream. This is the water that flows from the higher zone of the stepped scarp. There are 3" pipes in the stone wall to allow water passing through.

There are slide and toppling in the area, which have caused spectacular falling of the sidewalk and curb along the way up the hill. Owners try to keep repairing the road, but the effort seems to be useless, since the ground keeps yielding. They have experienced different routes for channeling pluvial water downstream, but they have not found a satisfactory alternative yet. However the house complex downstream continues being constructed. On the

other hand, the retaining wall is being cracked by the ground slide. Hopefully it will bear the complex landslide should it happened, but unfortunately and just from a rough sight estimation, it will not.

Owners repair approach has consisted in putting more mortar plaster to fill the wall cracks, and improve the way water pass through the wall, besides to keep experiencing with different paths to channel the pluvial water downstream. In the meantime, the house complex keeps going on, cutting the scarp to gain land for the construction of more two story houses.
