REVIEW OF RECONSTRUCTION IN ACEH FOLLOWING THE 2004 BOXING DAY TSUNAMI

Zygmunt Lubkowski¹, Jo da Silva², Kubilay Hicyilmaz³ and Damian Grant⁴

ABSTRACT :

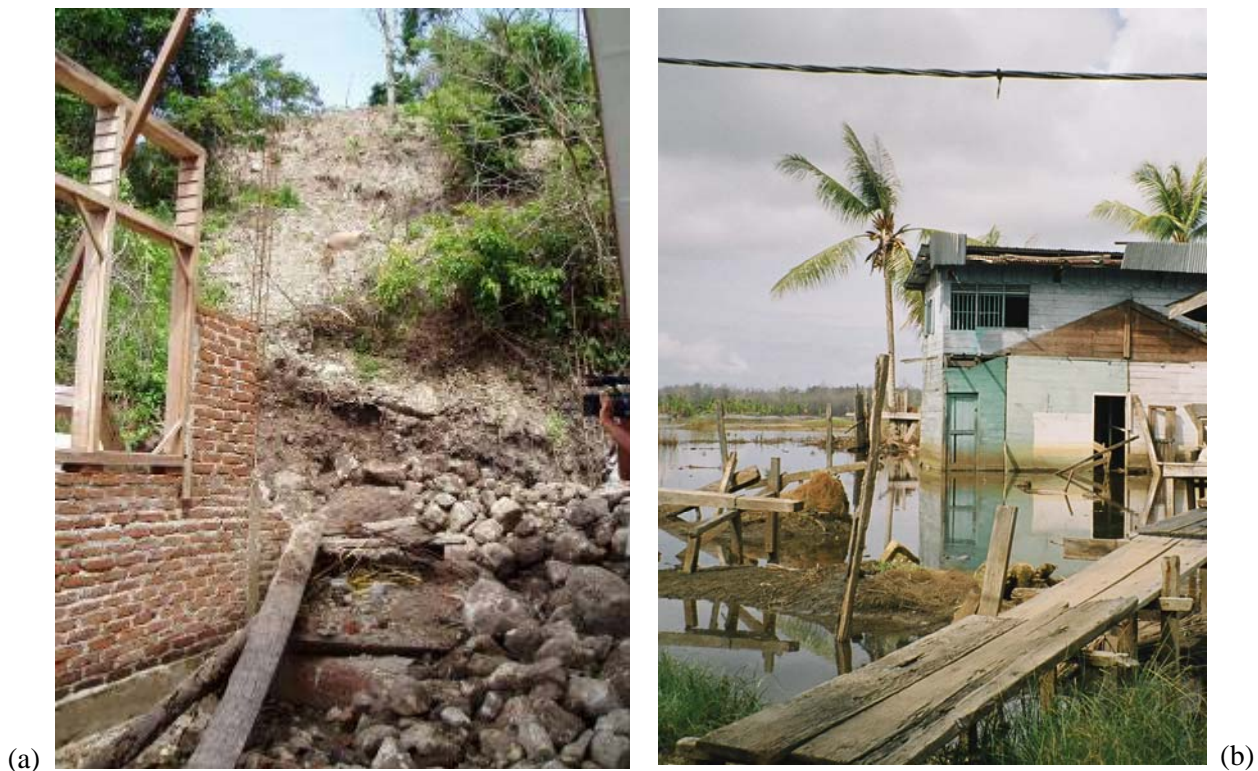
The average rainfall for Banda Aceh is about 1.6m in a year, with the principal rainy season being between September and January. The region is therefore susceptible to large water run-off that can lead to flash flooding. This requires adequate drainage design. Locating housing on high ground, or elevating it on stilts reduces the impact of flooding. Where developments are to be built on or near slopes, it is important that terraces and drainage channels are sufficiently engineered to ensure their stability (Figure 2a).

Figure 2 Examples of housing at risk due to non-tsunami hazards
(a) landslides due to rainfall (b) inundation by the sea

Flooding can also occur due to changes in topography following major earthquakes. Following the 26 December 2004 and 28 March 2005 earthquakes, the Sunda Plate has sunk by about 1m with respect to sea level. This has had a dramatic effect on towns such as Singkil (Figure 2b) and Rigaih, where large areas have been “lost to the sea” or highly susceptible to tidal flooding (the maximum tidal range along the Aceh coast is about 1.5m). As a result many villages have been displaced or have been made uninhabitable.

Where there has been significant loss of coastline due to large scale plate movements, one must consider the future viability of the affected settlements. Engineering solutions can be provided, but they will require detailed investigations and significant civil engineering works to provide a safe, flood free environment. Hydrological

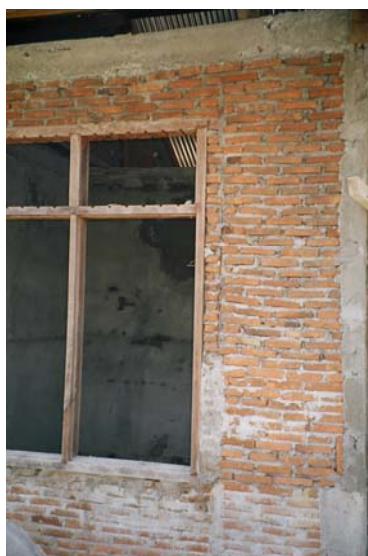
Openings/Wall Panels

During our first visit it became clear that the requirements of the Building Code were not being enforced, and many houses built at that time did not comply with these basic requirements (see Figure 3). Furthermore, it is noted that most international codes have restrictions on the use of unreinforced masonry for regions of moderate and high seismicity, such as Aceh. However, the Building Code for Aceh permits the use of masonry for wall panels, but provides no guidance on fundamental seismic principles including: maximum size of wall panels, openings in wall panels, minimum thickness of wall panel, tying of wall panels and provision of ring beams.

- The design and workmanship quality for many houses (reinforced concrete frame with unreinforced masonry infill) were found to be very poor when reviewed using the FEMA 154 approach. Many new constructions are thought likely to collapse in the next major earthquake.

- Experienced earthquake engineers should survey structures that survived the earthquake of 26 December 2004 and address the issue of retrofitting.
- Experienced engineers should develop a basic and comprehensive code of practice for post-tsunami housing, and possibly a complimentary training programme to reinforce it.
- Procedures should also be developed to regulate the quality of construction. These are critical to deliver a product that is fit for purpose, and reduce vulnerability to future events. In particular experienced engineers should review construction of critical facilities; hospitals, schools, bridges etc.
- An education programme on hazards should be implemented at all levels of government, in NGOs, and within the wider community to raise awareness.
