BEHAVIOR OF EXTERIOR CURTAIN WALL OF HIGH-RISE BUILDINGS AGAINST LARGE STORY DRIFT BY LONG-PERIOD EARTHQUAKE GROUND MOTIONS

KEYWORDS: Exterior curtain wall, full-scale shaking table test, long-period ground motions

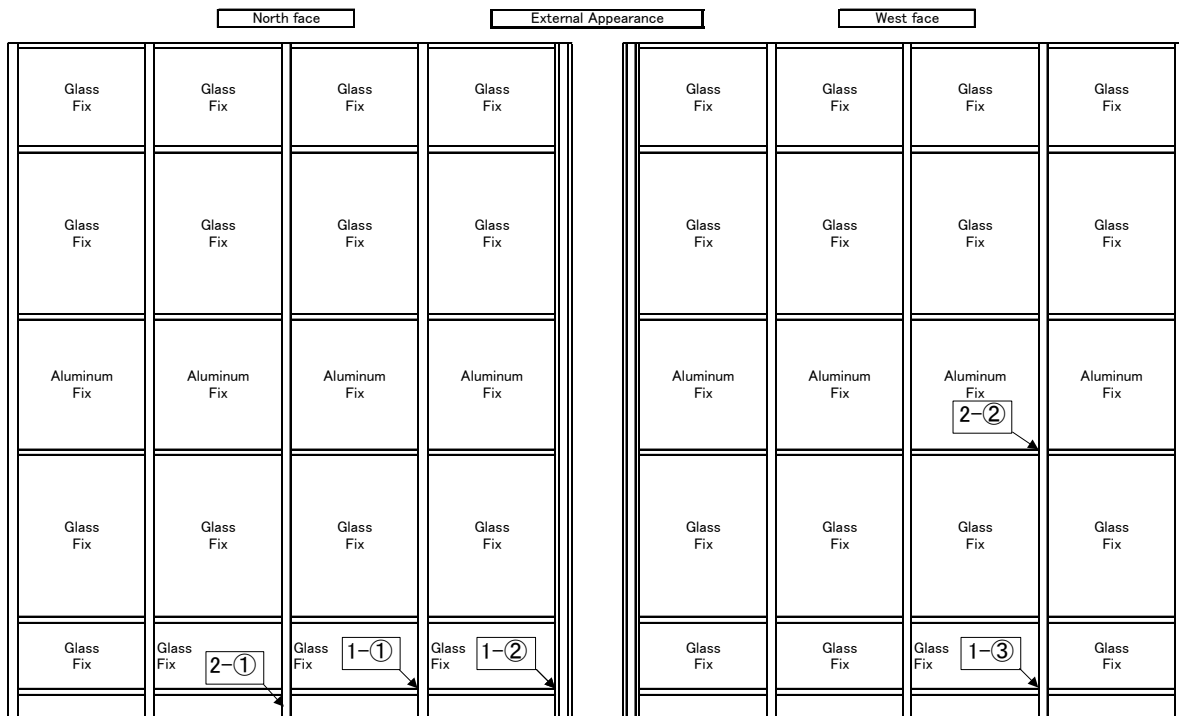
Figure 5 Place of damage of curtain wall in the test of Case 1) and Case 2)

Case 1) Although small, a slippage was generated in the lowermost fastener for both the north and the west face (Photo 2 (a)). No deformation was observed around glass.

Case 2) Washer slippage (Photo 2 (b)) was observed at the lowest part of the north face. Separation of a sealing member (Photo 2 (c)) was noted at the lowest part of the west face. Residual deformation was not observed around glass, as in case 1.

Table 5 Damage of curtain wall in the test of Case 1) and Case 2)

Place	Damage
Case 1-①, 1-②, 1-③	Fastener slippage
Case 2-①	Washer slippage
Case 2-②	Separation of a sealing member

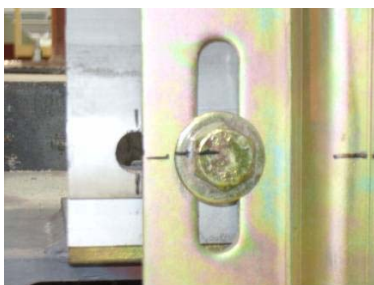
(a) Fastener slippage

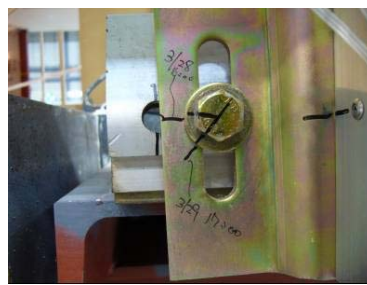
(b) Washer slippage

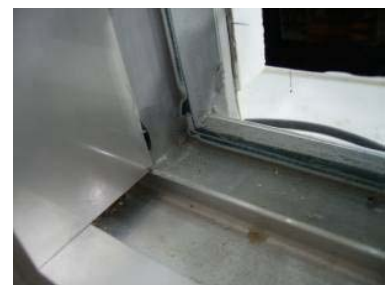
(c) Separation of a sealing member

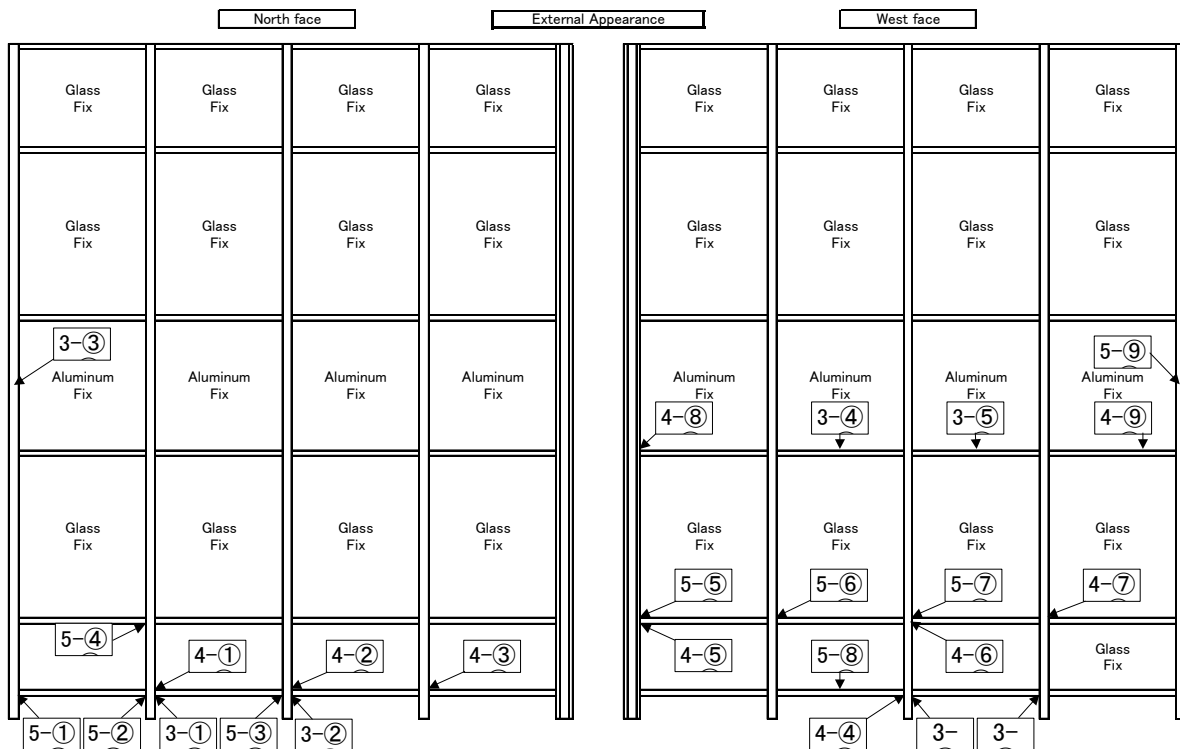
Figure 6 Place of damage of curtain wall in the test of Case 3) Case 4) and Case 5)

Case 3: Washer slippage was observed at the lowest part of the north face, and washer slippage, bead slippage, mullion slippage and bracket slippage (Photo 3(a)) were observed at the lowest part of the west face. Furthermore, at the end of center part of the west face, disengagement of a machine screw from the blind box (Photo 3(b)), and drops of machine screws of the fanlight receiver bracket were noticed in a couple of places.

Case 4) and 5) Bracket slippage was observed at the lowest part of the north face. Bead slippage (Photo 4 (a)) was observed at one location. Bracket slippage was also apparent at the lowest part of the west face, and bead disengagement was observed. Residual deformation was apparent around glass (Photo 4(c)), and rise up of height adjust bolt (about 1.5 mm) was observed at the south end center area (Photo 4(b)).

Table 6 Damage of curtain wall in the test of Case 3) Case 4) and Case 5)

Place	Damage
Case 3-①	Washer slippage, Horizontal gap of fastener bracket
Case 3-②, 3-⑦	Washer slippage
Case 3-③	Rise up of height adjust bolt
Case 3-③, 3-④	Disengagement of a machine screw at the blind box
Case 3-⑥	Rotation of fastener bracket
Case 4-①, 4-②, 4-③, 4-④	Washer slippage
Case 4-⑤, 4-⑥	Bead slippage
Case 4-⑦	Slippage of mullion component, bracket slippage
Case 4-⑧, 4-⑨	Disengagement of a machine screw at the blind box
Case 5-①, 5-②, 5-③	Bracket slippage
Case 5-④	Slippage of glazing bead
Case 5-⑤, 5-⑥, 5-⑦	Disengagement of glazing bead
Case 5-⑧	Bracket slippage
Case 5-⑨	Rise up of height adjust bolt (about 1.5 mm)

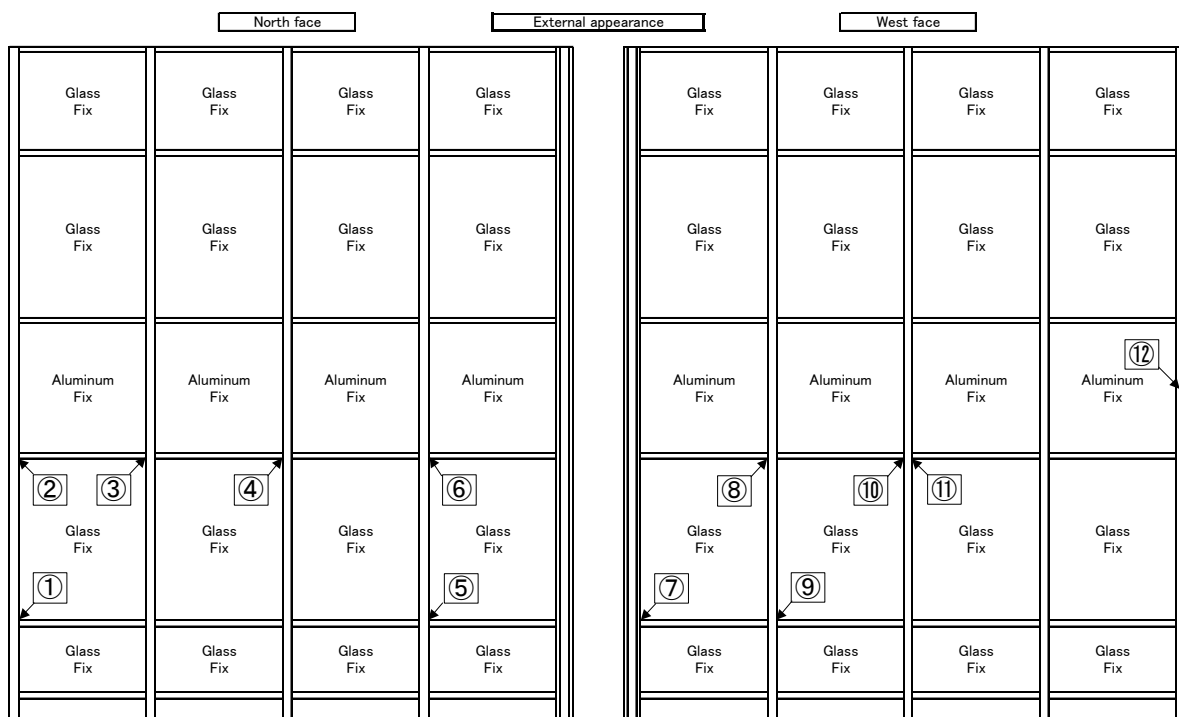
Figure 7 Place of damage observed by investigation after dismantle of Glasses after test

By investigation after dismantle of Glasses from aluminum members after test, some defects at glass corner (Photo 5 (a)), some dent at glass pocket of transom (Photo 5 (b)) and defect at glass corner (Photo 5(c)) were observed.

Table 7 Damage of curtain wall observed by investigation after dismantle of Glasses after test

Place	Damage
①	Dent closing plate at transom end
②	Dent at glass pocket of transom
③	Some defect at glass corner and dent at glass pocket of transom
④	Rise up of transom (residual displacement with 3mm) no dent, nor damage
⑤	Some defects observed at glass corner
⑥	Some defects at glass corner and slight dent at glass pocket of mullion
⑦	Unable to take off glazing bead due to deformation of mullion component
⑧	Some defect at glass corner and slight dent at glass pocket of mullion
⑨	Damage at pre-sealant at transom edge (no adhesion to substance)
⑩	Some defect (crack) at glass corner and dent at glass of transom
⑪	Slight defect at glass pocket of transom
⑫	Rise up of height adjust bolt(residual displacement with 2mm)

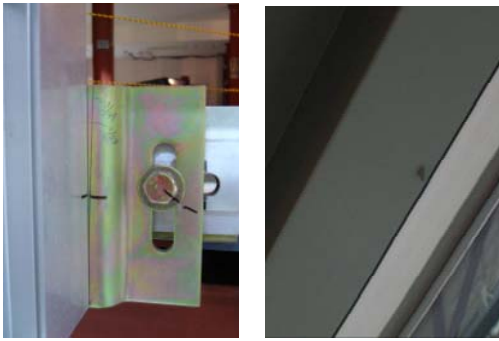
(a) Rotation of a fastener bracket
 (b) Disengagement of a screw at the blind box
 Photo 3 Damage of Case 3)

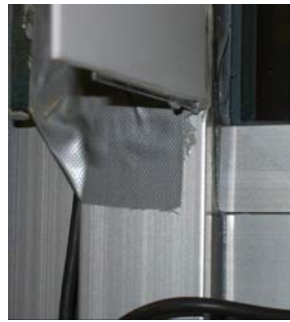
(a) Bead slippage

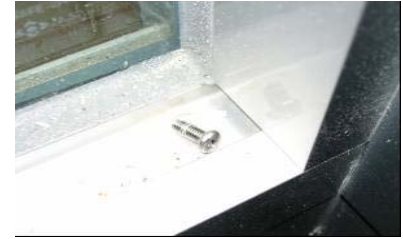
(b) Disengagement of height adjust bolt of transom

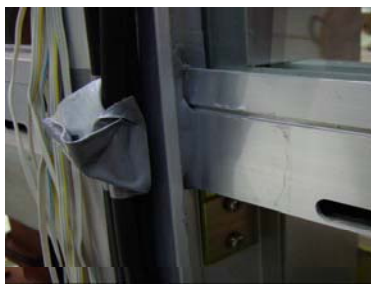
(a) Slippage of glazing bead

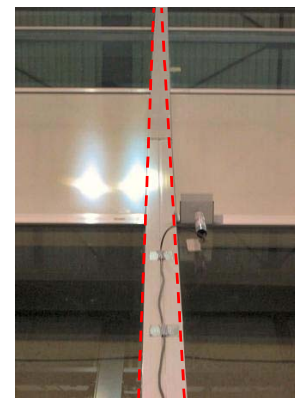
(b) Rise up of height adjust bolt

(c) Residual deformation of mullion →
 Photo 4 Damage of Case 5)

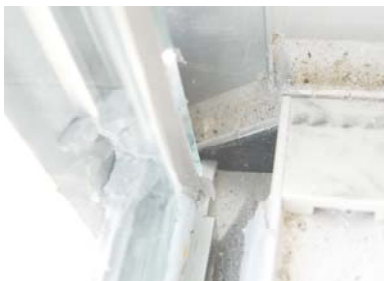
(a) Some defects at glass corner

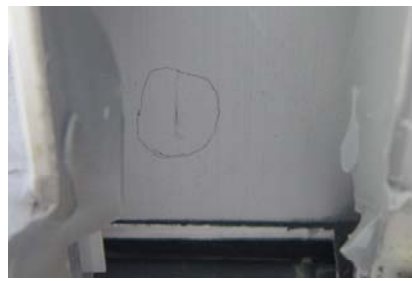
(b) Dent at glass pocket of transom

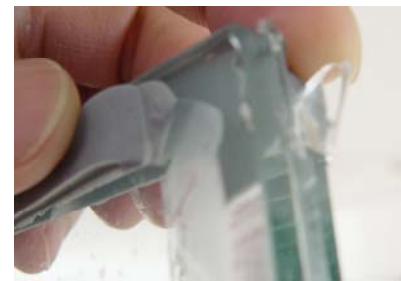
(c) Defect at glass corner
