SEISMIC DAMAGE TO STONE STRUCTURES IN MACHU PICCHU

C. H. Cuadra¹, K. Tokeshi² and J. G. Rojas³

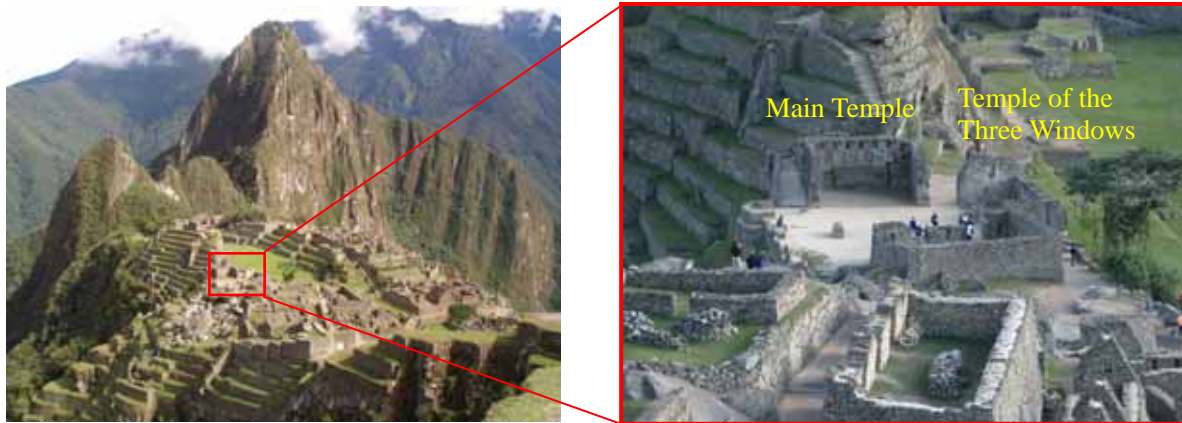
Figure 2. The main temple and the temple of the 3 windows in the Sacred Plaza sector

In previous research (Cuadra *et al.*, 2008), the equivalent Young elastic modulus for the first and the third style was studied. In this research, the second style was chosen to complete the study on the equivalent Young modulus of elasticity, and also to study the failure of this type of constructions in Machu Picchu. The targeted buildings and its overall location in Machu Picchu are shown in Figure 2. The Main Temple and the Temple of the Three Windows are located in the Sacred Plaza sector. Details of the Main Temple and the Temple of the Three Windows can be observed in Figure 3. The Main Temple shows damages of displacements between stone blocks of the north wall due to the settlement of the east wall (Figure 3 (a)). In the case of the Temple of the Three Windows, relative horizontal displacements of stone blocks can be observed (stone blocks on the left of Figure 3 (b)).

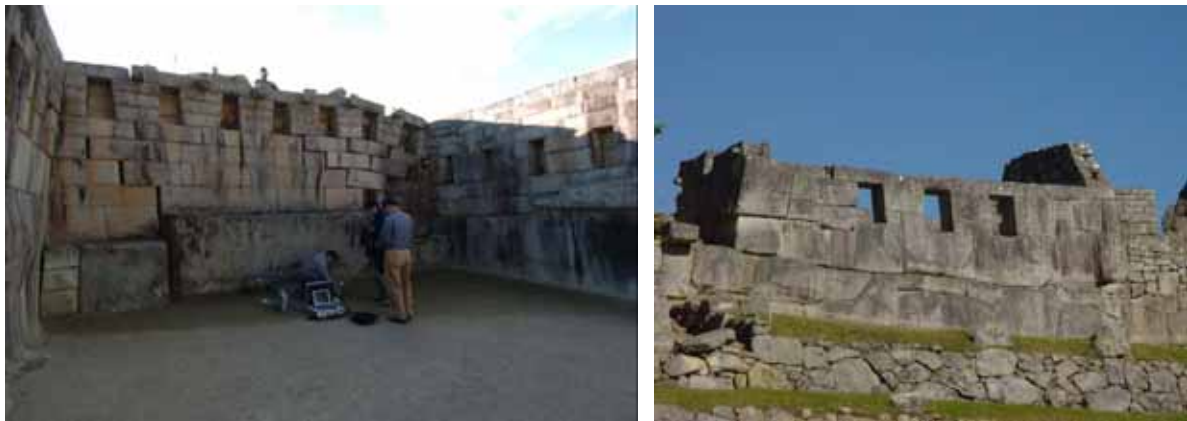
Figure 3. Details of the Main Temple and Temple of the Three Windows

Figure 4 shows the H/V spectral ratio obtained from microtremor measurements at the ground of Sacred Plaza. A predominant frequency of 23.7 Hz was estimated, which would mean that depth of the bedrock is shallow. Usually, the natural frequency of the ground ranges between 1 Hz for soft soil deposits and 10 Hz for hard soil deposits. Therefore, the estimated predominant frequency of 23.7 Hz indicates that the thickness for soft soil layer would be very thin (around 1 m) and that the bedrock would be close to the ground surface. In consequence, these buildings would be founded directly on the bedrock. The soil settlement failure observed apparently in Figure 3(a) would correspond to a failure in the bedrock. In that case, it is probable that some mechanical action on bedrock has produced the cracking of the rock, and as consequence, it has been the cause of settlement in the east wall of the Main Temple.

Finally, the horizontal sliding between stone blocks in the Temple of the Three Windows could be consequence of strong seismic forces of past earthquakes.

The settlement observed in the Main Temple is probably due to the fracture of the subjacent bedrock in which the building is founded.

The particular horizontal sliding between stone blocks at one wall corner of the Temple of the Three Windows could be consequence of strong seismic forces of past earthquakes.
