## SEISMIC VULNERABILITY OF LIMA CATHEDRAL, PERU

### ABSTRACT :

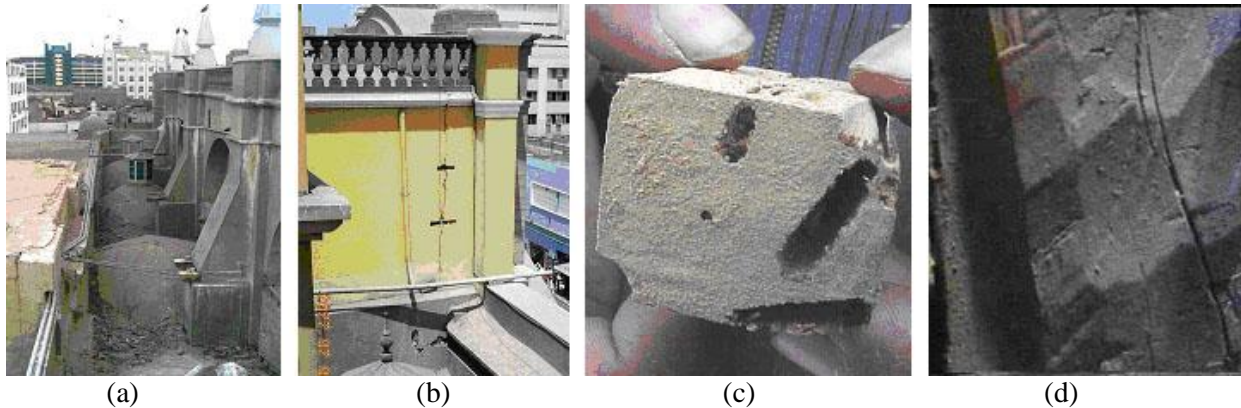
Figure 3 a) Poor maintenance of vaults and buttresses above chapels, b) Cracking in buttress at the crossing of the building, c) Biological attack in wood elements located between the vaults and roof framework d) Cracking in wood element above one pillar.

One of the most visible defects is the lack of verticality of the wood framed pillars. They have horizontal displacement in both directions, with values at the top ranging from 4cm to 15cm (in 13m) with maximum values in the central part of the building. There is no evidence of differential settlement in the walls.

Diagonal cracks were observed in the covers of most pillars. There is also visual evidence of deterioration and cracks in some of the wood elements located between the vaults and the roof framework structure. There is evidence of humidity and termite attack.

Most masonry walls do not have signs of distress, although the towers, the front walls and adjacent areas have always been affected in past earthquakes. However, there are important vertical cracks in the upper portion of the buttresses located in the crossing area of the building.

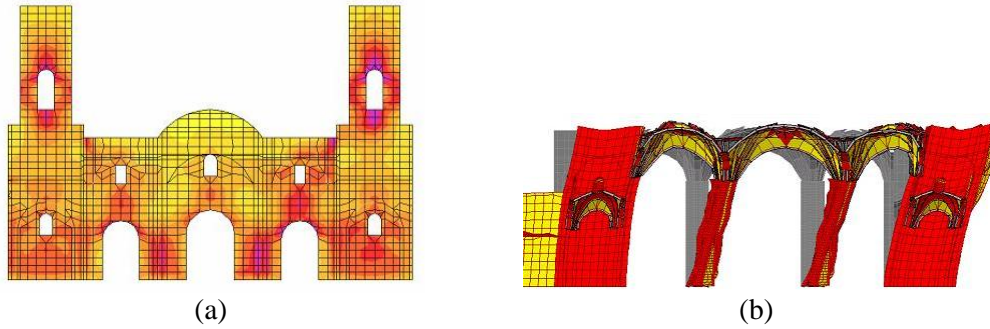
The towers of the cathedral are flexible (their fundamental vibration period being 0.6 seconds). The maximum shear stress will occur in the zone of the belfry, with values between 0.19MPa and 0.24MPa ( $2.0\text{kg/cm}^2$  and  $2.5\text{kg/cm}^2$ ). These exceed the capacity of the unreinforced masonry. As a matter of fact, the towers have been severely damaged in all major earthquakes in the past, affecting also the adjacent areas of the structure.

The front wall of the cathedral has its major weakness in out of plane direction. This wall is connected to the wood roof structure by four arches, located in pairs at the heights of 7m and 13m, which provide some lateral bracing. The analysis predicts an out of plane displacement of the order of 7cm for the design earthquake. The maximum in plane shear stress in this wall is 0.24MPa ( $2.5\text{Kg/cm}^2$ ).

Figure 6 a) Shear stress concentration in facade wall and towers b) Deformed shape of the structure due to earthquake component in transverse (X) direction.

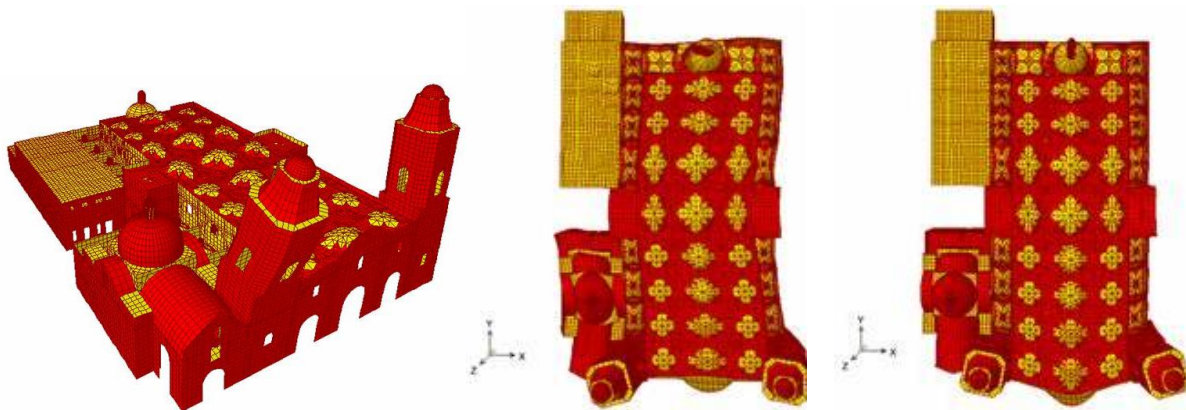
The buttresses in the crossing zone next to “Los Judíos” threshold are very flexible due to their considerable mass and 18m height. When treated as separate structures, these buttresses have a fundamental period of about 0.45 seconds, which is larger than the 0.39 s obtained for the complete building. This means that they do not effectively restrain the lateral displacement of the roof structure, but rather impair its performance.

Figure 7 Vibration modes: (a) 16<sup>th</sup> mode T=0.6s (b) 31<sup>st</sup> mode T=0.45s (c) 34<sup>th</sup> mode T=0.36s

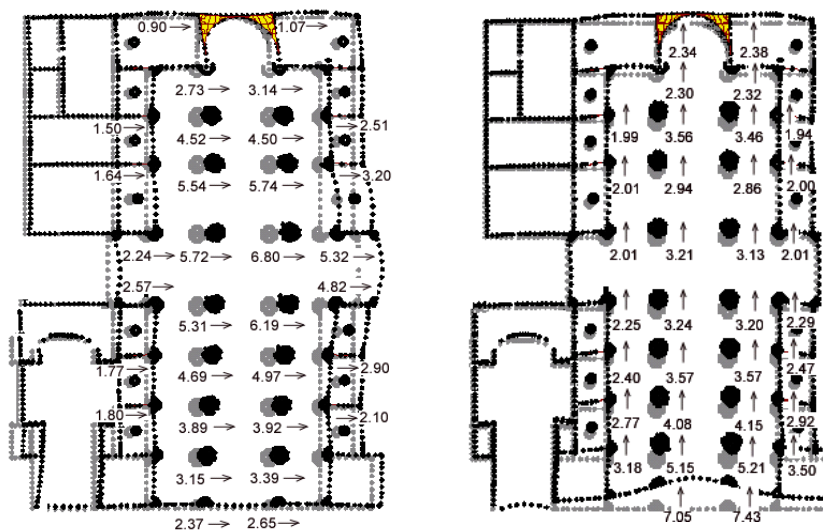
None of the analysis could completely explain the large horizontal displacements at the top of the pillars. The

analysis predicts maximum lateral displacements of 6.8cm in the area of the cruise and of 7cm in the facade wall, in the transverse (X) and longitudinal (Y) directions, respectively (see figure 9). The observed, permanent, maximum displacements are of the order of 15cm. They are obviously related with the insufficient lateral stiffness at roof level and most probably are the result of accumulated displacements, which were not completely corrected in successive reconstructions of the roof of the cathedral.

Figure 8 Lateral displacements at the top of the pillars due to earthquake components in transverse (X) and longitudinal (Y) directions.
