STRUCTURAL AND EARTHQUAKE RESPONSE ANALYSIS OF THE MURADIYE MOSQUE IN BULGARIA

ABSTRACT :

Recently, a large scale restoration has been started by the Great Municipality of Istanbul for the Muradiye Mosque of Filibe (Plovdiv), Bulgaria. Within this activity, the building is investigated in detail, damages of the building have been documented and soil testing has been carried out to identify properties of the soil and the foundation configuration. In this study, structural and earthquake responses of the Muradiye (Djumaya) Mosque of Filibe, Bulgaria, are investigated and by using these information a detailed repair and strengthening project is developed. The paper presents a summary of the results of the structural response analysis including seismicity of the building. Main principles of the recommended repair and strengthening interventions for the building are given as well. The authors participated to the project in developing geotechnical and civil engineering analysis and supplying technical support for its evaluation and strengthening.

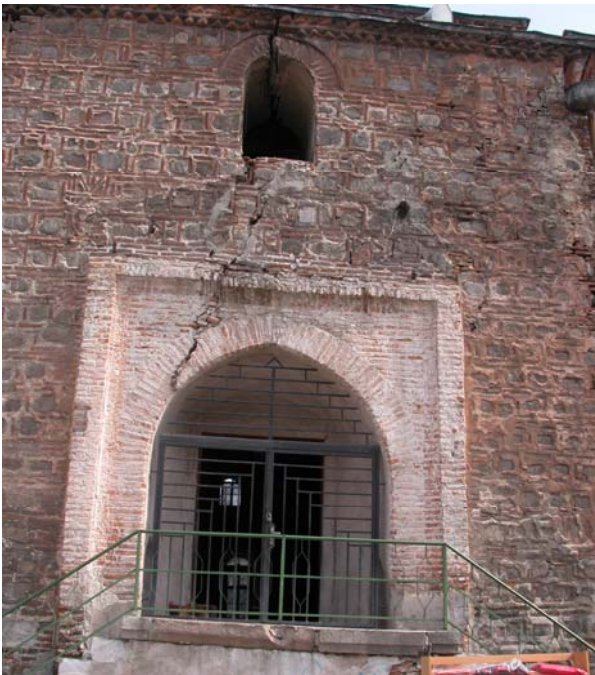
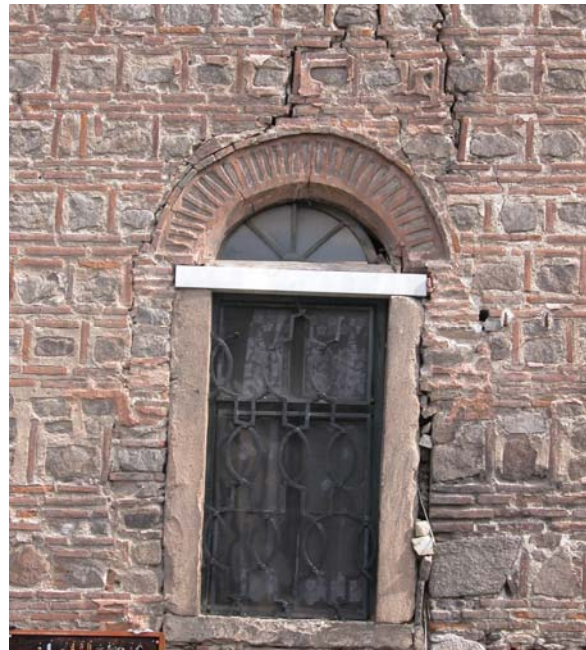
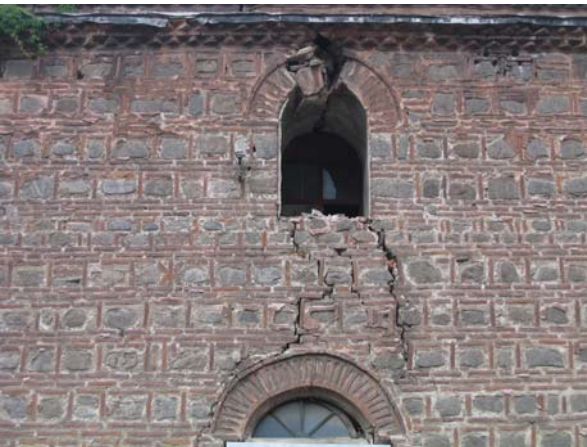
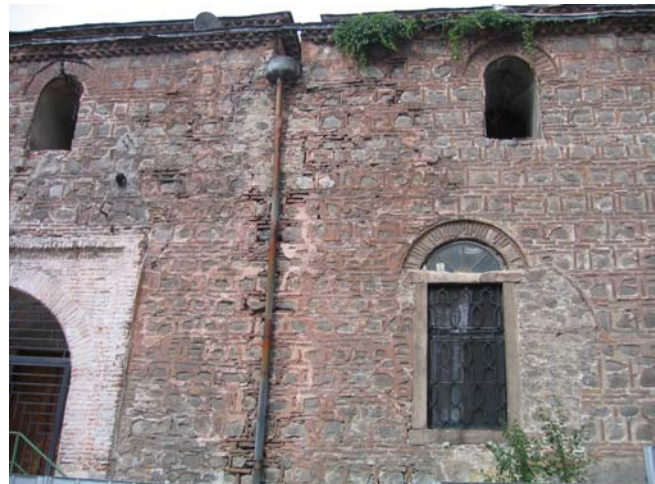
The building has lived several earthquakes, various parts of the building had been damaged, plasters fell and cracks appeared in the walls due to lack of proper maintenance. The building has undergone various structural modifications as well, due to produce commercial rooms facing to outside. The city of Filibe is located in a relatively active seismic zone experiencing by large scale earthquakes in the long period of existence of the building. According to the sources, the last large earthquake was in 1928 of a Richter magnitude of 7.0, which caused a number of cracks in the walls, domes and vaults and leakage from the roof. At the site observations, it is noticed that some parts of the walls as well those of domes and vaults had been damaged heavily due to environmental conditions as well. However, it is reported that severe cracks appeared after excavation for a minor Roman historical side next to the mosque. Although the recent damages threaten the integrity of the building significantly, almost no repair has been under taken. It is the first time that a comprehensive repair, strengthening and restoration procedures are planned (*Figure 2*).

Structural problems were become more significant after change done in the ground level as a result of the excavation. Since these historical remnants are very close to the mosque and probably the excavation was carried out without taking necessary precautions, the soil level was lowered down to the level of the foundation of the mosque. *Figure 2* shows various damages observed in the structural walls. Further damages came into being to the leakage in the sewage system. Deterioration of the building occurred mainly as a result of the environmental effects and change in the soil surface. In course of time the cracks and damages worsen, they threaten the structural integrity of the building. Following these unfavorable conditions, in order to prevent further damages, the Great Municipality of Istanbul has launched a large scale of repair and restoration work to rehabilitate the building for further use and maintain its historical value. To develop an effective methodology for repair and strengthening of the mosque, an integration of knowledge of seismology, geotechnical and structural engineering and architecture are carried out.

Figure 2 Cracks and damages in the walls of the mosque

Since observations shows that the major cause of damages in the building is the change in the soil profile originating mainly due to the excavation done close to the building. Consequently, in strengthening procedure priority is given to retrofitting of foundations by utilizing widely used underpinning method with micro piles which are used in various part of the world [3]. Micro piles are recommended under the bearing walls and piers to support structural loads and transfer loads to deeper layers of the soil and to prevent structural settlement. The micro piles recommended have a diameter of $0.20m$ and a steel tube of diameter of $100mm$ and a thickness of $5.5mm$, they are drilled, cast-in-place (Figure 4, Figure 5 and Figure 6).

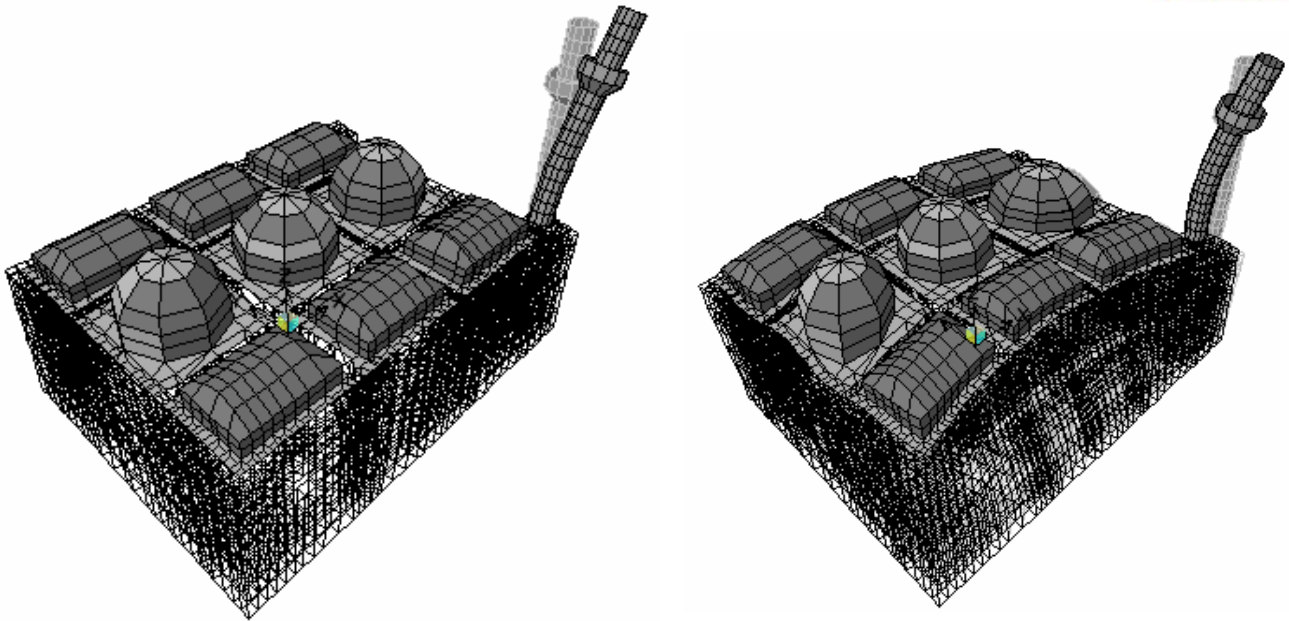
- b. *Spectral seismic analysis*: It is carried out by assuming a constant spectral coefficient of $S(T) = 2.5$ and a seismic area coefficient of $A_o = 0.4$ [1]. In the analysis ten free vibration modes are considered and the complete quadratic combination is adopted. The analysis provides a purely near elastic representation of the structure. Being insensitive to values of modulus of elasticity the non-linear elasto-plastic behavior of masonry comes into being due to cracking and weakening of the masonry at a specific tensile stress level. This behavior is taken into account by using a seismic load reduction factor of $R_a = 2$ for all periods of the structures. The first and second mode shapes corresponds to the vibration of the relatively elastic minaret in two directions (T_1 and $T_2 \cong 1.25\text{s}$), and the remaining ones (T_3 and the others $\leq 0.39\text{s}$) to the mode shape of the structural system itself, where the higher modes of the minaret can be seen as well.

Figure 3 Mode shapes related minaret only and to the walls sat the periphery ($T = 1.29s$ and $T = 0.39s$)

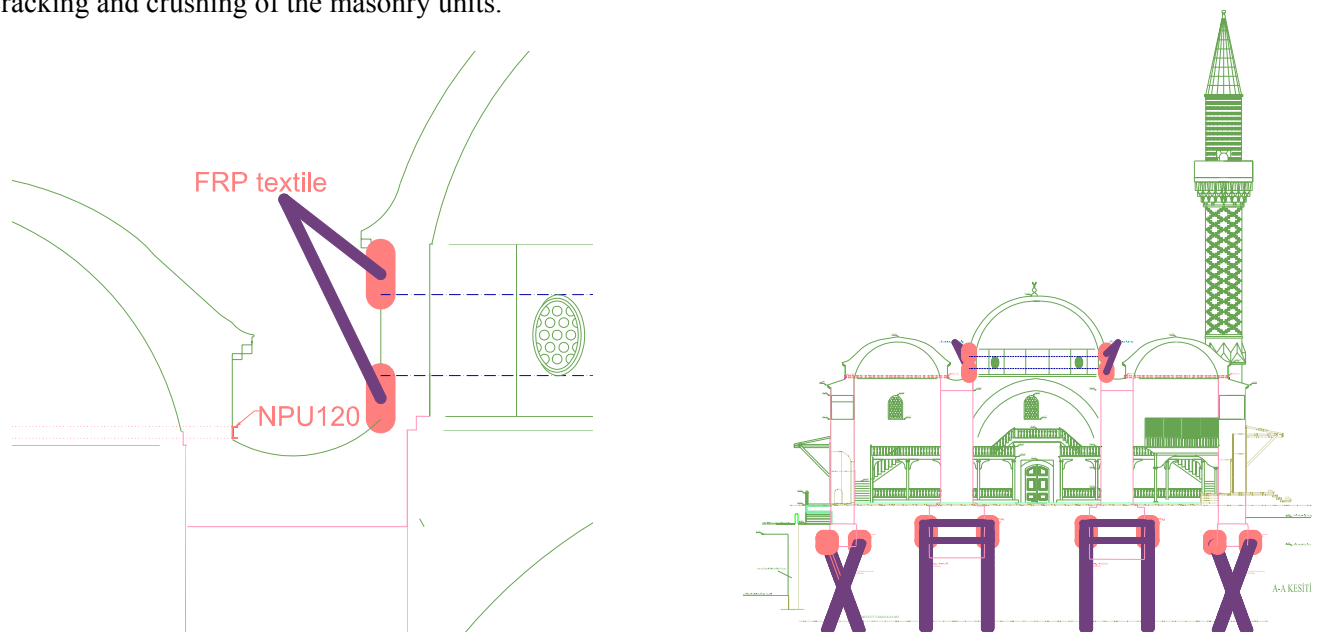
Figure 4. Strengthening of vaults and domes and foundation strengthening of the building

To provide the integrity of the domes and to prevent opening of the domes at the support level, FRP strips are applied at the support of the domes to bear to rotationally symmetric support reaction. However, the same procedure can not be recommended for the vaults due to their rectangular configuration. In stead of FRP strips steel elements of NPU120 around the vaults having rectangular configuration are used. Measures are taken to provide integration between these additional strengthening elements and the existing masonry structure. Furthermore, repair and strengthening of the external walls, domes and vaults are recommended by replacing the missing and damaged masonry units and cracks and damages are repaired by using specially design mortar to provide integrity of the structural elements. Furthermore, it is recommend that measures should be taken to carry off surface waters including from the roof further away from the outside walls of the mosque. Another measure is maintaining plumbing and sewage system inside the building of the mosque in the good working conditions.

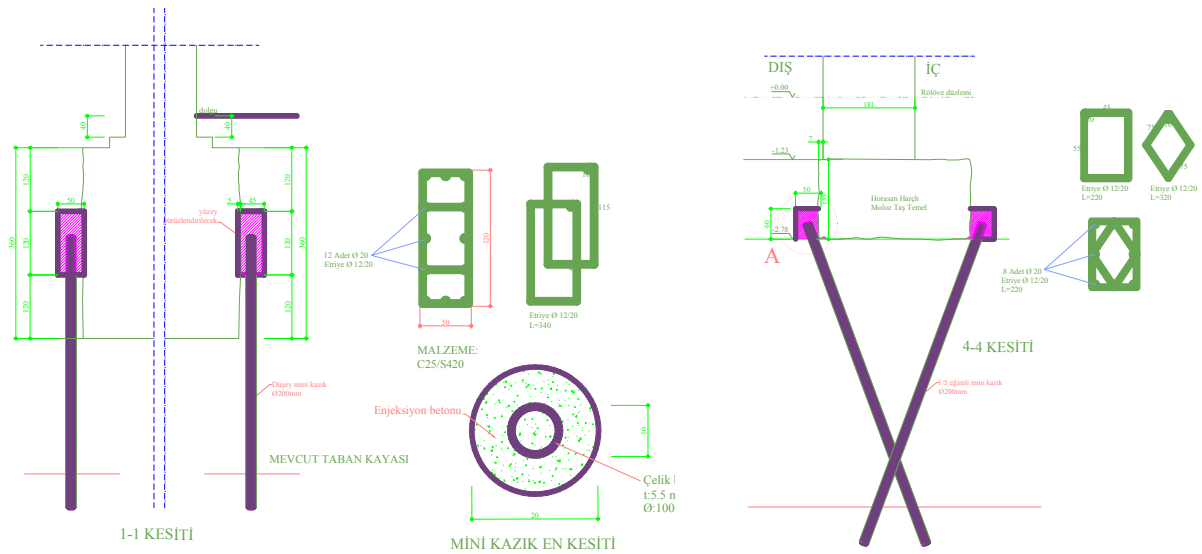
Figure 5. Micro pile application in the foundation strengthening of the building

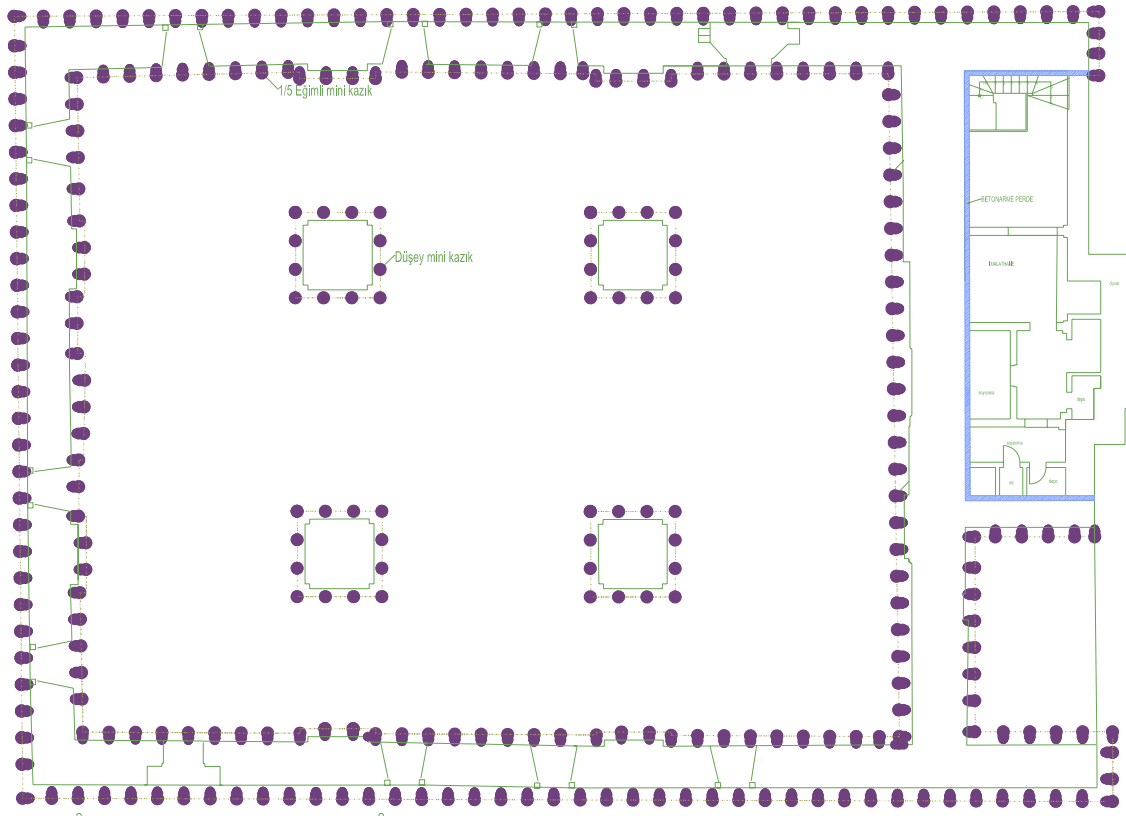
Figure 6 Configuration of micro piles at the foundation
