## SEISMIC EVALUATION OF TRADITIONAL TIMBER STRUCTURES IN TAIWAN

Pin-Hui Tsai<sup>1</sup> and Dina D'Ayala<sup>2</sup>

### ABSTRACT :

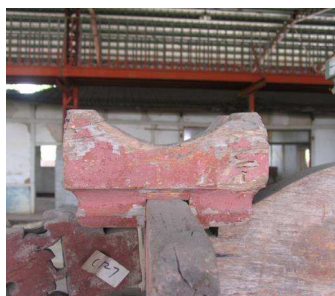
Figure 2 Upper Dou saddle to place purlin

From the failure modes discussed before, the following conclusions can be drawn: 1)The two parallel timber Dieh-Dou frames are easy to separate (because purlins, linking two frames, sit on the top Dou without a proper connection, see Figure 2) and vibrate independently, 2)The bottom of columns can be considered as hinges; 3) horizontal elements easily pull out from joints; 4) There are several elements pulling out and rotating from joints(Figure 3) but few failing by material rupture; 5)The movement of the frames can be substantial before the frame collapses.

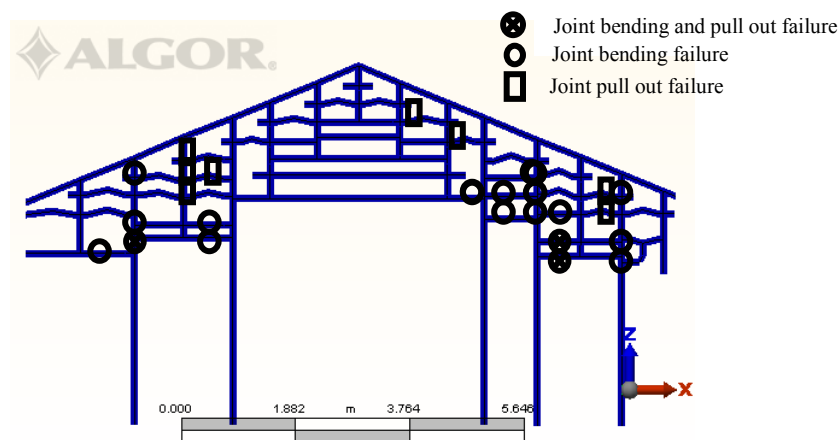
Figure 9 Element failure

According to Hsu (2002), the main hall of Guan-Shi family Temple suffered severe damage after the 1999 Chi-Chi earthquake. One frame collapsed and the other one was seriously damaged. The results of FE model with the criteria can therefore match reality reasonably well. Furthermore, in the damaged frame, the main space of frame remained intact while the outer parts damaged with most elements pulling out of their original position, but no material rupture was found. This failure compared well with the FE model result, see Figure 10. This confirms that the strategy of using such numerical analysis coupled with modest number of full scale laboratory tests can successfully predict the structural behaviour of Dieh-Dou frames

The results of step by step analysis shows that the joints in the corridor and main beams are easy to fail at low levels of load and these are the critical elements to focus on first. This failure mode compared well with

the observed failure of this frame and proved that the FE analysis is apt to assess Dieh-Dou buildings. Therefore, from the step by step FE analysis a preliminary result has been obtained which can help to identify the critical and vulnerable elements of the Dieh-Dou buildings. Different Dieh-Dou buildings, which have slightly different frame geometries, should be analysed to observe if the critical and vulnerable elements are similar and the structural behaviour follows the same trend. A parametric study on all results on different buildings can finally help to address the directions the conservation should take. Once the vulnerable and critical element has been defined, a strengthening strategy can be conveniently put into place.
