PUSH-PULL TESTS ON A REAL MASONRY-INFILLED RC BUILDING

ABSTRACT :

1. THE TESTED BUILDING

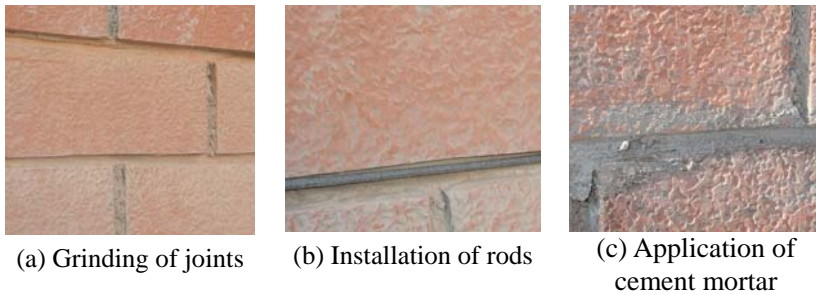
Figure 5. FRP structural repointing: installation procedure

The installation procedure consisted in the following phases (Fig. 5): (a) grinding of joints: this phase consists of the cutting out part of the mortar using a grinder; (b) installation of carbon fiber rods in the bed-joints previously raked out; (c) bonding of carbon fiber rods with the pre-mixed cement mortar.

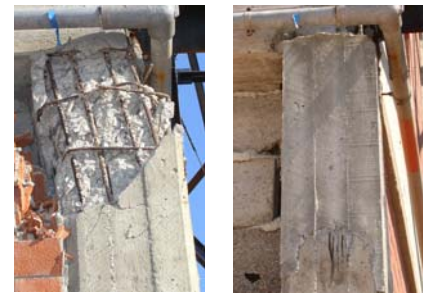
Figure 6. Column repairing

The repairing and strengthening of the damaged end portions of the external columns was carried out by removing degraded concrete and reconstructing it with the “Emaco[®] Formula Tixo” pre-mixed cement mortar. The portions of the steel bars permanently bended have been removed and replaced (just one location over the whole building) using new ribbed bars having the same diameter and similar grade as the original bars. Lap splice joints of length equal to about 60 bars diameter were provided between old and new portions of bars. The column repairing is shown in Figure 6.

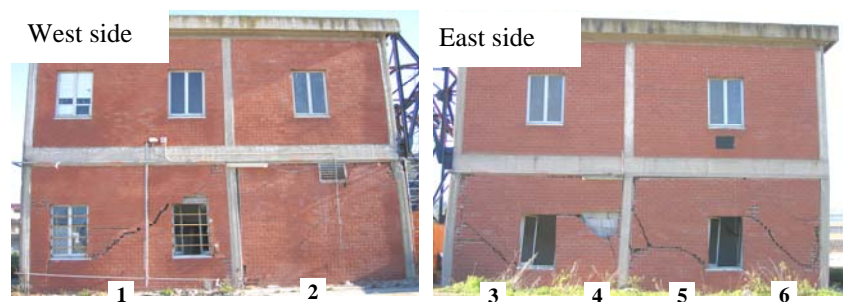
After two cycles of fully reversed loading in the quasi-elastic field of response, the structure has been pushed up to a maximum first-storey drift ratio of about +5% (Fig. 8), which produced extensive damage in both MIPs and RC frame columns at the first storey of the structure. Figure 9 shows the damage state visible from outside of the building, at the point of maximum storey drift ratio, for the perimeter infill-walls having their plane parallel to the load direction. After reaching the maximum lateral displacement, the lateral force applied by the hydraulic jacks was fully reversed, now pulling the structure up to a lateral drift of opposite sign equal to about -3% (Fig. 8). At this lateral displacement the structure damage at the first storey was very extensive, with the out-of-plane collapse of almost all the MIPs (both external claddings and internal partitions) having their original planes parallel to the loading direction. After reaching the point

of minimum lateral displacement, the structure was again pushed in the positive direction and a few more small loading cycles were necessary to be applied for approximately re-centring the structure in its original position. The main failure modes observed in the infills were (Fig. 9): diagonal tension cracking in the infill #1; masonry crushing, sliding and diagonal tension cracking in the infill #2; diagonal tension cracking in the sub-panel #3; sliding and diagonal tension cracking in the sub-panels #4 and #5; diagonal tension cracking in the infill #6. Along with the MIPs also the first-storey frame columns and the staircase structure were severely damaged during the loading test. Damage in the RC frame was characterised by flexural-shear plastic hinges formed at column ends, with the strongest shear effects occurring at the top end of columns located adjacent to the strongest masonry panels and for large inelastic displacements. The test has shown that damage in the MIPs was negligible up to an inter-storey drift angle equal to about 0.002 rad (at this point the first cracks appeared with amplitude less than 1mm). At 0.003 rad damage was very clear but still moderate, with amplitude of cracks of a few millimeters at maximum. From 0.004 rad through 0.005 rad damage in the MIPs became extensive, the size of cracks reaching several millimeters. At 0.005 rad, which approximately corresponds to the maximum lateral strength achieved in the test, also the corner crushing of MIPs was extensive and an evident gap between MIPs and columns occurred.

Figure 9. Damage of perimeter masonry walls at the point of maximum lateral displacement (+20 cm)

After the first test, the building was partially repaired. In particular, only some damaged elements of the building were repaired (perimeter columns) or rebuilt and strengthened (external MIPs parallel to the loading North-South direction), while the other elements (internal columns, partition walls and staircase structure) were not repaired nor substituted. The perimeter MIPs with the plane parallel to the loading direction were rebuilt using materials having geometrical and mechanical properties as close as possible to those of the original elements. After the erection of the external MIPs, the facing walls were strengthened by means of the fiber reinforced polymers (FRP) structural repointing technique. This technique consists in placing composite FRP bars in the masonry bed joints, using either an epoxy paste or a cement mortar for bonding.

The main objective of the FRP strengthening system for MIPs was to change the failure mode from the predominant diagonal tension cracking, as it was observed during test #1, to predominant shear sliding. In fact, the diagonal tension cracking failure mode is deemed to be relatively more brittle than the shear sliding mode. Thus, having dominance of shear sliding would help the MIPs maintaining their integrity during the lateral loading, with a favorable effect on life-safety performance levels. Furthermore, the strengthening of MIPs can favorably affect high-level performance objectives, such as the “operational” level, as testified also by previous research on this topic (Calvi and Bolognini, 2001). It was decided to place FRP bars in the bed mortar joints of only the external façade of the semi-hollow brick walls, i.e. a one side strengthening system was selected. This choice was made because of simplicity, low-cost and reversibility of the intervention. However, since available literature seemed to suggest limited effectiveness of one-side strengthening, it was decided to apply FRP bars in every joint, in order to get the maximum possible improvement of the shear strength. In addition, FRP rods were placed also in the secondary sub-panels, when windows are present, because of the aim of limiting deleterious effects of stress-concentration at corner joints.

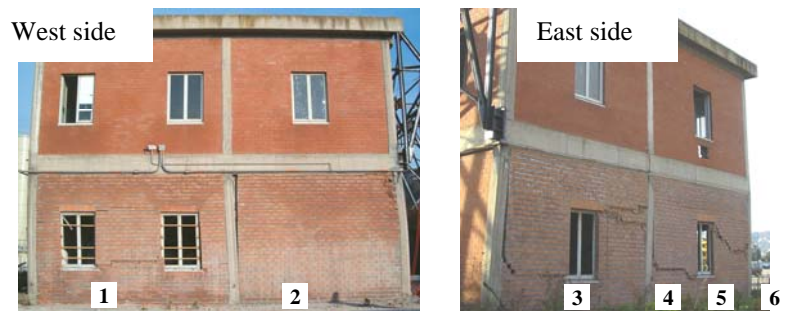
Figure 11 shows the damage state of the exterior façades parallel to the load direction for a drift ratio close to the peak value reached during the test on the original building. The dominant failure modes were: sliding in the infills #1, #3, #4 and #5; masonry toe crushing and sliding in the infill #2; sliding and diagonal tension cracking in the infill #6. Damage in the RC frame was similar to what observed during the test on the original building.

Comparing Figure 9 and Figure 11 it may be noted that repaired infill walls exhibited different failure modes, characterized by a reduced influence of the diagonal tension cracking mode. In addition, it has been observed that the damage level in the strengthened MIPs was smaller than that exhibited by the original MIPs at the same level of lateral displacement. Comparing the maximum lateral strength obtained in the second and first test (Figure 10), a reduction of about 60% (+1021 kN vs. +2501 kN) and 50% (+803 kN vs. -1527 kN) are obtained for pushing and pulling phases, respectively. This result can be attributed to the extensive damage produced during the first test to the staircase structure and to the partition walls. Also damage produced in columns may have contributed, because only marginal repairing was carried out for them (just the most damaged in shear and flexure, as shown for example in Figure 6). Therefore, the strength measured at large drifts during the test #2 is to be considered a residual value of the RC columns after the damage sustained during the previous loading cycles.

Figure 11. Damage of perimeter masonry walls at a lateral displacement of +20 cm
