## RECONSTRUCTION PRACTICES IN ACEH AFTER 2004 TSUNAMI DISASTER

### ABSTRACT :

**KEYWORDS:** Aceh (Indonesia), reconstruction, houses, seismic safety

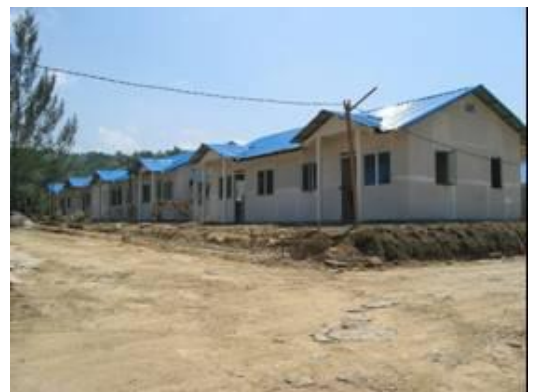
Figure 1 Type 36 houses

follow typical design structures. Most school buildings surveyed show that one- or two-story buildings are commonly used for school buildings, and the two-story buildings are often engineered buildings while most of the one-story buildings can be categorized as non-engineered buildings. The houses are mostly what is called type 36 houses, which means that the total floor area is 36 m<sup>2</sup>. This type of housing is a one-story building; most of them can be categorized as non-engineered building. Type 36 houses were endorsed by the government as replacement houses for the victims. Most buildings are made of burnt brick walls with reinforced concrete columns and beams. Roofs are constructed with wood trusses and galvanized iron sheets or roof tiles. Because these materials are commonly used for buildings in Indonesia, these buildings conform with the local culture. Figure 1 shows a typical example of this type constructed by BRR. However, some projects use imported materials and technology, which makes for questionable maintenance and sustainability.

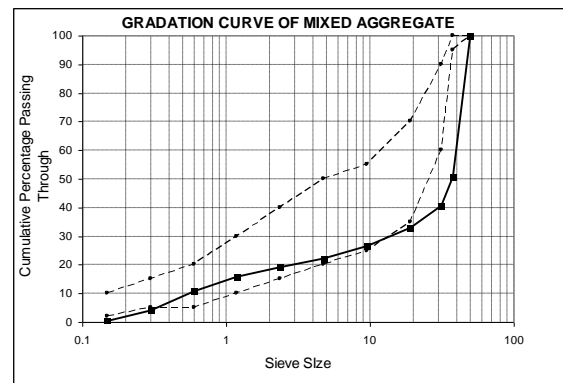
The concrete mixture is a serious problem for reconstruction of houses. The materials used for the mixture were adequate in most cases. However, almost no projects used the proper composition for the concrete mixture (volume ratio of 1 cement : 2 sand : 3 gravel). The most common mixture is cement and sand-gravel (sand with some gravel) with composition of 1 bag of cement for 3 carts of sand-gravel (about 1 : 5.25 in volume ratio). No sieving process was done to comply with the standard material gradation used for concrete mixture and no effort was made to avoid large aggregates getting into the mixture, which leads to a mixture having a very poor gradation with a high percentage of coarse aggregates. Our laboratory tests clearly illustrate this fact, as seen in Figure 2. Another critical issue concerning concrete is cement/water ratio. We found excessive water in most of the cases. Proper curing for concrete is also not common in the area. Considering all these facts, we have to conclude that the quality of concrete is one of the most serious problems in the reconstruction projects.

Figure 2 Gradation curve of mixed aggregate of three samples from construction sites in Aceh (The two dashed lines show the range of ASTM C33-90.)

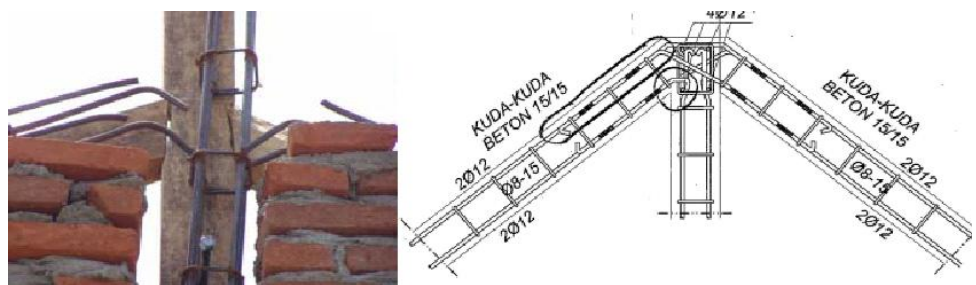
Figure 3 Construction does not follow the drawing, which requires longitude rebars in columns bended and connected to beams

construction sites, even weaker reinforcements were found: diameter 8 mm for longitudinal plain rebars and diameter 4 mm for hoops. The Indonesian seismic code specifies the following minimum diameters for materials to be used in earthquake resistant buildings: 12 mm for deformed bars for column longitudinal reinforcements, 10 mm for deformed bars for beam longitudinal reinforcements, and 8 mm for plain bars for hoops. Most of the reinforcements found in the field survey violated the building codes. Even worse, detailing of reinforcement such as bending work does not satisfy seismic demands for safety. Figure 3 shows the contrast between the drawing (the intended design) and the actual situation, a difference that is quite common in the area.

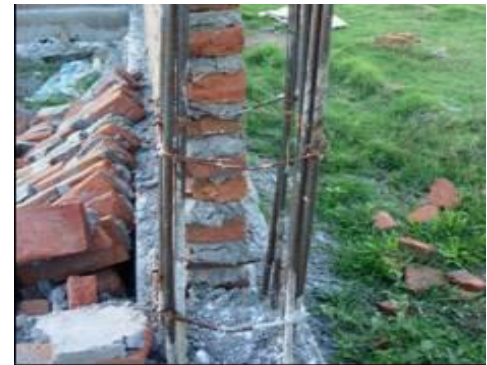
Figure 4 Widely spaced hoops

The spacing of the hoops also poses a problem, with spaces averaging 200-250 mm, in contrast to the code's requirement of minimum spacing of 150 mm or less (see Figure 4). The lab tests show that the strength of the steel bar is also below standard (see Table 2). All these facts indicate that the strength capacity of the structural elements for bending and shear in the buildings being constructed could be much lower than what was expected.

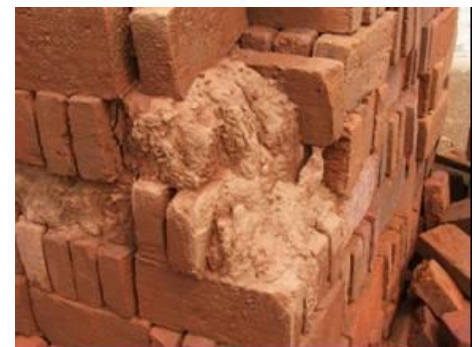
The quality of bricks used in the area is very low. The lowest class of bricks in the Indonesian code is Class III, which requires strength of minimum 25 kg/cm<sup>2</sup>. Most bricks fall below the minimum strength and even "melt" when soaked with water (Figure 5). The mortar quality is also questionable because of poor composition: too little cement and too much water. The bricks observed at construction sites were not installed in straight lines and mortar was often excessive (spacing of more than 15 mm).

Figure 5 Melting bricks
