LESSONS LEARNED FROM THE 2007 PISCO EARTHQUAKE (PERU) AND RECOMMENDATIONS FOR DISASTER MITIGATION

C. H. Cuadra¹ and K. Tokeshi²

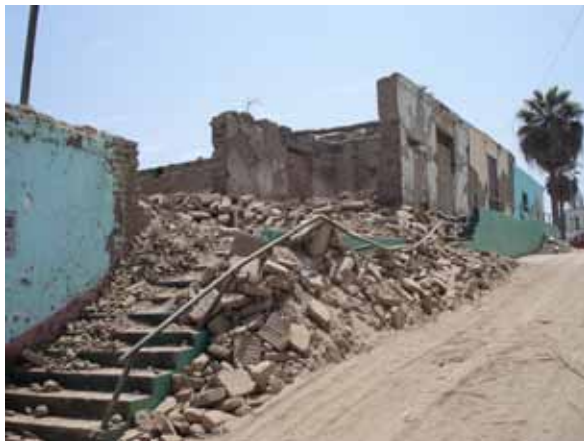
In the area affected by the Pisco earthquake, as well as, in many rural areas of Peru, the traditional construction system consists of sun-dried bricks laid with mud mortar. This system known as adobe is used mainly for houses. Also, old public buildings like churches use this system. Definitely, this kind of buildings collapsed completely or partially, as can be observed in Figures 2, 3, 4 and 5. Even in the case of no collapse, the cracking and failure pattern show that the building is not longer safer as dwelling. No doubt, the adobe system shows low seismic performance and this generalized failure of adobe buildings overlook the failure of confined masonry buildings and even failures of reinforced concrete buildings.

Figure 2 Collapse of adobe house

- The traditional constructions like adobe building must be prohibited in the seismic zone 3. For zones 1 and 2, only one floor adobe buildings must be allowed. In general, the adobe system must not be employed in public facilities like school, medical post, etc.

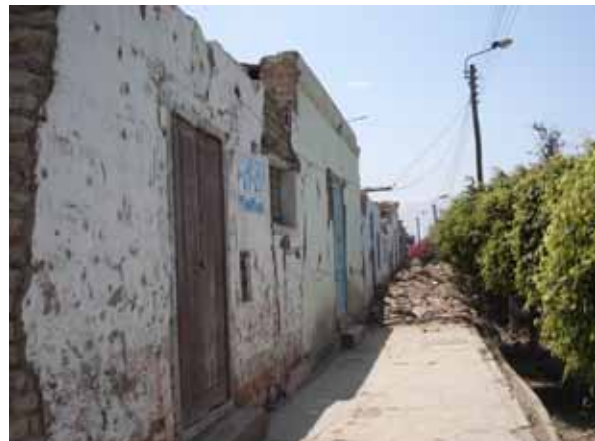
Figure 3 Damage in a group of adobe houses

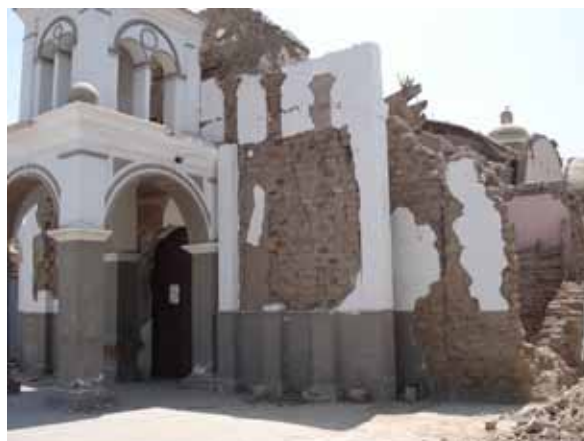
Figure 4 Damage in an adobe church

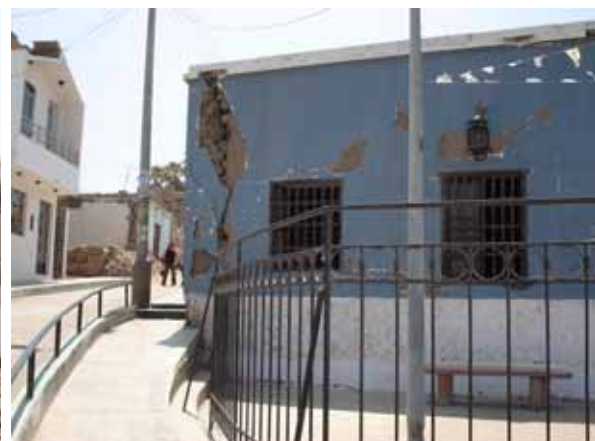
Figure 5 Typical failure of adobe construction

In Peru exists the national code or norm for adobe constructions (NE 060). However, this norm is not used in common adobe houses due to that the adobe constructions are not controlled by any official government. Only very few public buildings, like small schools and medical post, are constructed with adobe according to the above mentioned norm. Also, some pilot programs that try to demonstrate the applicability of the adobe use the correspondent norm. On the other hand, in the practice, engineers are not interested in this kind of design due to its low seismic performance and its low security factors for design. Therefore, it is very difficult to insure a high seismic performance.

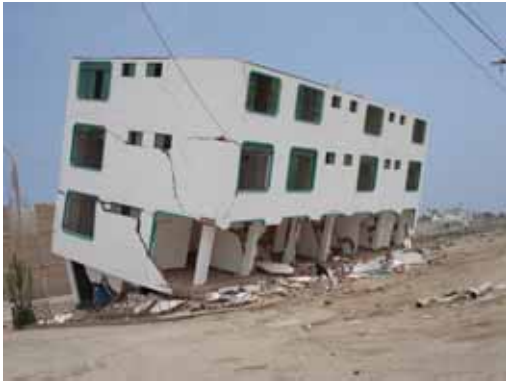
The influence of these underlying causes of failure in buildings can be detected by analyzing the damaged buildings during the last Pisco earthquake. In Figure 6, the collapse of the 1st floor of an apartment building of 4 stories is shown. From the structural point of view, it is clear that the building failed due to low stiffness distribution in this level. Unfortunately, it was not possible to confirm with the city officers if the building project was approved or not by the correspondent division. However, the characteristics of the building suggest that it was constructed following an approved project. It can be observed that the building was completed up to the 4th floor following a continuous process of construction, which was apparently supervised by an engineer. This case is different than the previous self construction process where the construction advances with clear identifiable jumps. The collapse of this building was due to the failure of the north side columns, while the south side columns have infilled walls that provided greater stiffness to that north side, as is shown in Figure 7. However, it can be noted in a detail of the failed column in Figures 8 and 9 that the reinforcement of the column corresponds to 4 bars of 12 mm diameter (bar No 4) with stirrup of 6 mm diameter. This kind of reinforcement is usual in confined masonry system where the reinforced concrete elements and their reinforcements are designed to take the tension stresses in case of seismic events. In this structural configuration, the column of the north side corresponds to a portal frame where the columns must resist the axial force in combination with bending moment. Therefore, the provided quantity of reinforcement was not enough to resist the seismic force generated by the Pisco Earthquake. These columns should be designed according to the reinforced concrete code instead of the masonry code. Apparently in this case, there is a misunderstanding between the concept of reinforced concrete system and the confined masonry system. In this case, if the project specifies this design, the structural engineer in charge of the structural project had not clear the right criterion for the design. On the other hand, when the project is presented for revision to obtain the correspondent construction license, the inspector officer (whom is supposed to be an engineer) did not detect this mistake in the structural project. Moreover, the engineer in charge of the construction works did not notice the error in the dimensions and reinforcement amount of the mentioned columns during the construction process.

Figure 6 Collapse of 1st floor of a masonry building

- To limit the height of confined masonry buildings to a maximum of four stories. In case of using hand made clay brick, the height must be limited to three stories. For practical reasons, 4 stories must be the maximum number of stories for hotels without elevators, even though the structure is made of reinforced concrete.

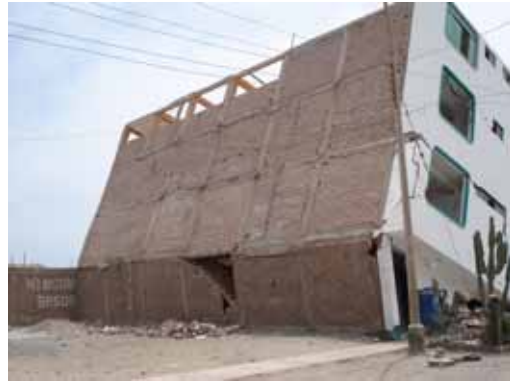
Figure 7 South view of collapsed building

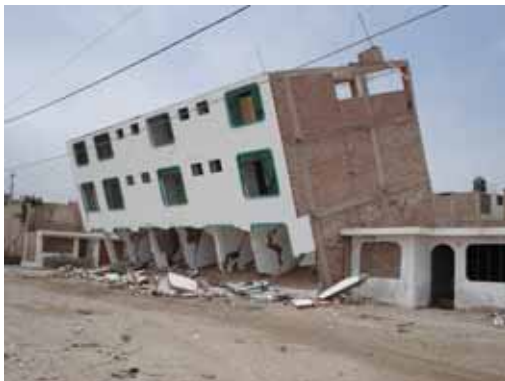
Figure 8 Failure of north side columns

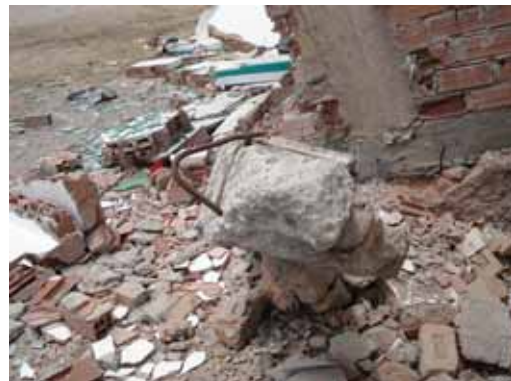
Figure 9 Column reinforcement detail

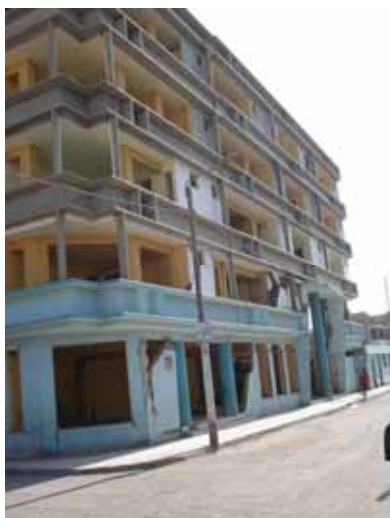
building code for confined masonry structures. Figures 10, 11, 12 and 13 show some pictures of these buildings which remain stand up but with serious damages in their structures. In the first plane of Figure 13 can be observed also an empty terrain where it was located a hotel of five stories that collapse completely. In this case, the original structure was a house of two stories that was converted into a hotel. These facilities were constructed after participating designer engineers, and surely, after approving by the local government officers. All of them failed in achieve a safe project. It is very difficult to point out that it was the result of administrative corruption, instead of that it is believed that the fail in all steps of the project is due to the lack of qualification of the designer, the inspector officer and the constructor.

Figure 10 Reinforced concrete hotel

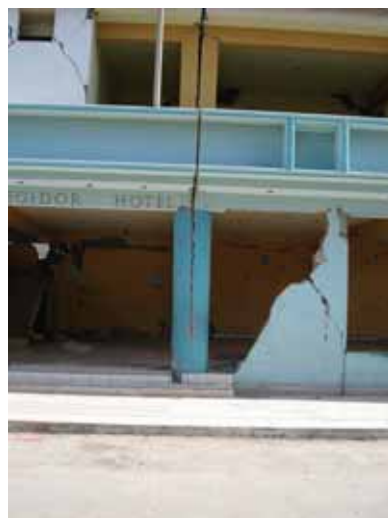
Figure 11 Detail of column failure

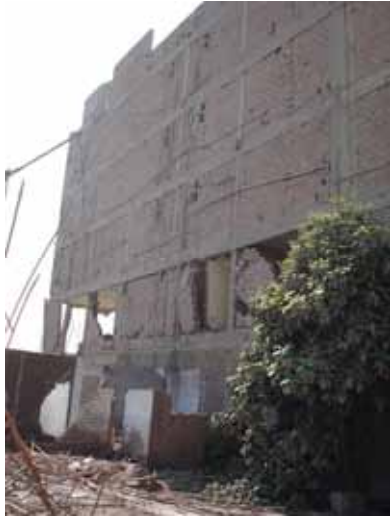
Figure 12 Six stories hotel

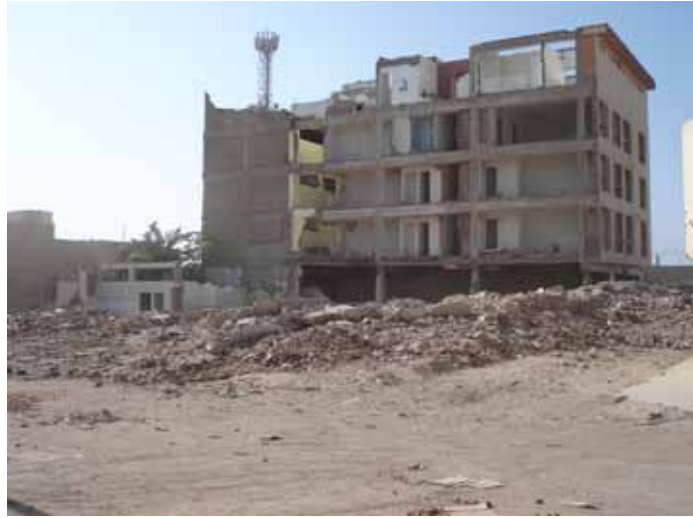
Figure 13 Collapse of five stories hotel
