## REDUCING EARTHQUAKE VULNERABILITY OF NON-ENGINEERED BUILDINGS: CASE STUDY OF RETROFITTING OF SCHOOL BUILDING IN INDONESIA

D. Kusumastuti<sup>1</sup>, K.S. Pribadi<sup>1</sup>, and Rildova<sup>1</sup>

#### **4. CASE STUDY: RETROFITTING OF SD CIRATEUN KULON II**

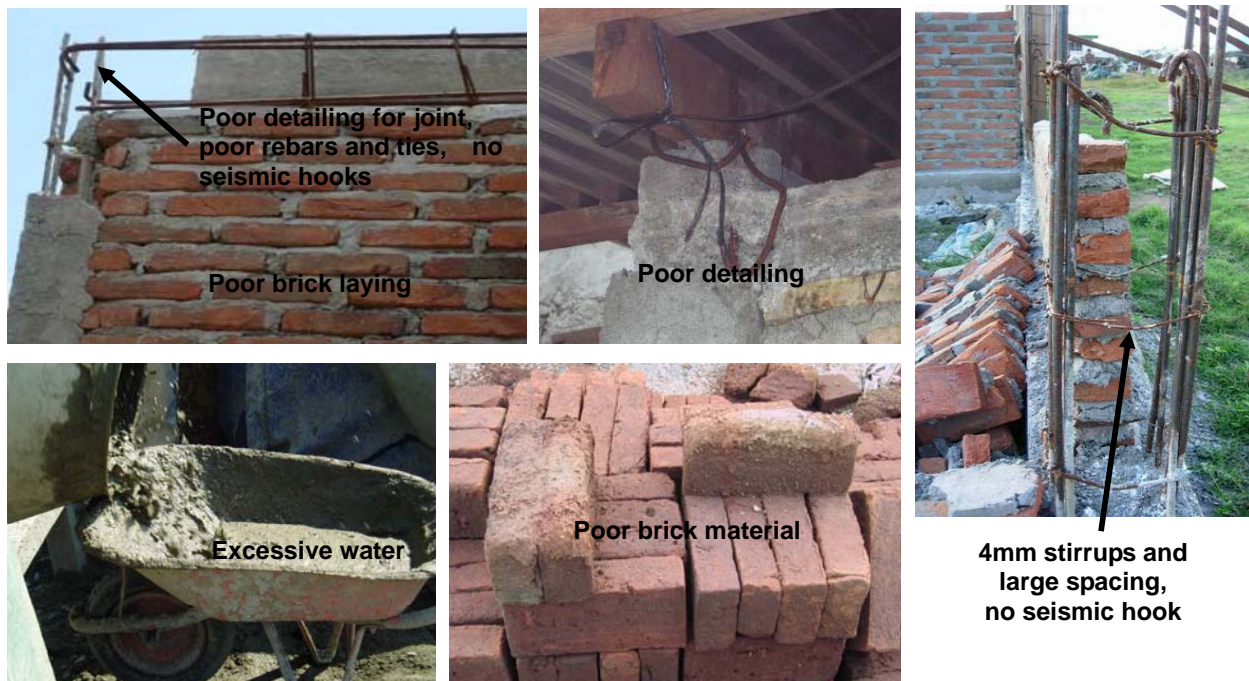
Problems for non engineered structures in Indonesia are mainly due to minimum reference to standards/codes. Many house owners do not verify if their structures comply to building codes since the houses are built traditionally, meaning that the structures are built by local masons/workers, using local materials and traditional construction methods. Engineers are not involved in the design process, thus design adequacy according to building codes is also rarely checked. The construction of houses or other non engineered buildings is typically left to the workers with minimum supervisions, and building permits are often issued without proper inspections. Therefore, these buildings are frequently found to have poor detailing, wide variety of quality of materials, and wide variety of construction methods, as presented in Figure 1. Consequently, the structures are more susceptible to damage during earthquake due to poor quality and high vulnerability.

Figure 1 Problems in quality of material and construction techniques

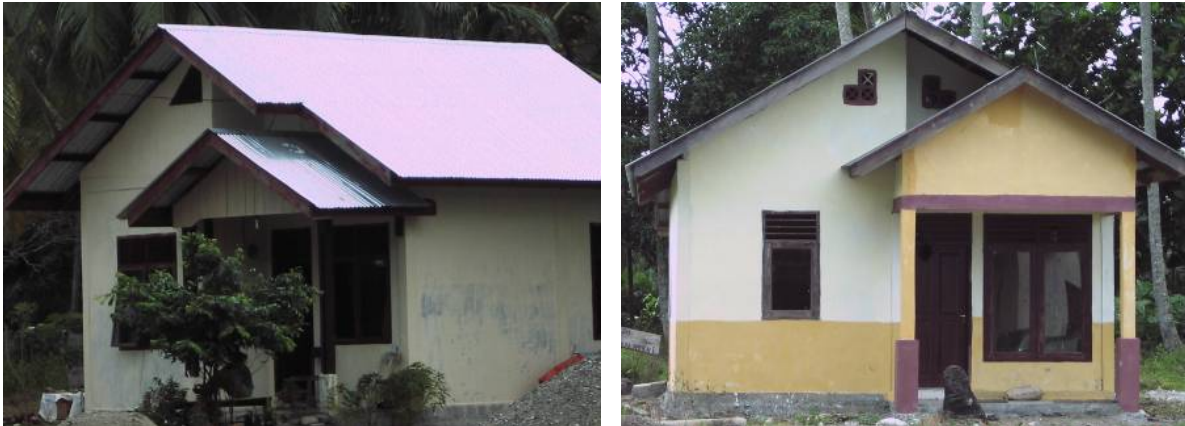
The problems for non engineered structures are amplified by improper structural design. Many houses have building layouts and plans based on aspirations of the owners, which often follow the layouts and shapes of traditional houses. These traditional houses were originally made of woods or bamboo, thus they had a tendency to be flexible and lightweight. These houses could perform well under seismic load. However, current condition shows that people are more likely to build their houses using RC frames and masonry walls. These RC and masonry structures are considered more modern and show the prosperity of the owners. When the concept of the traditional houses is adapted to modern structures, the building shapes and layouts are usually maintained, but the traditional materials are replaced with concrete and bricks (see Figure 2). This creates problems due to structural irregularities, as well as heavy masses for roofs and facades. As a result, more and more non engineered structures were built with poor quality and to be vulnerable to earthquake. Considering large number of non-engineered buildings and their vital functions, as well as the high occupancy rates of these structures, efforts on making these buildings safer are significant in reducing the number of casualties and economic losses.

Figure 2 Typical houses with façade and canopy adapted from traditional house concept

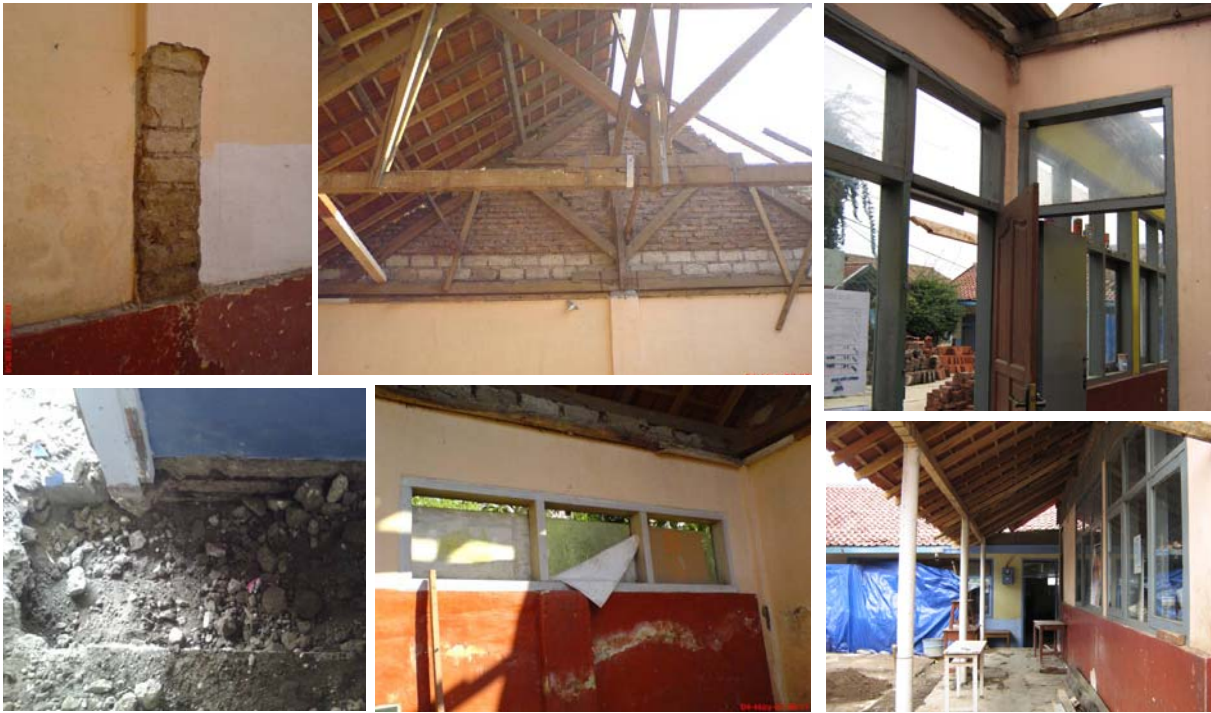
One of the buildings that were retrofitted in this project is an elementary school in the city of Bandung, West Java, which is located on moderate seismic zone. The school, SD Cirateun Kulon II, has 423 students and 14 teachers. Considering that it is occupied from 7AM to 4PM, the safety of the building is crucial. Moreover, the school also functions as a social gathering place for the community, and it can play significant role during post-earthquake recovery efforts. Therefore, the buildings should perform satisfactory during earthquake. The school buildings consist of two buildings made of RC frames and masonry walls, as presented in Figures 3 and 4. Survey showed that the buildings had inadequate foundation system (shallow foundation, no tie beam). The structural system of Building I were made of pilaster columns a, ring beams with poor materials and detailing (longitudinal reinforcement of  $4\phi 8$ ,  $f_y=240$  MPa, and stirrups of  $\phi 8-400/500$ mm), and no tie beams. Building II had RC tie beams, ring beams, and columns, with poor materials and poor detailing (longitudinal reinforcement of  $4\phi 8$ ,  $f_y=240$  MPa, and stirrups of  $\phi 8-400/500$ mm). Both buildings showed poor beam-roof connection and poor roof truss element and connection. However, the walls were of good quality.

Structural analysis was performed on the existing structures using the actual material and structural components obtained from survey and tests. Earthquake risks were introduced to the buildings by applying loads based on potential seismic risks and local soil conditions. The result of the analysis showed that the two buildings were considered likely to behave poorly under seismic loadings. Based on the evaluation of the structural quality and earthquake vulnerability, repair and retrofitting was necessary. With funding from Hanshin Department Store Labor Union from Japan, the physical works were then conducted to improve the structural quality.

Figure 4 Existing structural condition

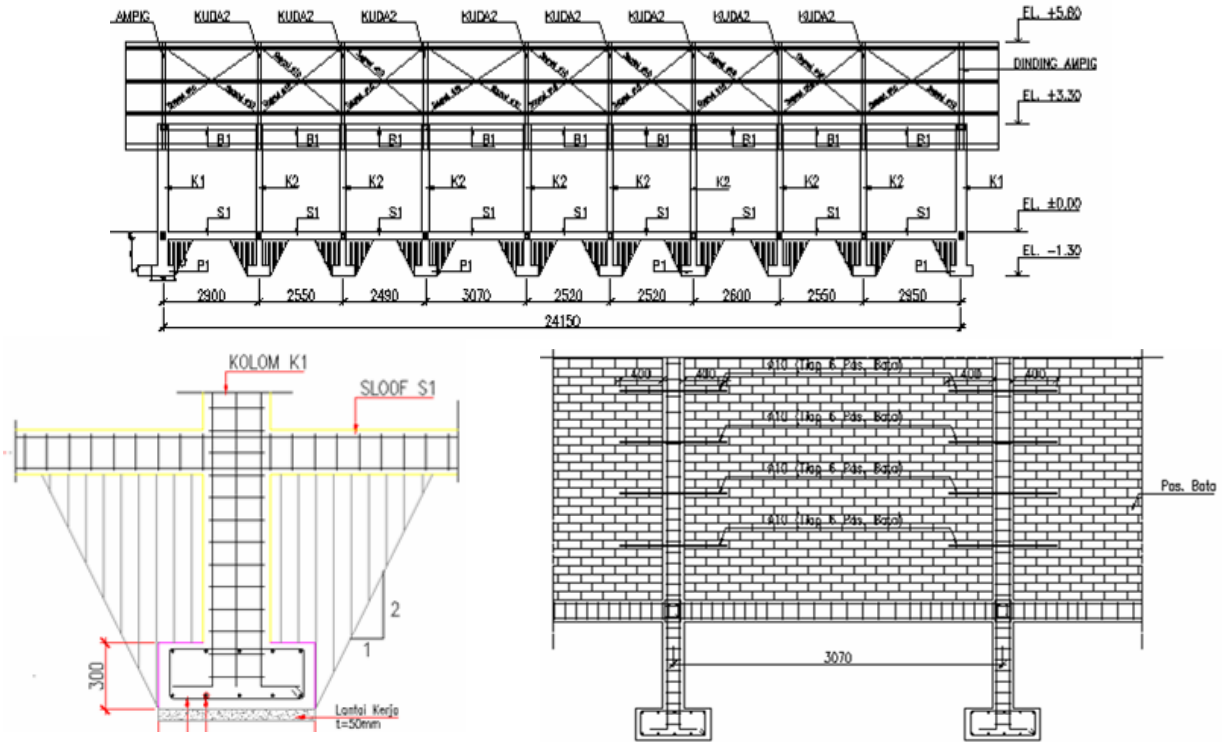
(a) Retrofitting strategy for Building I

Two types of retrofitting strategies were applied to these structures due to different structural qualities, as well as needs and capabilities of the school communities, as shown in Figure 5. Building I which was considered to have lower quality was retrofitted by adding adequate RC frames with mat footings, and proper detailing of connections of structural elements. Anchorage was provided to connect walls with columns and beams. Building II which was in better condition was retrofitted using wire mesh for strengthening wall elements. Double tie beams were added adjacent to the existing one for better foundation system. For both structures, proper detailing was applied to roof truss systems, and repair was carried out for nonstructural elements such as doors/windows and ceilings. Various stages of construction work are presented in Figure 6. Repair of sanitary facilities was also conducted to the structures.

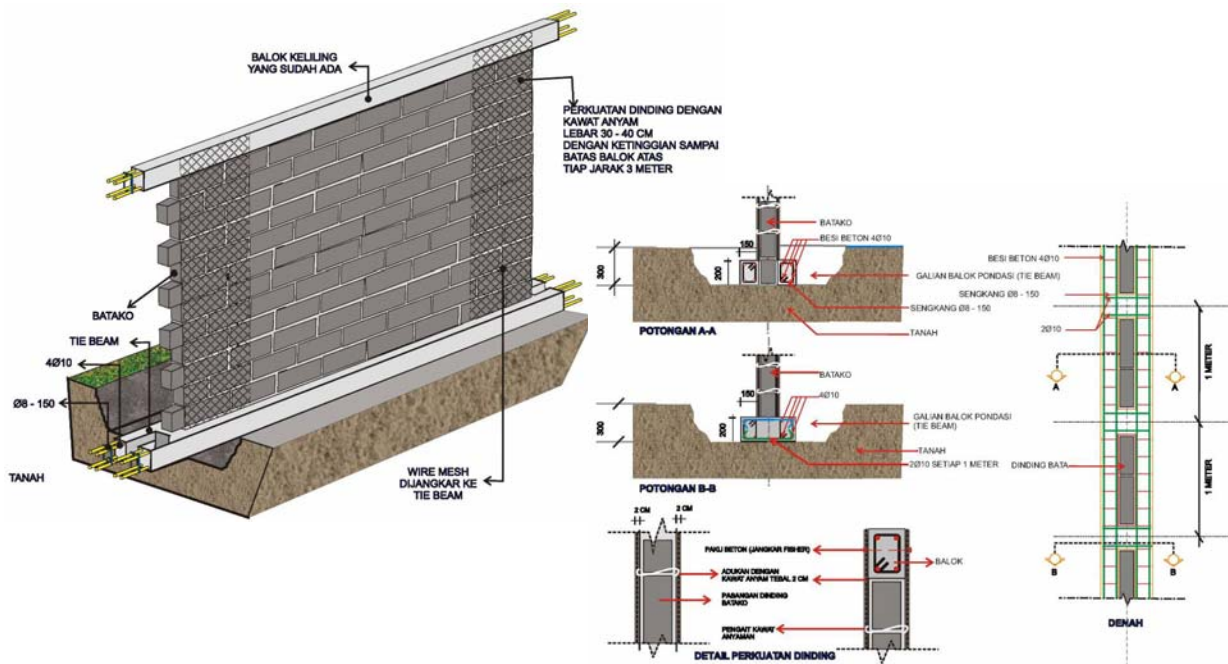
(b) Retrofitting strategy for Building II

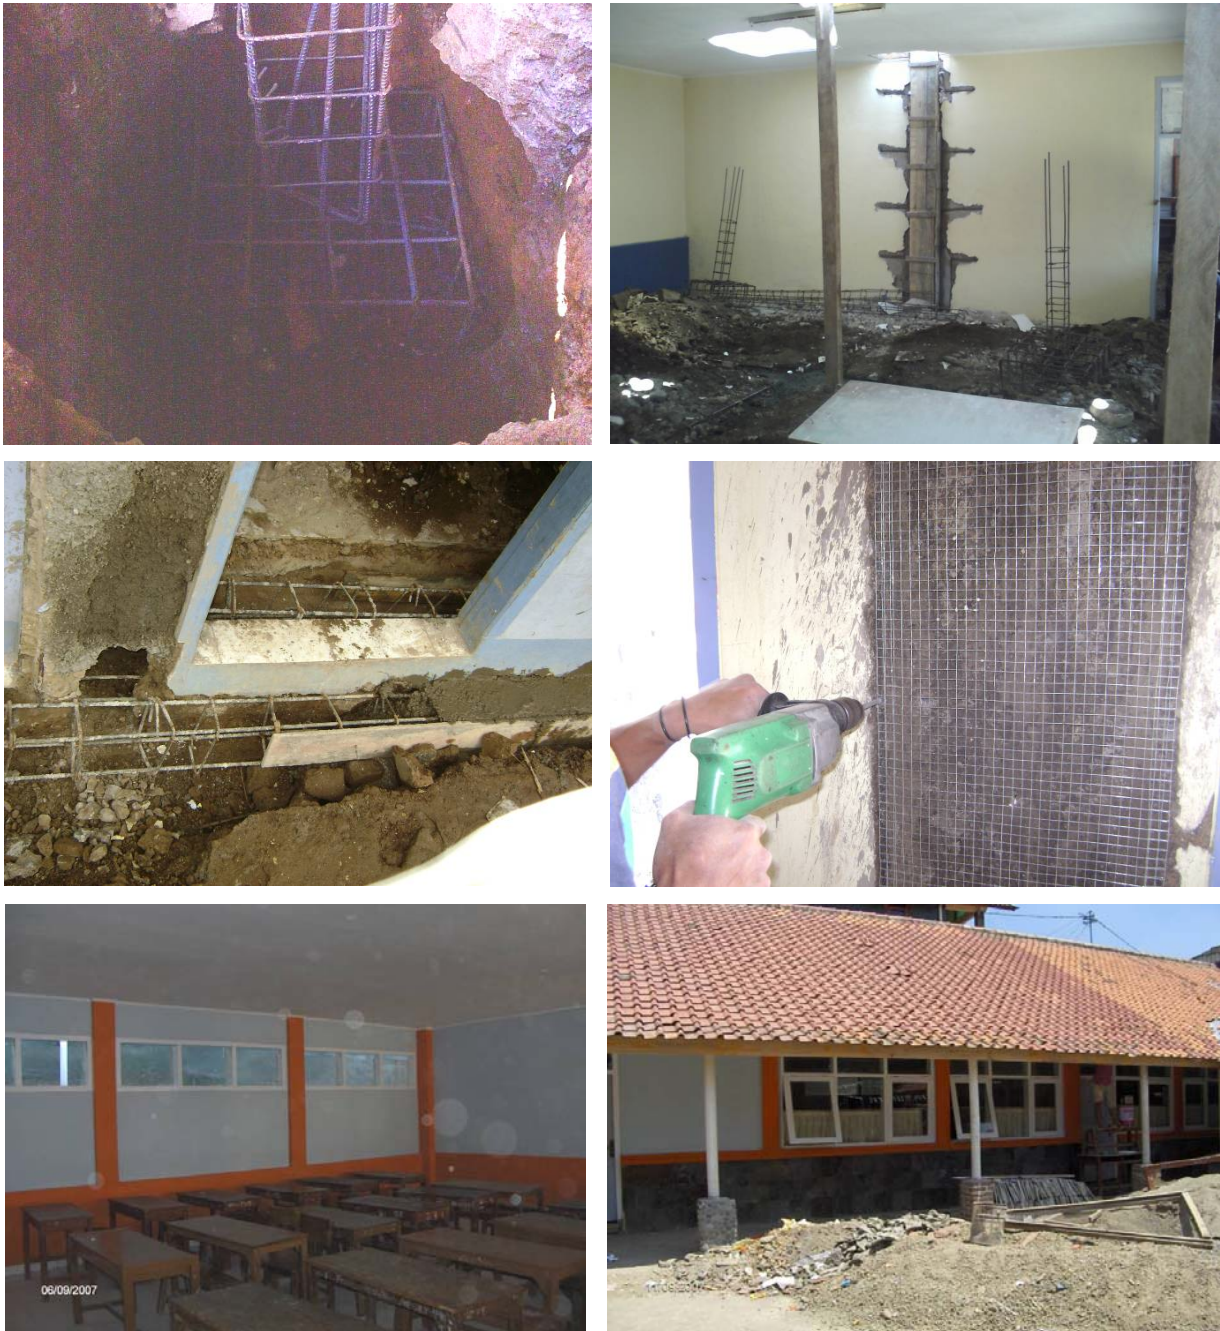
Figure 6 Various stages of the retrofitting process
