## BEHAVIOR OF NON-ENGINEERED HOUSES DURING PISCO EARTHQUAKE 15/8/2007

C. Zavala<sup>1</sup>, M. Estrada<sup>1</sup>, L. Chang<sup>2</sup>, L. Cardenas<sup>2</sup>, J. Tayra<sup>2</sup>, L. Conislla<sup>2</sup> and G. Guibovich<sup>2</sup>

### ABSTRACT:

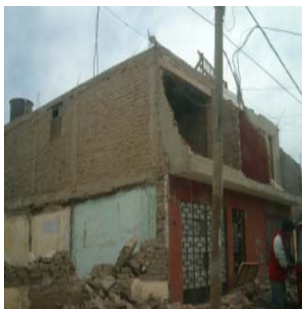
On soft soils areas, the houses built with clay masonry walls, but following engineering procedures, experienced moderate damage, represented by collapse of balconies and non structural walls (see Photos 5, 6 and 7)

Photo 5: Overturning wall

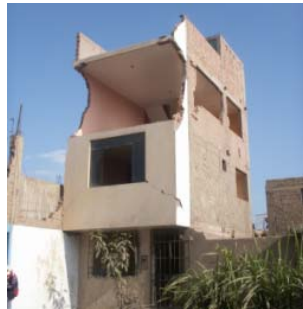
Photo 6: Damage on wall

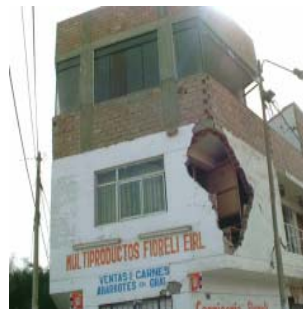
Photo 7: Facade collapse

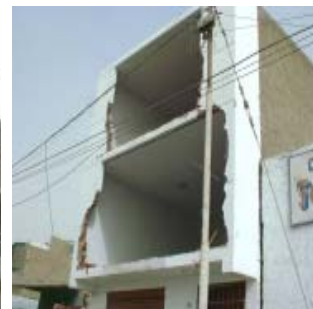
Also the collapse of non structural walls due to irregularity is presented on Photo 8. In the process of auto construction, many owners used non regulated brick units generating failure on non structural walls or producing collapse on buildings when these walls were used as structural units.

Photo 8: Collapse cantilever

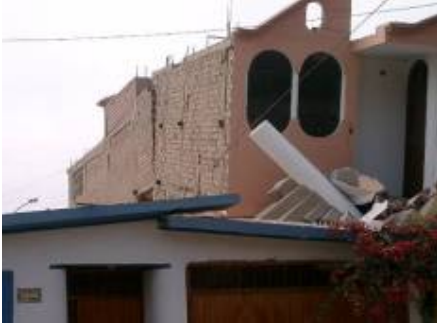
The masonry structures built by auto construction or with irregular configuration or built with non regulated bricks (not permitted by the standards) suffered severe damage and in some cases impossible to be repaired (see Photo 9, Photo 10 and Photo 11). Some old buildings built by blocks without reinforcement like Hospital San Juan de Dios (see Photo 12) presents failure on walls with severe damage, without possibility to be repaired after the event. In this case this hospital was an essential structure same as other hospitals in the area (see Photo 12) and don't comply the criteria of safe hospitals defined by WHO-PAHO. Therefore, after the quake Pisco city hasn't hospital for attention, just because all the hospitals on the city collapsed.

Photo 9: Collapse due to cut on belt beam

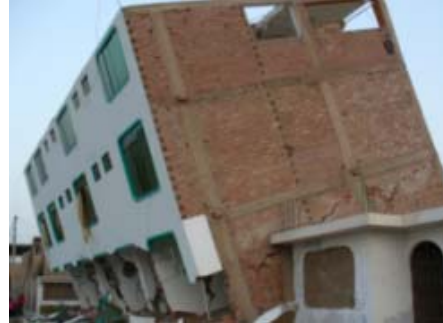
Photo 10: Collapse due to irregularity

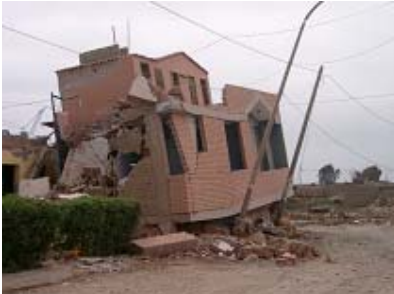
Photo 11: Collapse due to soft story

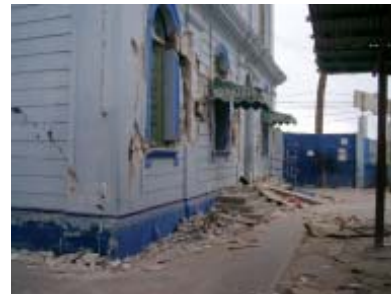
Photo 11: Failure because non reinforce

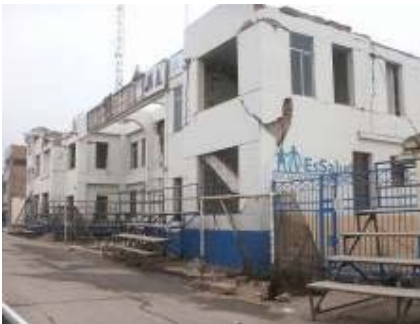
Photo 12: Damage ESSALUD Hospital

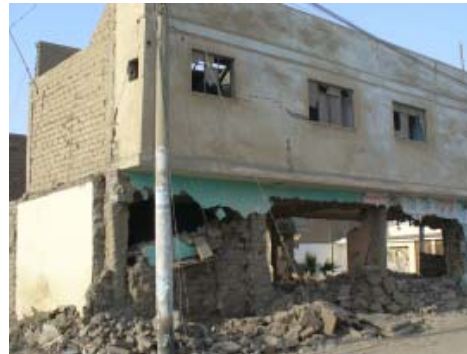
Many buildings in the city with severe damage or collapse were mix structures with first floor of adobe and second floor of masonry (see Photo 13), this type of buildings is not regulated and is considered a non engineering structure.

Photo 13: Mix structure – Failure on adobe

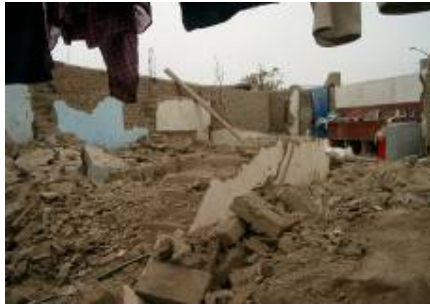
There are two predominant materials in San Luis de Cañete housing: adobe and masonry. Adobe buildings are traditional non structural structures and represent the 62% of the total. They are distributed among the two types of soil in the city. The adobe houses built over soft soil collapsed total or partially, where a particular construction was used: the front build with masonry and the rest of the house with adobe. So adobe part collapsed but the facade of the house, made of masonry, appeared stand or partially stand as shown in Photo 15. Here the internal adobe walls collapsed completely and it is possible to observe a tent inside. On the other side Photo 14 shows the complete collapse of an adobe house in the main street of the city over soft soil.

Photo 14: Total collapse on adobe house

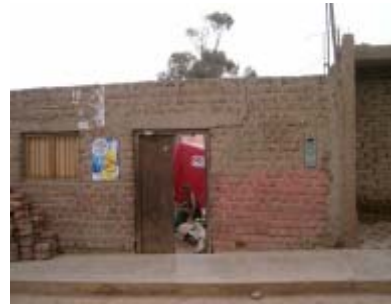
Photo 15: Internal collapse of adobe house

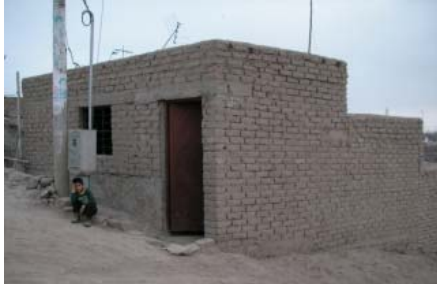
The behavior of the houses was completely different on the rock hill at one side of the city. Photo 16 shows an example of adobe house without any damage and Photo 17 present the slope road with adobe houses without any damage on the San Luis's hill. However from Photo 17 it is possible to see the flat area of the town with green fields where the soil is soft and adobe houses collapsed.

Photo 16: Adobe house on a hill of San Luis

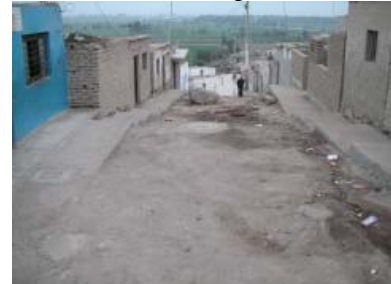
Photo 17: Slope road with adobe houses

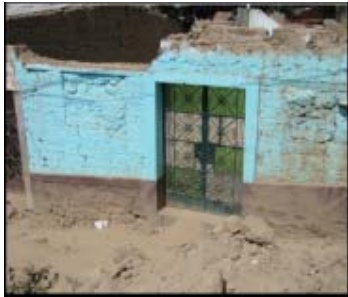
The city of Huaytara is a typical Andes city with heavy slopes with two types of soil as was mentioned before. The old adobe houses suffered the strike of the quake with the collapse of walls and roof (Photo 18), or the big cracks on walls of one and two story buildings (Photo 19). However new constructions has no damage (Photo 20) because they are following the standards.

Photo 18: Collapse in Huaytara

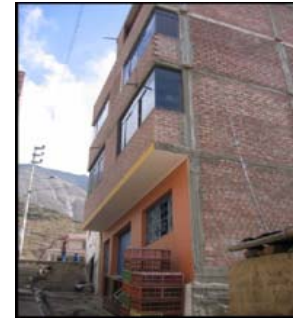
Photo 20: Non damage

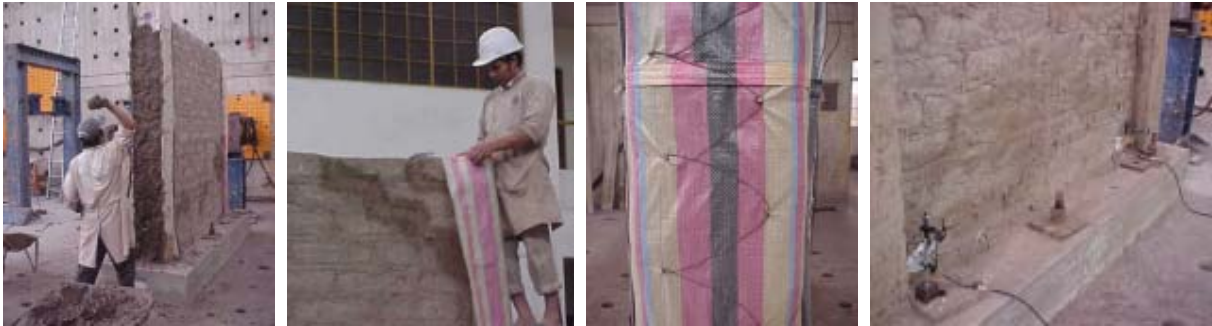
Photo 21: Four stages of reinforcement an adobe wall

The use of a fiber disposable plastic bag or rice bag can be used as an economic alternative to reinforce an adobe wall and avoid the collapse. This technique could be applied increasing the section of the walls totally or increasing the corner section as confinement. Photo 21 presents the sequence of the reinforcement increasing the corner section.

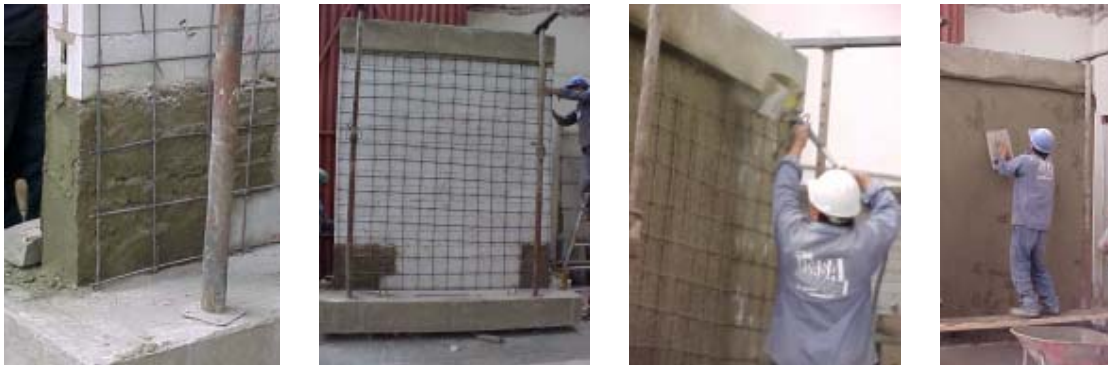
Photo 22: Four stages of reinforce a masonry wall with electro welded mesh

Masonry walls of 2.25 m. length, 2.40 m. height and 0.15 m. thickness with vertical reinforcement of #3 bars inside each hollow block, and #4 on the corners and horizontal reinforce of 8 mm bar were tested (original wall). Walls started their cracking at drift of 1/1000. At 1/500 drift walls started the damage of the toe that collapse at 1/100 drift. The wall was reinforced with steel mesh equivalent to 8 mm bar following the procedure presented in Photo 22. Toe was repair and mesh was fixed with anchors. After a mortar 1:4 was sprayed over the mesh and finishing the wall.
