## DAMAGE INDUCED BY THE 2007 NIIGATAKEN CHUETSU-OKI, EARTHQUAKE

A. Onoue<sup>1</sup> and H. Toyota<sup>2</sup>

### ABSTRACT :

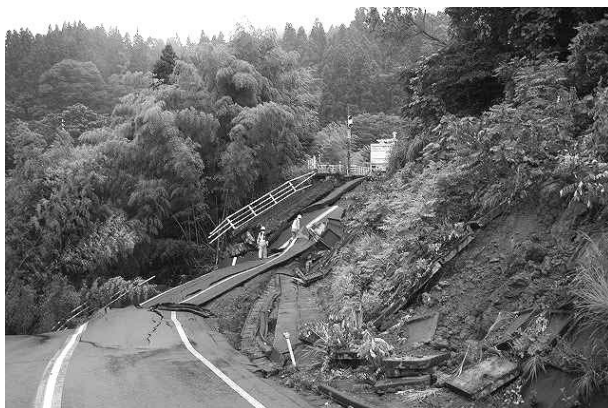
As shown in Photo 1, the strongly weathered soil slid almost along the dip slope of stiff sand and silt rocks at Ozumi Sembom-cho, Nagaoka-city, resulting in the collapse of National Route No.8 for a length of 140 m and blockage of the Kuro river at the toe of the slope for a length of over 50 m. The road shoulder of Route No.116 sank at various places in Nishiyama-cho, Kashiwazaki city. Photo 2 (a) shows a horizontal gap of the roadbed in a transverse direction, and level difference in the run direction at the boundary of the high banking section on alluvium and the natural ground section of diluvium. Photo 2 (b) shows a landslide depositing on Route 352 at Shiya-shore, Kashiwazaki. The slope with a system of fissures dipping backward of Shiya Formation is an abrasion cliff of about 60° inclination. Photo 2 (c) shows a liquefaction induced slope failure including a sand quarry and its front road at Yamamoto, Kashiwazaki. Photo 2 (d) shows subsidence and lateral spreading of Arahama-Nakada Route at Shimodaka, Kariwa Village. The roadbed is new dune sand. According to Ministry of Land, Infrastructure, Transport and Tourism Hokuriku Regional Development Bureau (MLITTHRDB, 2007), serious damage occurred at 44 places within major transportation routes.

Photo 1 Ozumi, Nagaoka: Landslide at Route No.8

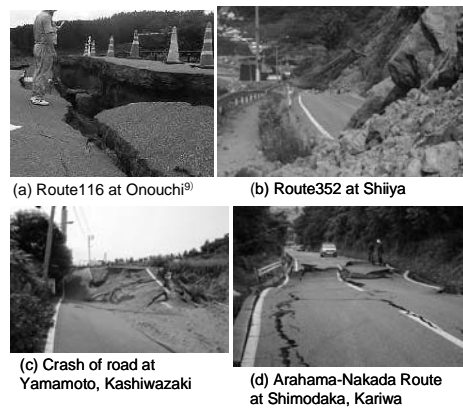
Photo 2 Damage of roads

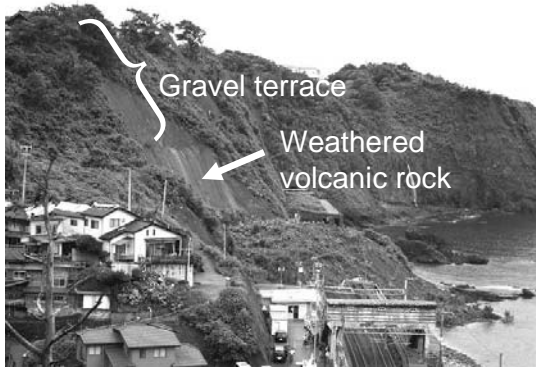
As seen in Photo 3, the sand gravel terrace at the top of a sea cliff slid with collapse of strongly weathered volcanic rock surface below the middle part of the steep slope at the Omigawa Railroad Station on the Shinetsu Line, spilling debris on the station and tracks. At the Omigawa Railroad Bridge, the abutment backfill subsided and the rails hung (Photo 4 (a)).

Photo 3 Omigawa Station, Kashiwazaki: Collapse of sea cliff and berried railroad station of Shinetsu Line

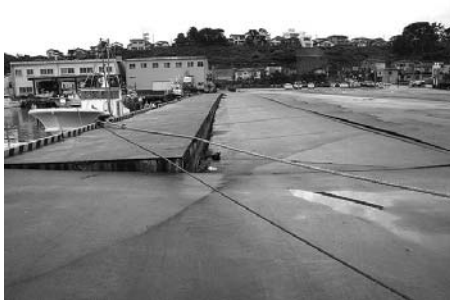
The east quay of the central wharf at Kashiwazaki Port inclined forward (Photo 5), and the aprons of the central and west quays settled due to liquefaction of sandy backfill. No. 3 quay of the Nakahama wharf also inclined forward at its east end. Displacement and rotation of caisson were confirmed at other quays, too, of this port.

Photo 5 Inclination of caisson quay and trace of sand pumping at Kashiwazaki Port

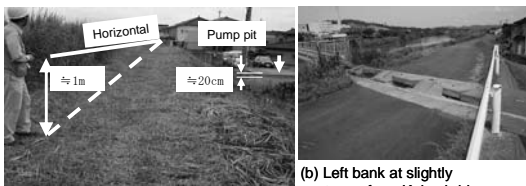
Photo 7 Damage of river

of the bank, subsidence of the road surrounding a pump pit nearby (Photo 7(a)), and ejection height of a water pipeline supported by piles in the embankment (Photo 7(b)), elevation of the river bank is considered to have decreased by 20 cm to 1 m or more from place to place in this region.

A crack of 5 m deep and 100 m long (Photo 7(c)) was found in the left bank of the Shinano River at Machikarui, Teradomari town. Deep longitudinal cracks at other sections of the bank, sand boils and cracks parallel to the river at various places of high water channel (Photo 7(d)) along this river occurred. According to Shinanogawa River Office of MLIT/THRDB (2007), totally 18 damage were caused in the Shinano River System. The Jorakuji River was blocked at Jorakuji, Izumozaki.

(a) Relative settlement of left bank of the Sabaishi river

(b) Left bank at slightly upstream from Kaiun bridge, Sabaishi river: Ejected water pipeline supported by piles

(c) Machikarui, Teradomari: Crack in left bank of the Shinano River (Photo: By Shinanogawa River Office, MLITT)

(d) Machikarui, Teradomari: Crack at high water channel of the Shinano River (Photo: BY Shinanogawa River Office, MLITT)

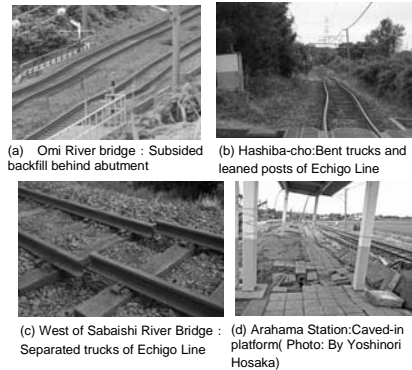
With respect to Echigo Line, lateral and vertical deformations in train tracks (Photo 4 (b)) were observed throughout this region. Joint bars dispersed and the tracks were separated on the railroad embankment to the west of the Sabaishi River Bridge (Photo 4 (c)). The railroad bed in this region is considered to be banked with sand. The platform at Arahama Station caved in below the level of track due to liquefaction of subsoil (Photo 4 (d)).

Photo 4 Damage of railroads

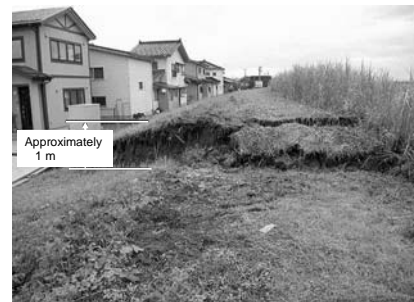
The left bank of the Sabaishi River subsided approximately 1 m over a distance of 50 m associated with lateral spreading at Hashiba-cho, Kashiwazaki (Photo 6). Since this place is one where the old channel was coffered by new bank for river training, the underlying loose sandy soil liquefied. Lots of liquefaction induced long crest cracking were observed at other new banks crossing the old channel near and adjacent to the Kaiun Bridge. Judging from a significant longitudinal gradient with height difference along the crest

Photo 6 Subsided bank of Sabaishi River

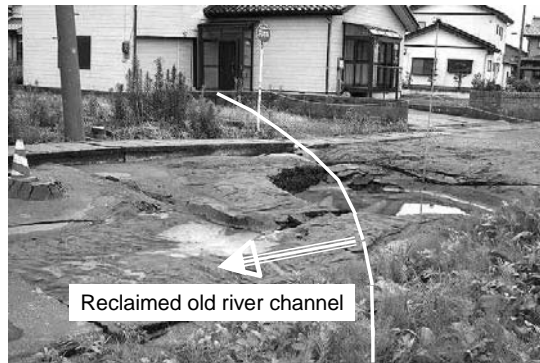
Photo 9 Crater in the street and damaged house

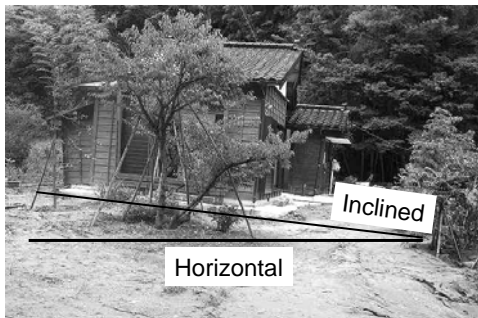
Photo 10 Tilted house due to liquefaction

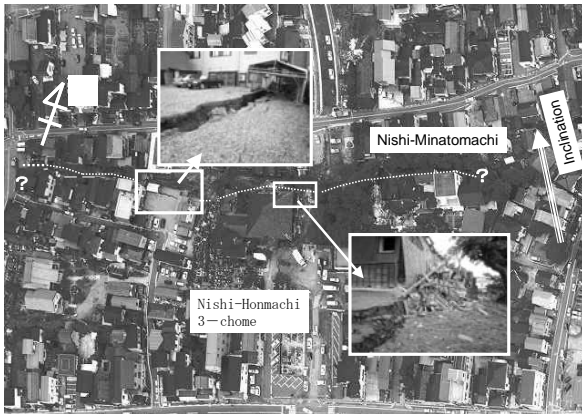
Downtown central of Kashiwazaki city where the new sand dune covers most of the area has a ridge in the east-west direction. Landslides with long distance occurred at both the north and the south slopes. The broken line in Photo 13 shows the scarp of the north landslide along the border of Nishi-Honmachi and Nishi-Minatomachi. The scarp appeared at the shoulder of steep slope and just behind the top of cliff for a distance of approximately 200 m. This slide partially includes caves in of backfill behind retaining walls. Collapses of houses, temples are identified in the photo. The broken line in Photo 14 shows cracks and remarkable level differences appeared in the south slope with an inclination of around 5 % at Higashi-Honcho. The ground slid and spread toward the south. Many houses and buildings straddling this

Photo 13 Scarp appeared at north slope of Downtown Kashiwazaki

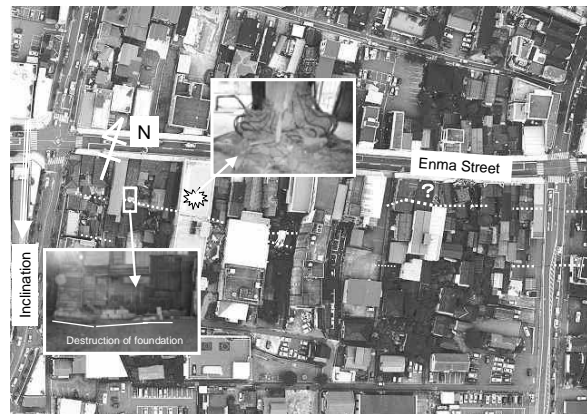
line were heavily damaged and some of them collapsed. The two transverse cracks are clear in the pavement of the east street end. The crack of the roof marked with the star symbol caused partially because bending fracture of the building itself due to collapse of pillars on the ground floor which is open to the street without any wall as well as lateral flow of ground associated with the liquefaction related landslide.

Photo 14 Marked level difference and crack appeared in gentle slope of dune at Downtown Kashiwazaki

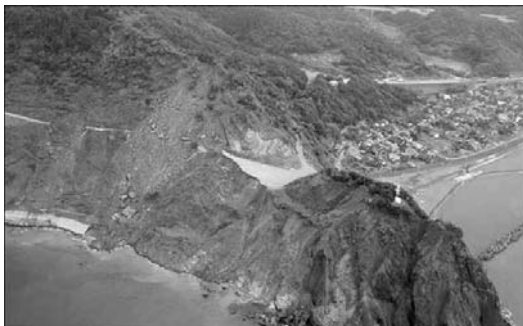
A large translational landslide occurred at Higirigahana, Kashiwazaki, as shown in Photo 15. The slip surface is about 100 m wide at maximum, the sliding distance is over 200 m and the height difference is about 100 m. The surface consists of several bedding planes which constitutes thin alternating beds of sandstone and mudstone. Although the total number of slope failure exceeds 400, it is around 1/10 compared with over 4400 caused by the previous Central Niigata Earthquake because of offshore type events.

Photo 15 Slope failures along the multiple dip surfaces at Hijirigahana (Photo:By Pasco Co.)

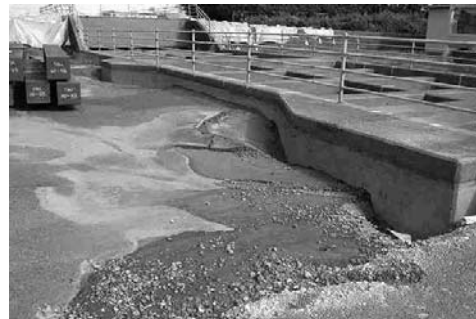
was affected in various features including liquefaction-induced excessive settlement of the ground (Photo 16). A fire occurred at the in-house electrical transformer of Unit No. 3 (Photo 17) due to the settlement of the duct supported by footing foundations. Although many other damage were caused to non-nuclear structures systems and facilities, all reactors in operation at the main event were shut down automatically and no abnormality that could impact the functional or structural integrity was found in the equipment in the reactors.

Photo 16 Settlement and apouted sand at Kashiwazaki Kariwa Nuclear Power Plant

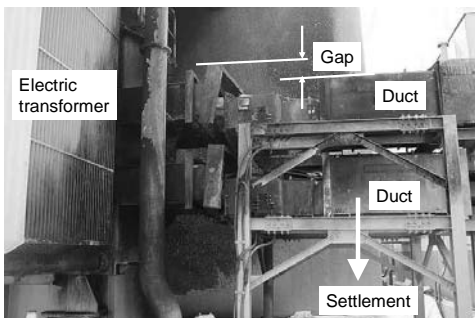
Photo 17 Differential settlement-induced gap which caused fire of the electrical transformer

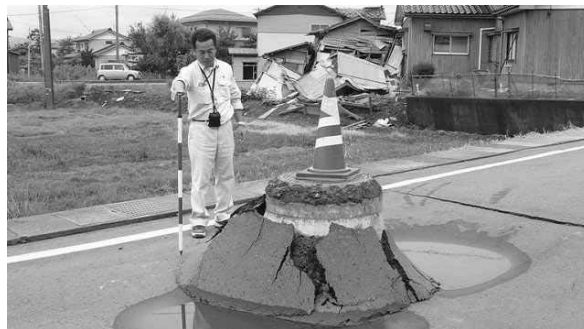
Since numerous sewer manholes uplifted due to liquefaction of soil at the 2004 Central Niigata earthquake were back placed by using cement or lime mixed sand, the number of uplifted manhole is not so much this time. Marked uplifts were, however, identified here and there where no countermeasures have been applied because of non damage last time (Photo 18).

Photo 18 Uplifted sewer manhole (Photo: By Hiroyoshi Kiku)

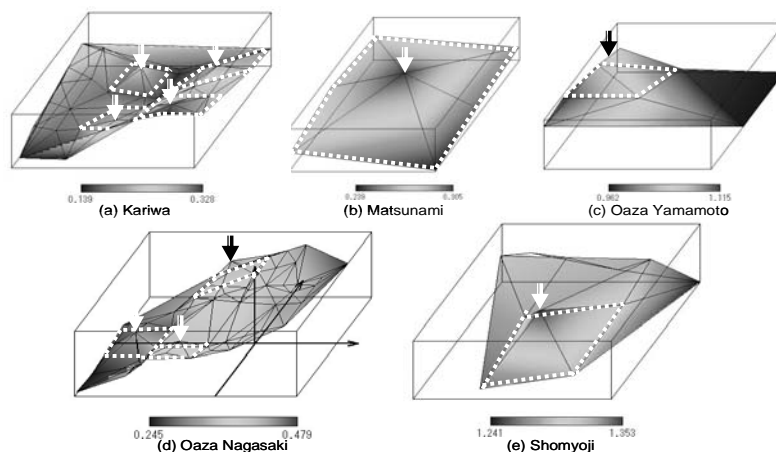
The floor of room in a house is usually supported by several floor posts with an individual footing in Japan, whereas columns and walls are generally supported by continuous footings. In the process of reconnaissance and subsequent investigation, it was made clear as aforementioned that the floor heaves up due to uplift of the floor posts caused by liquefaction of soil. Figure 7 shows examples of survey result regarding floors of damaged houses at various areas shown in Figure 5. Each figure shows single room or multiple rooms. The arrow shows the summit in each room and broken lines show edges of the relevant room. As seen in this figure, the elevation of the floor is the maximum near the center of each room besides inclination and twist of the house itself.

Fig. 7 Heaved up floor of houses damaged due to liquefaction  
(Broken line: Edge of room, Arrow: Top of the floor in elevation)
